**UNITED STATES AIR FORCE**  
**AIRCRAFT ACCIDENT INVESTIGATION**  
**BOARD REPORT**

**C-130H, T/N 88-4404**

**C-27J, T/N 10-27030**

**DATE OF ACCIDENT: 1 DECEMBER 2014**

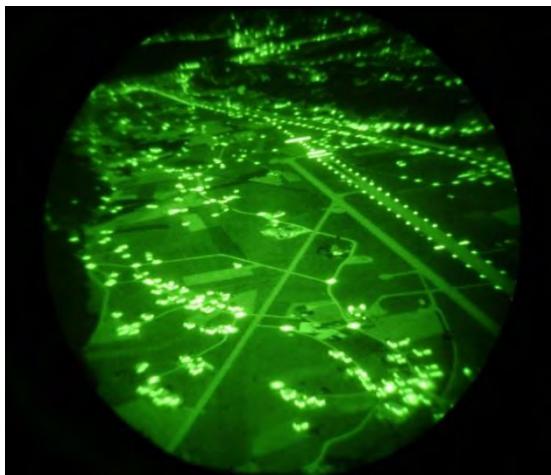
Figure 4.

All aircraft are equipped with external lighting sources to improve their ability to be seen. Both mishap aircraft displayed overt external lighting to include steady position lights and navigation lights as well as white anti-collision strobe lights. This visible energy would be easily acquired by the pilots wearing NVGs, but "halos" surrounding external lights from aircraft may change in appearance (AFMAN 11-217, Vol 3, paragraph 12.13.2.1; Tab DD-21 to DD-22).

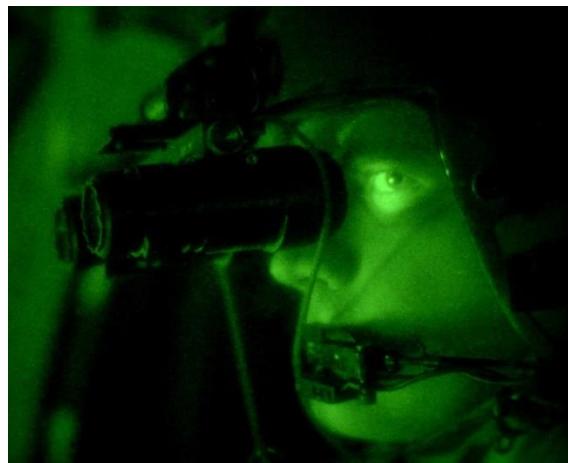
Figure 5.

times (Tab DD-24 to DD-25). The majority of energy at night is infrared. NVGs take ambient light and near-infrared energy, intensify it and display it on a screen that rests approximately 1-inch from the pilot's eyes when helmet-mounted (Figure 5). NVG performance is based on the amount of ambient and infrared energy captured and the scanning technique employed to maximize their effectiveness

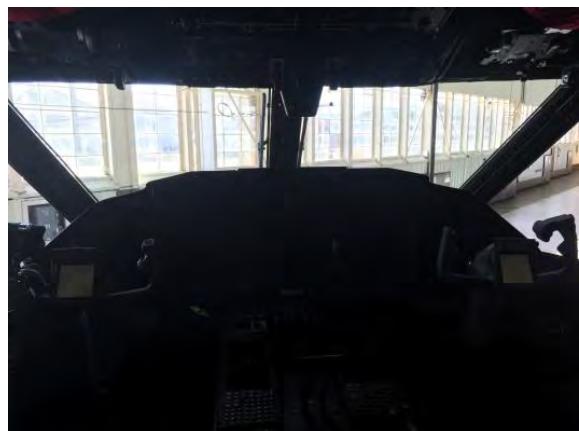
Figure 7. C-27J Canopy

The C-130H and C-27J windshields were designed with segmented sections separated by window posts (Figures 6; 7; 8; 9). This design increases strength during pressurized flight, increases resilience to bird strikes and reduces maintenance costs. Although justified, this common large aircraft design impedes pilots' ability to conduct an uninterrupted visual scan. The Aeronautical Information Manual, paragraph 8-1-8.j, directs pilots to "move their heads to see around blind spots caused by fixed aircraft structures" or even maneuver the aircraft to facilitate their scans (Tab DD-13).

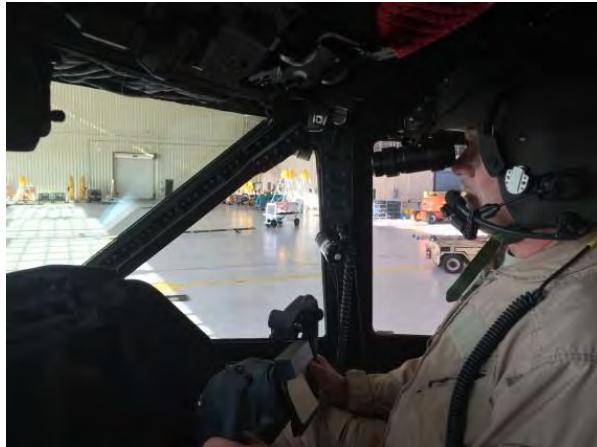
**Figure 8. C-27J Left Seat Pilot Right Side View**

At the time of the midair, MIP1 was flying and conducting scanning duties in the C-27J (V-15.26 to V-15.27). However, his view out the right side of the aircraft was significantly obscured by large window posts and the helmeted MP1 (Figures 8 and 9). MP1's attention was distracted as he was looking down and to the left at the center pedestal performing support pilot duties (Tab V-15.25 to V-15.27). Had he been scanning outside, his view from the right seat would have been impeded by some of the same aircraft structure (Figure 10).

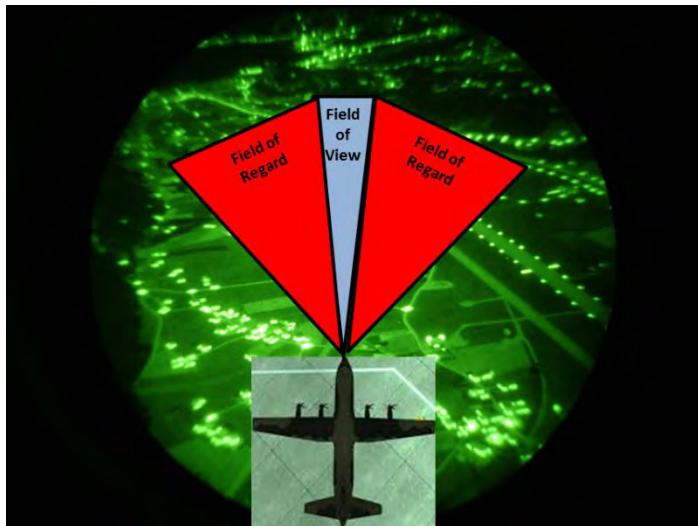
**Figure 12.**

The military flies with various types of NVGs. Some have enhanced design specifications and, therefore, better image quality than others. The C-130H and C-27J pilots were wearing F4949G and AN/AVS-6 goggles, respectfully (Tabs V-15.19; V-16.12). Both models functions the same but with one noticeable difference: the F4949G used by the C-130H aircrew has an enhanced image intensification tube that improves image quality (Tab V-15.19). However, considering both goggles have the same 40 degree field of view and the favorable environmental conditions (e.g., high illumination, contrast) on the night of the mishap, the type of NVGs worn by the C-27J pilots was not a factor in this mishap (Figure 12).

Neither aircrew visual acquired the other with sufficient time to maneuver to avoid a collision. Human factors that affect a breakdown in visual scan are both controllable (cockpit resource management) and not (aircraft structure). In the mishap C-130, MP1, MCP and MN stated that were distracted performing other duties that directed their attention away from the aircraft flight path (Tabs V-4.15; V-6.13; V-15.26 to V-15.27). In the mishap C-27, MIP1, while visually clearing, was unable to see the conflict develop with the mishap C-130 as it was outside his field of view and his field of regard was obscured (Figure 12). MP3 in the mishap C-130 channelized his attention on general aircraft and altitude control placing the mishap C-27 beyond his field of view (Tabs V-3.21 to V-3.22; DD-35). Aircrew over-reliance on TCAS to queue their visual scan resulted in a relaxed scan outside the aircraft V-3.62; V-4.14; V-4.28; V-5.12; V-5.39; V-6.27; V-15.27; V-17.48). The lack of visual cues in the periphery at night can be compounded by the lack of relative motion of offending aircraft (optical flow) and the restricted field of view provided by the NVGs (Tab DD-45 to DD-48; Figure 12).
