# Preventing Main Landing Gear Shimmy Events

Main landing gear (MLG) shimmy is a rare event that starts at airplane touchdown and continues during rollout. Boeing has determined several causes of shimmy, particularly for the 737-200/-300/-400/-500 fleet and offers specific actions that can prevent this vibration from occurring.

By **Warren Malkowicz**, Senior Engineer, Landing Gear Structures, Service Engineering, and  
**Christopher Dubuque**, Senior Engineer, Landing Gear Systems, Service Engineering

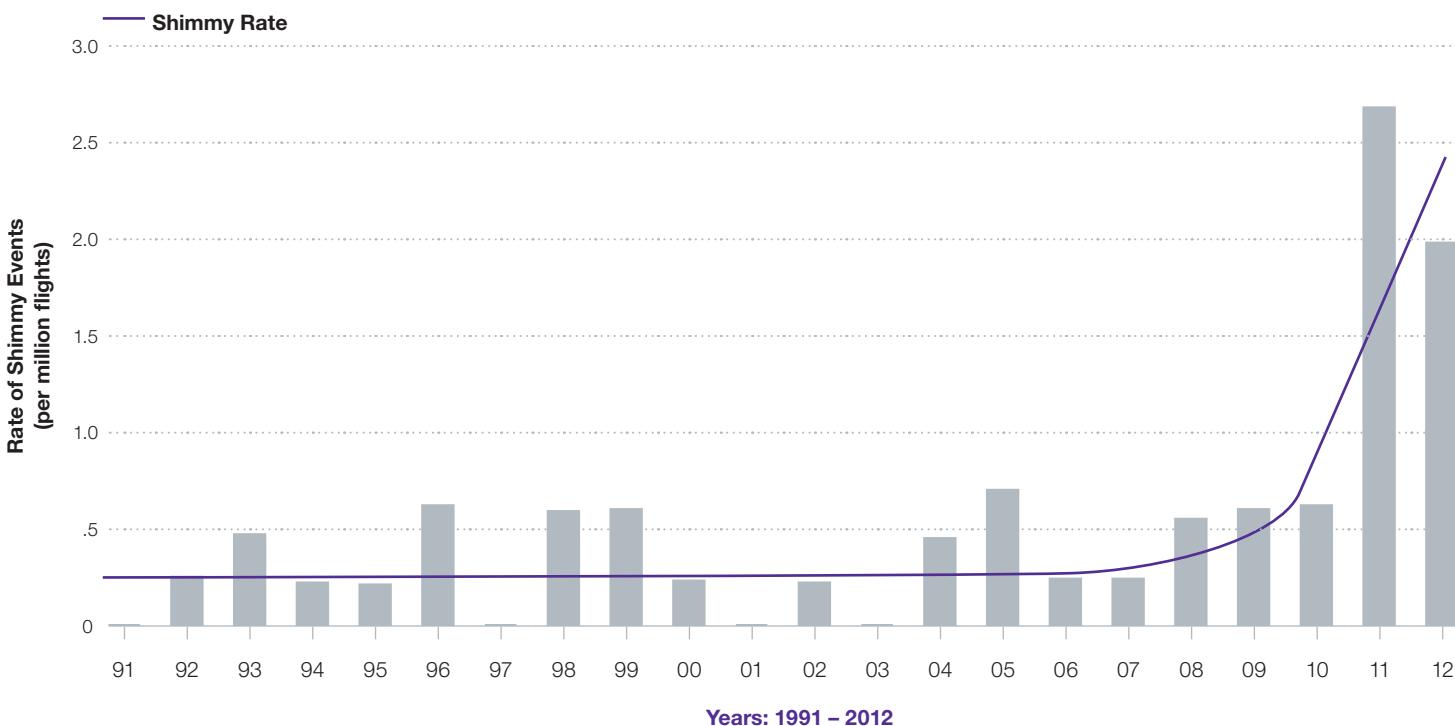
## Figure 2: Increase in shimmy occurrence

The number of reported shimmy events has increased somewhat during the past several years. But the rate has significantly increased due to new operators with less familiarity in maintaining and operating 737-200/-300/-400/-500 airplanes along with the decreasing number of these airplanes in the worldwide fleet (see fig. 2). Because some operators mistakenly categorize the event as a hard landing instead of a shimmy, the amount of shimmy reports is considered to be lower than what actually occurs.

The shimmy rate is calculated by dividing the number of reported shimmy events by the average flight cycles accumulated by the fleet annually. The rate has significantly increased due to new operators with less familiarity in maintaining and operating 737-200/-300/-400/-500 airplanes along with the decreasing number of these airplanes in the worldwide fleet.

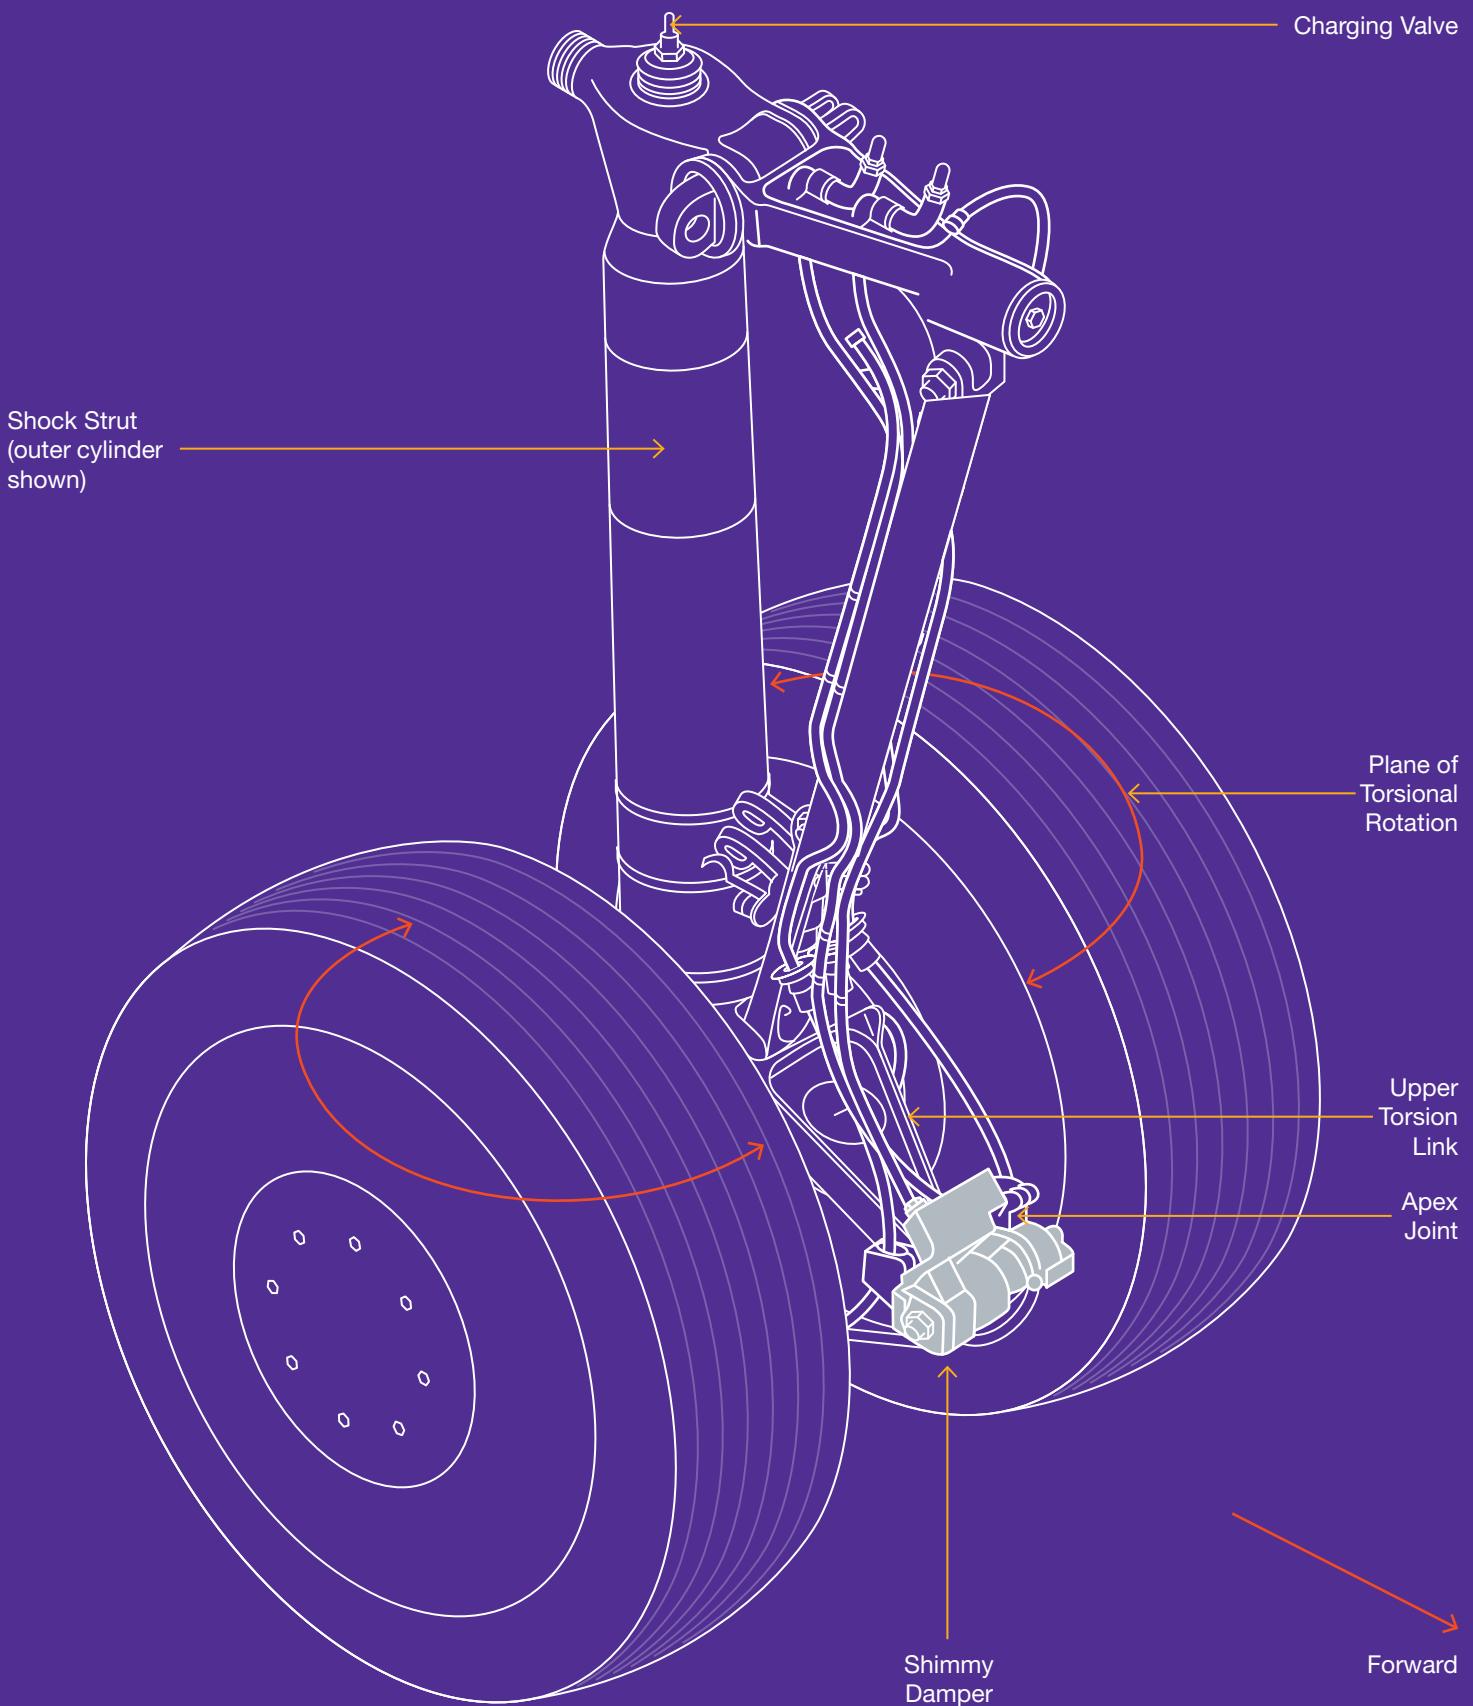
**Figure 3: Torsional vibration is the cause of shimmy**

Shimmy is a torsional vibration excitation of the landing gear in which the inner cylinder, wheels, and tires rotate (or oscillate) relative to the outer cylinder that is fixed to the airplane structure (see fig. 3).

Shimmy is a torsional vibration mode of the landing gear in which the inner cylinder, along with the wheels and tires, rotates (or oscillates) relative to the outer cylinder. To prevent this vibration mode, airplanes have a hydraulic damper installed between the upper and lower torsion links to allow a small, highly damped motion to occur around the torsional axis of the gear.
