# Unreliable airspeed indication and stall warning involving Airbus A320, VH-FNP

near Perth, Western Australia, on 12 September 2015

**ATSB Transport Safety Report**  
Aviation Occurrence Investigation  
AO-2015-107  
Final – 4 April 2019

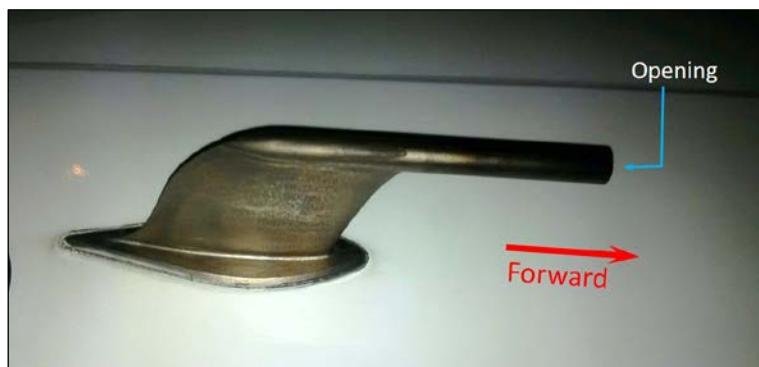
**Figure 15: Pitot probe**

The ATSB found that blocked drain holes in the pitot probes prevented water from being effectively discharged, resulting in erroneous airspeed measurements in all three systems at various times during the take-off and climb. The erroneous airspeeds were not detected by the flight crew, but had been detected by the system, resulting in the autothrust and autopilot disconnecting, and the generation of multiple alerts, including a NAV ADR DISAGREE alert. That alert required the flight crew to crosscheck the three airspeed indications and the result would indicate if they had an airspeed or angle of attack disagreement. Due to the limited space in the alert message area, the NAV ADR DISAGREE alert was initially pushed off the screen by engine related alerts that were programmed to have a higher priority.

The pitot probe is a tube with a forward facing opening mounted on the side of the fuselage (Figure 15). To ensure it has clean air, the opening of the probe is held away from the fuselage. To prevent water from blocking the probe, two small drain holes are drilled into the lower side of the probe.

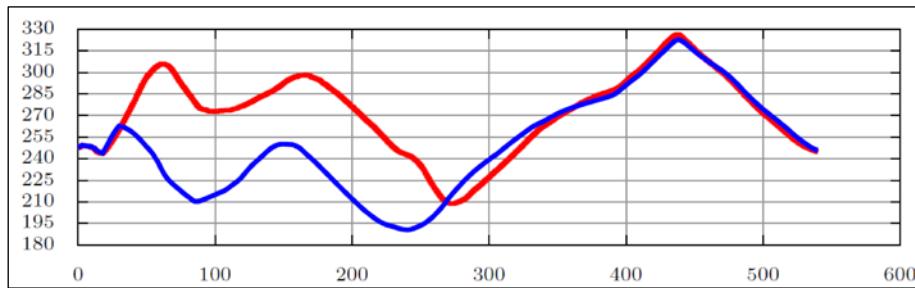
**Figure 26: Airspeed estimation during the climb phase (recorded – red, estimated – blue)**

The simulation showed that the recorded CAS 1 deviated from the actual airspeed for a period of about 4 minutes, before returning to the actual airspeed (Figure 26). The simulation showed that CAS 1 was overestimated by up to 60 kts. The estimated and recorded values reconverged at about 0700, shortly before the aircraft was levelled out at FL 200.

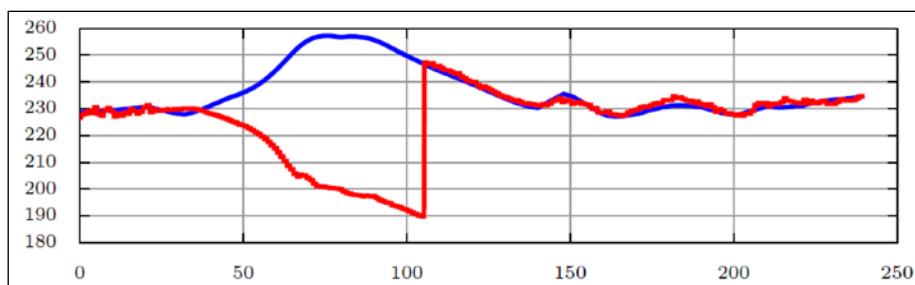
**Figure 27: Airspeed estimation during the descent phase (recorded – red, estimated – blue)**

The simulation showed that CAS 1 deviated significantly from the actual airspeed (Figure 27). In this case, the recorded airspeed underestimated the airspeed by up to 60 kt, before the flight crew switched to ADR 3 at about 106 seconds. The correlation between the recorded and estimated airspeeds from this time onwards indicates that ADR 3 was correctly computing the airspeed.

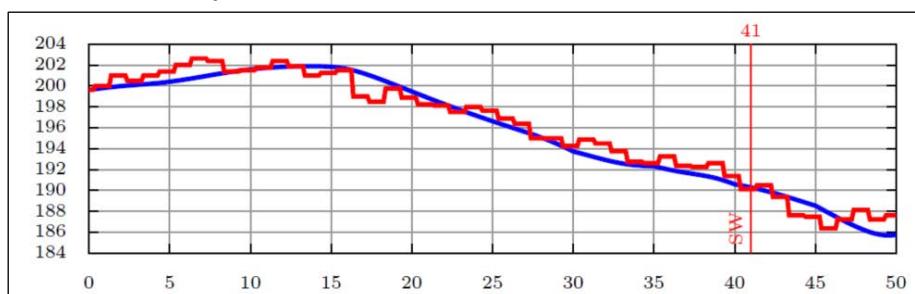
**Figure 28: Airspeed estimation around the time of the stall warning (recorded – red, estimated – blue)**

A period of 50 seconds, incorporating the stall warning at 0755:03, was simulated (Figure 28). This showed that, at this time CAS 3, which was the airspeed referenced on the captain's PFD, was consistent with the actual airspeed.

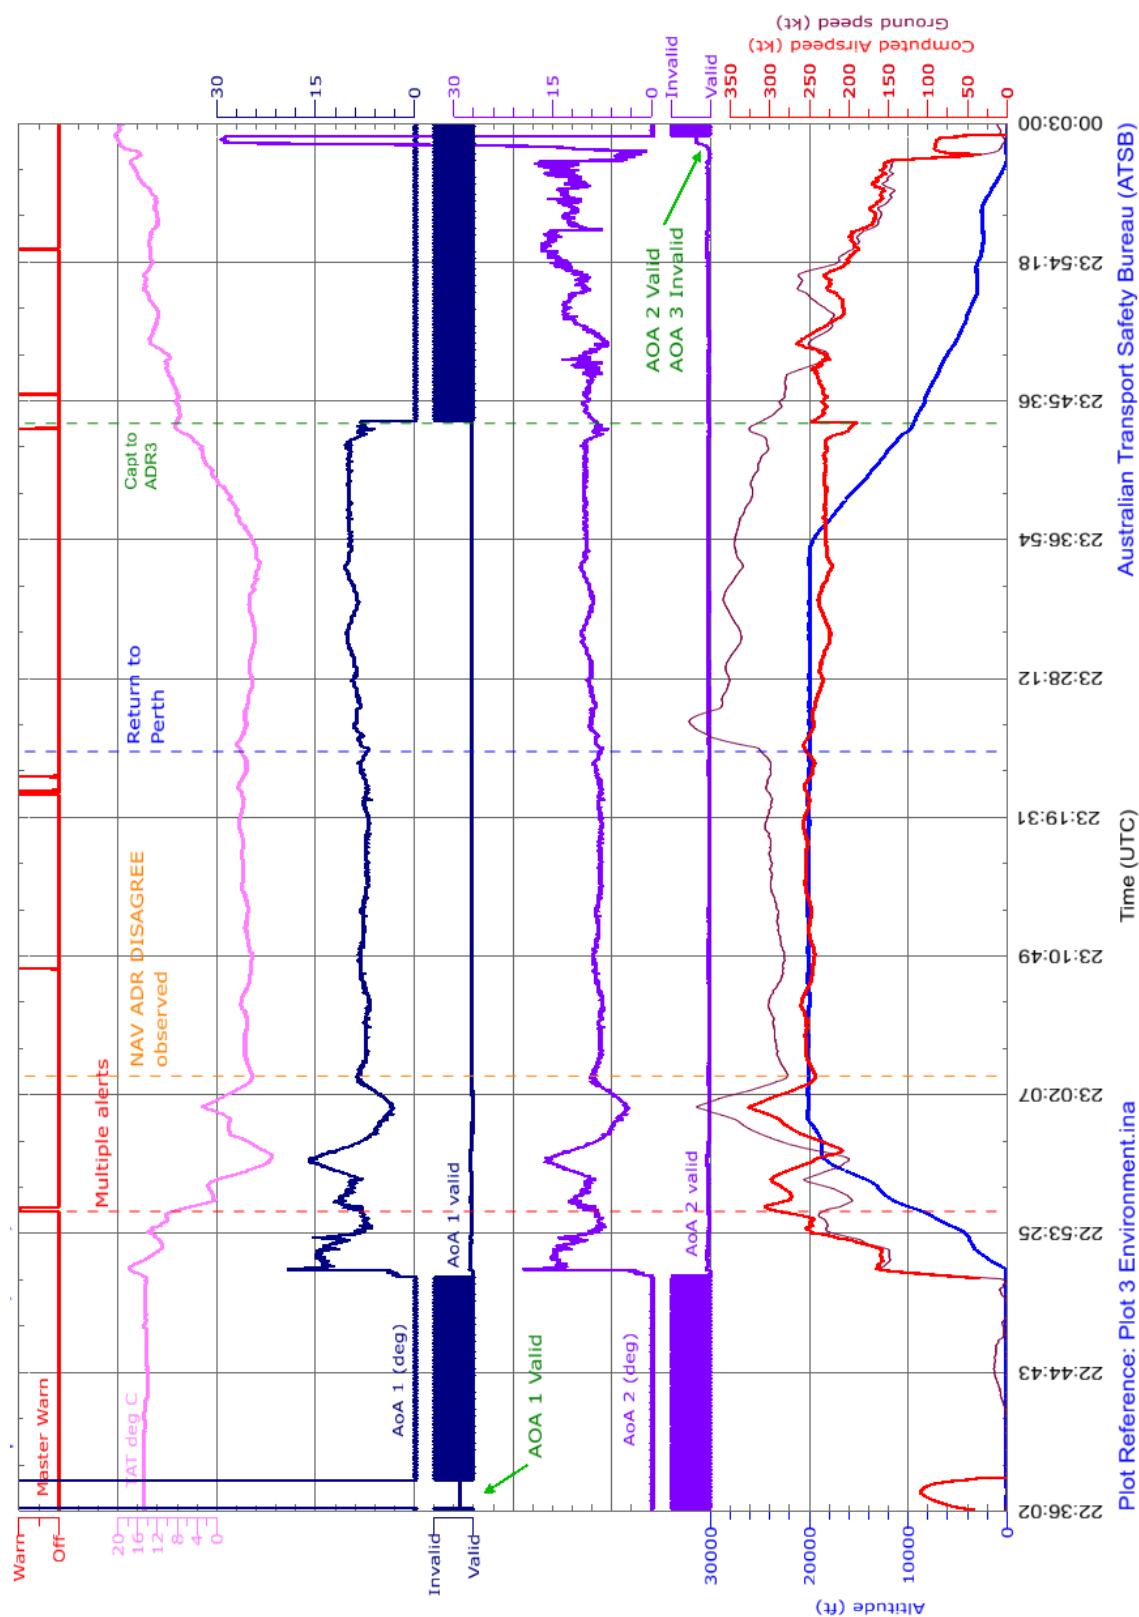
**Figure C4: Flight data – environmental parameters (complete flight)**

Note: The validity of the angle of attack (AOA) is inferred by its behaviour. When it cycles between maximum and minimum values, it is deemed invalid. Source: ATSB

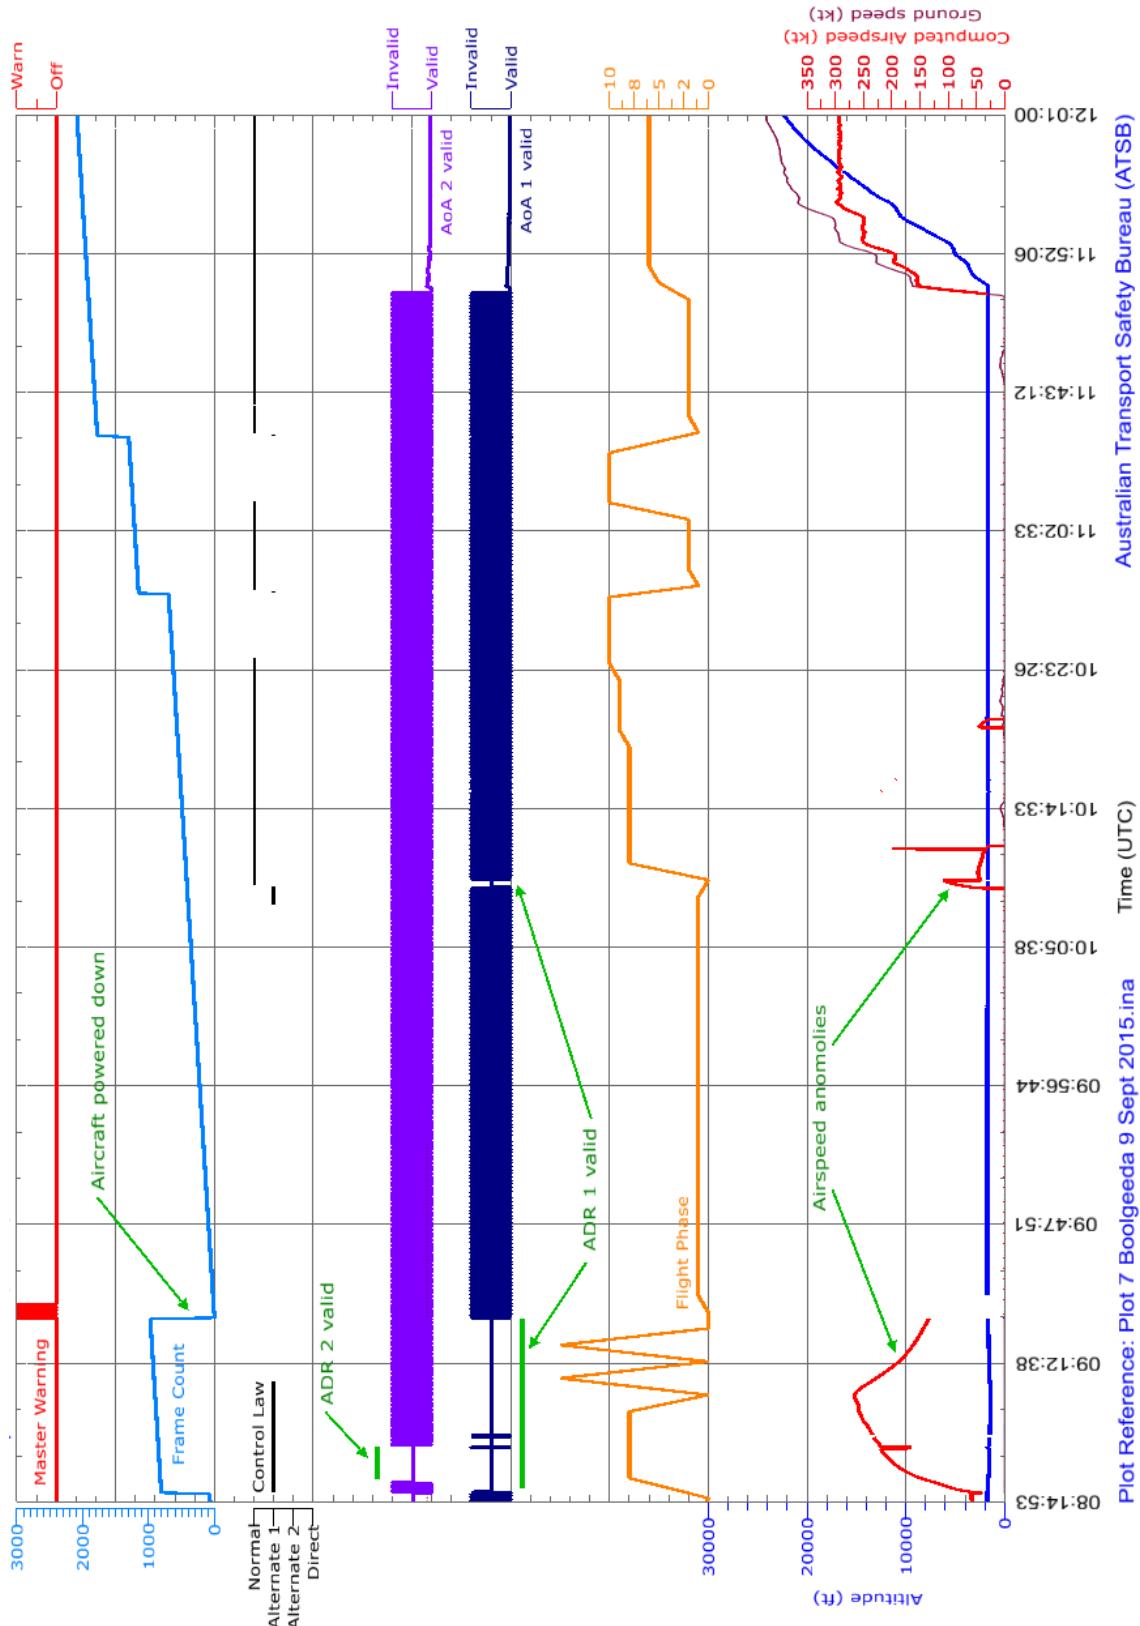
## Appendix E – Recorded data from 9 September 2015 airspeed anomaly

A review of the previous flights contained on the FDR found that on 9 September 2015, the recorded airspeed increased up to around 250 kt while the aircraft was stationary on the ground at Boolgeeda Airport, WA.<sup>46</sup> This was three flights prior to the incident flight on 12 September 2015.

Note: The frame count is a parameter recorded on the FDR that counts in seconds. This count is generated external to the FDR, so when power is removed from the FDR, but other systems have power, the count continues, but is not recorded by the FDR, resulting in steps in the count. If the aircraft is completely powered down, the count resets to zero. Such steps indicate some level of powering down of the aircraft. Source: ATSB
