FINAL REPORT
A - 158/CENIPA/2013

OCCURRENCE:	ACCIDENT
AIRCRAFT:	PT-MVL
MODEL:	A330-203
DATE:	02SEPT2013

This is the Final Report of the 02SEPT2013 accident with the A330-203 aircraft, registration PT-MVL. The accident was classified as "Caused by Meteorological Phenomenon in Flight".

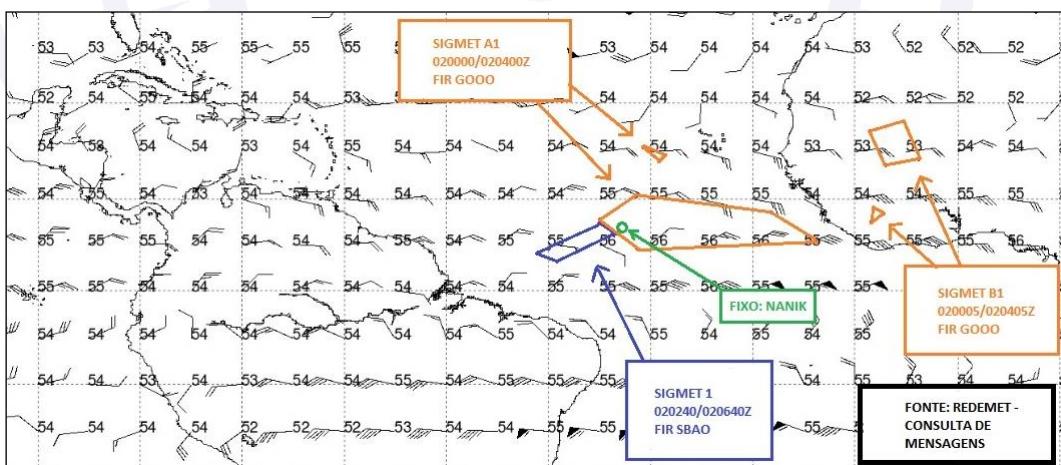
Figure 5 - Wind chart at 0000 (UTC), from FL390.

The FL390 (39,000 ft.) Wind Chart of 0000 (UTC) of 02SEPT2013, valid from 0600 p.m. on 01SEPT2013 to 0600 p.m. on 02SEPT2013, predicted northeast winds with 15 to 20kt intensity, discarding the possibility of severe turbulence in clear sky (CAT). This product was available for access on the REDEMET website at 1704 (UTC) on 01SEPT2013 (Figure 5).

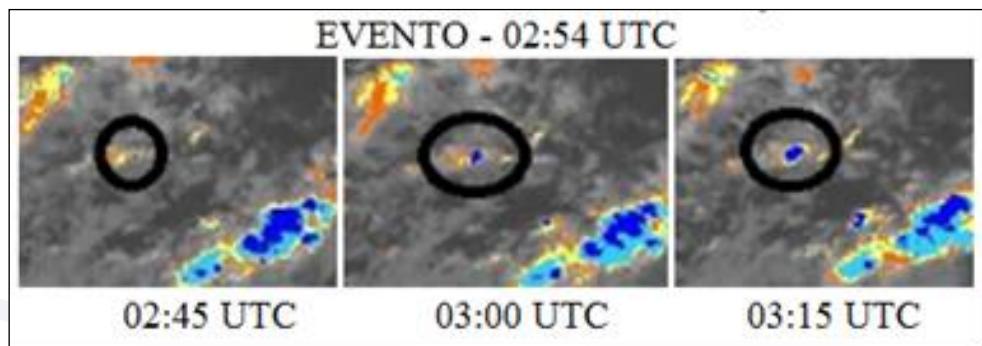
Figure 6 - Satellite images of CPTEC recording the development of cumulonimbus (CB) cells, in the region of the occurrence.

On 02SEPT2013, between 0230 (UTC) and 0300 (UTC), the ITCZ (Intertropical Convergence Zone) oscillated, in the Atlantic, between coordinates 5 ° N and 12 ° N, with moderate convective activity. The region of the abnormal condition was surrounded by cumulonimbus (CB) cells, predominantly in development / maturity phase (Figure 6).

With the help of the enhanced image of the CPTEC and the radiosounding of Fernando de Noronha (most representative place of the abnormal condition region), it was possible to infer that its top, at 0245 am (UTC), was around FL370, that is, below (FL 400). It was evolving fast, arriving at 0300 am (UTC), as highlighted by the images shown in Figure 6, close to the flight level of the aircraft.

In this sense, and considering that no adverse weather formations were detected or visualized on the radar screen at the time of the accident, it can be deduced that the aircraft would be flying over a cumulonimbus cloud, at FL 400. Its top was estimated in FL 370, in the development / maturity phase, as highlighted in the CPTEC satellite images (Figure 6).

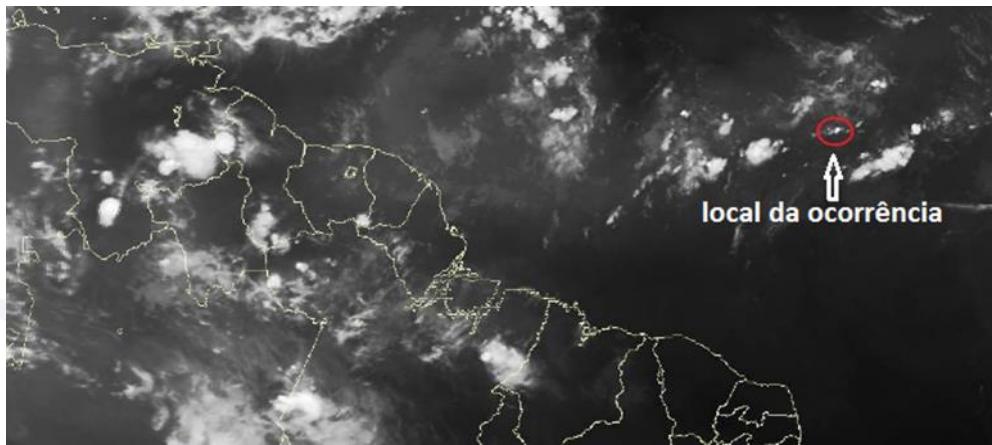
Figure 8 - Satellite image of 02SEPT2013, at 0300Z, in the water vapor image.

In relation to the humidity present in medium and high levels of the atmosphere, in the image of water vapor of 0300 (UTC), it can be observed that the significant humidity in the region of the abnormal condition was restricted to the CB. It suggests that the aircraft was not inserted into extensive areas of significant cloudiness at the time of the reporting of severe turbulence. This fact clarifies why the crew did not see any formation in the route, when near the place of the event (Figure 8).

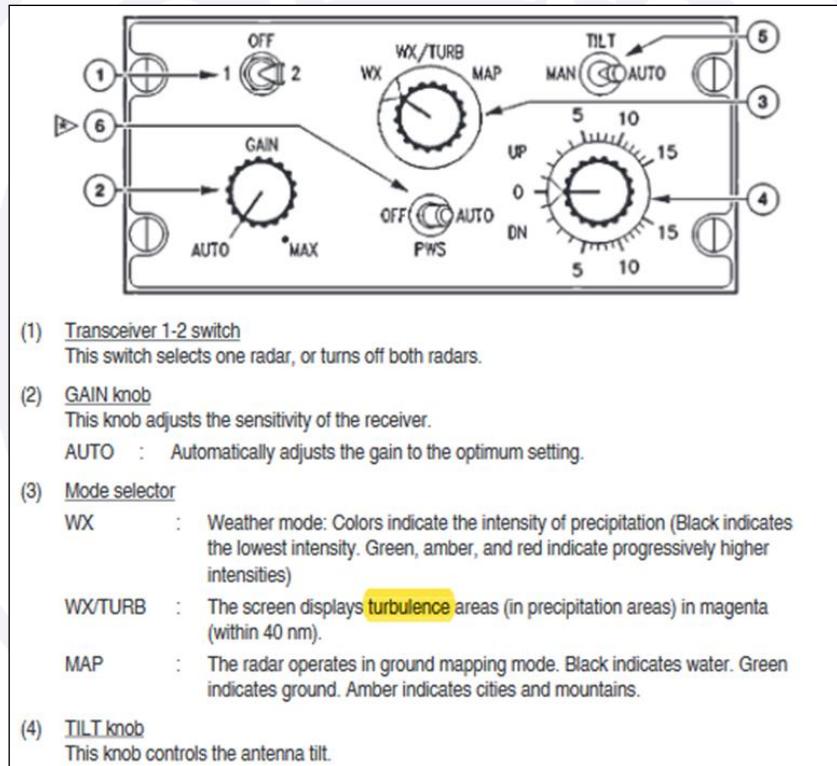
Figure 11 - Honeywell radar control panel installed on the aircraft.

The aircraft was equipped with Honeywell RDR-4B meteorological radar (Figure 11).

According to the information provided by the pilots, the radar control panel at the time of the accident had the following adjustments:

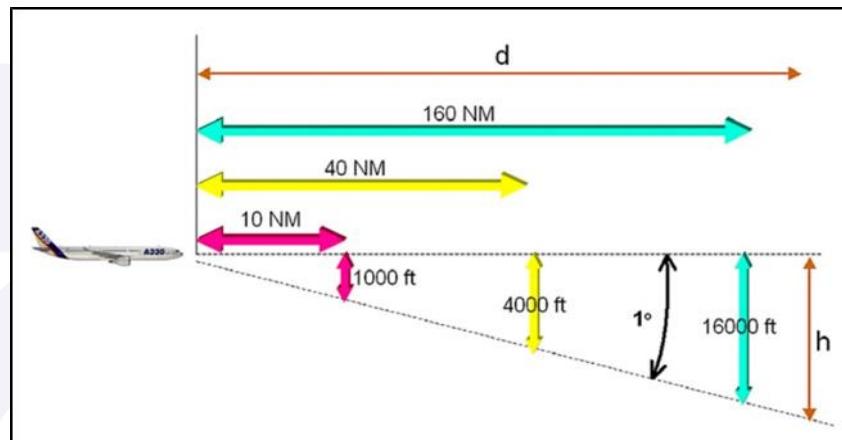
Figure 13 - Relation between distance, TILT and height.

To illustrate, the simulation below was presented, indicating that the eco-radar would disappear at 40NM away with a TILT of -1° , with the top being located at 4,000ft below the aircraft's flight level (Figure 13).

Considering that, according to the FDR, the range of the two pilots (PF and PNF) was set to 80NM and that the TILT selected was -1° . It could be inferred that this configuration of the on-board radar did not allow the detection of the CB cloud that was forming at the lower levels (FL 370) of the aircraft (Figure 13).

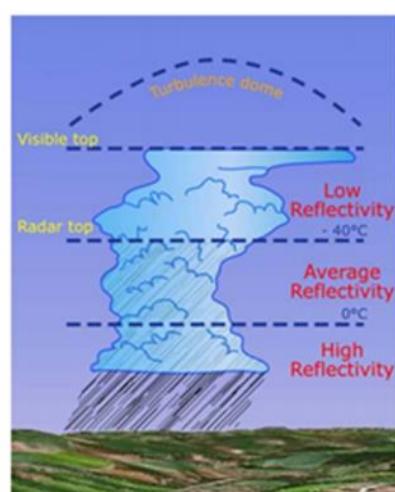
Figure 16 - Reflectivity degree of the storm.

In the same way, the airbus publication - Flight Operations Support & Services - Getting to grips with Surveillance, in item 6.1.1.2, which talked about the reflectivity of storms, emphasized that a storm could be divided into four areas, with the reflexivity degree of each one of them (Figure 16):

- **The turbulence dome** defines an area of very severe turbulence. It can reach several thousand feet above the visible top, when the thunderstorm is growing
- **The upper part above the altitude of -40°C** (if applicable) contains ice crystals only. It reflects a very small portion of the radar pulse. This part may be invisible on the weather radar image whereas it is clearly visible through the windshield
- **The intermediate part from the freezing level up to the altitude of -40°C** contains ice crystals and super-cooled water. The super-cooled water reflects a portion of the radar pulse. Ice crystals absorb the remainder of the radar pulse
- **The lower part up to the freezing level** is the most reflective part of the thunderstorm due to the heavy rain.
