Serious incident

to Dornier 328

registered **HB-AEO** and operated by SkyWork
and to Embraer 190

registered **PH-EXB** and operated by KLM Cityhopper
on 7 March 2016
at Bâle-Mulhouse

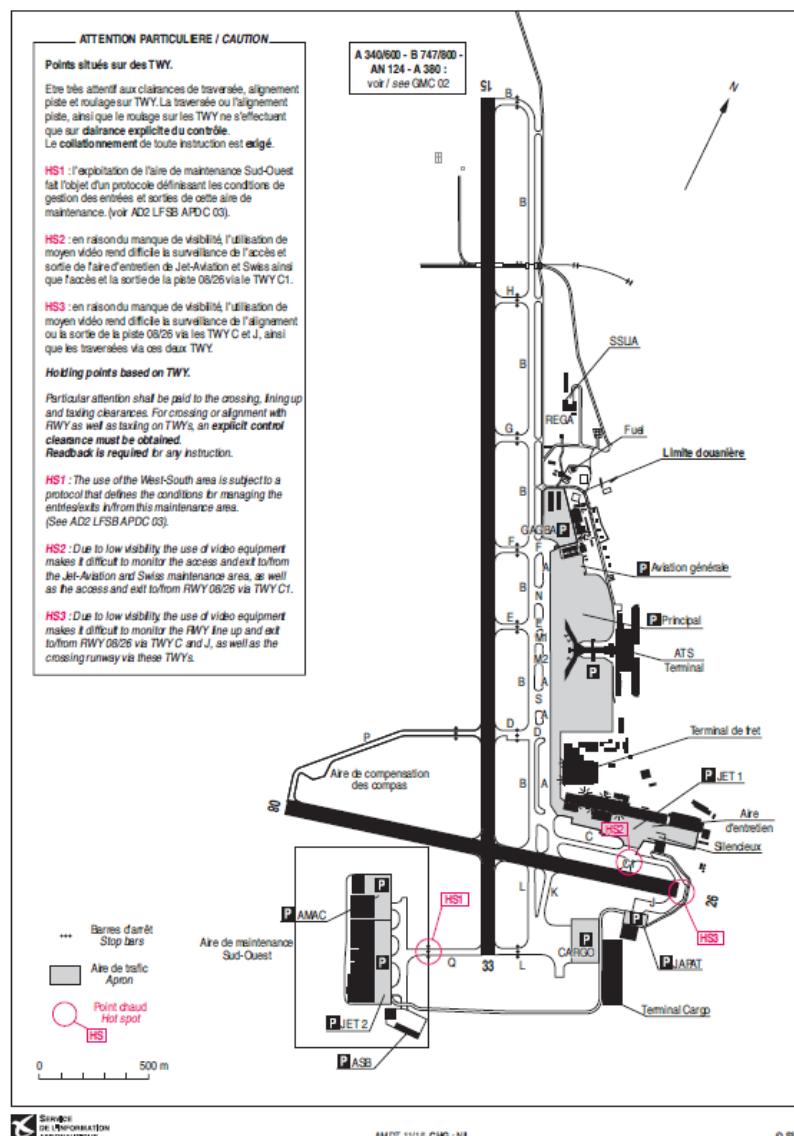
Figure 2: Ground movements chart

The Basel-Mulhouse aerodrome has a movement display system that informs the ATC of the ground movements of the traffic (Figure 2). This system provides a synthetic colour image of the aircraft and vehicles on the runways and taxiways. This basic informative system does not include automatically generated runway details, easy identification of moving vehicles or runway incursion warnings. The ATCs also said that the accuracy of the system is such that the exact position of an aircraft cannot be located.
