Air Accident Investigation Unit

SYNOPTIC REPORT

SERIOUS INCIDENT

ATR 72-212A, EI-FCY

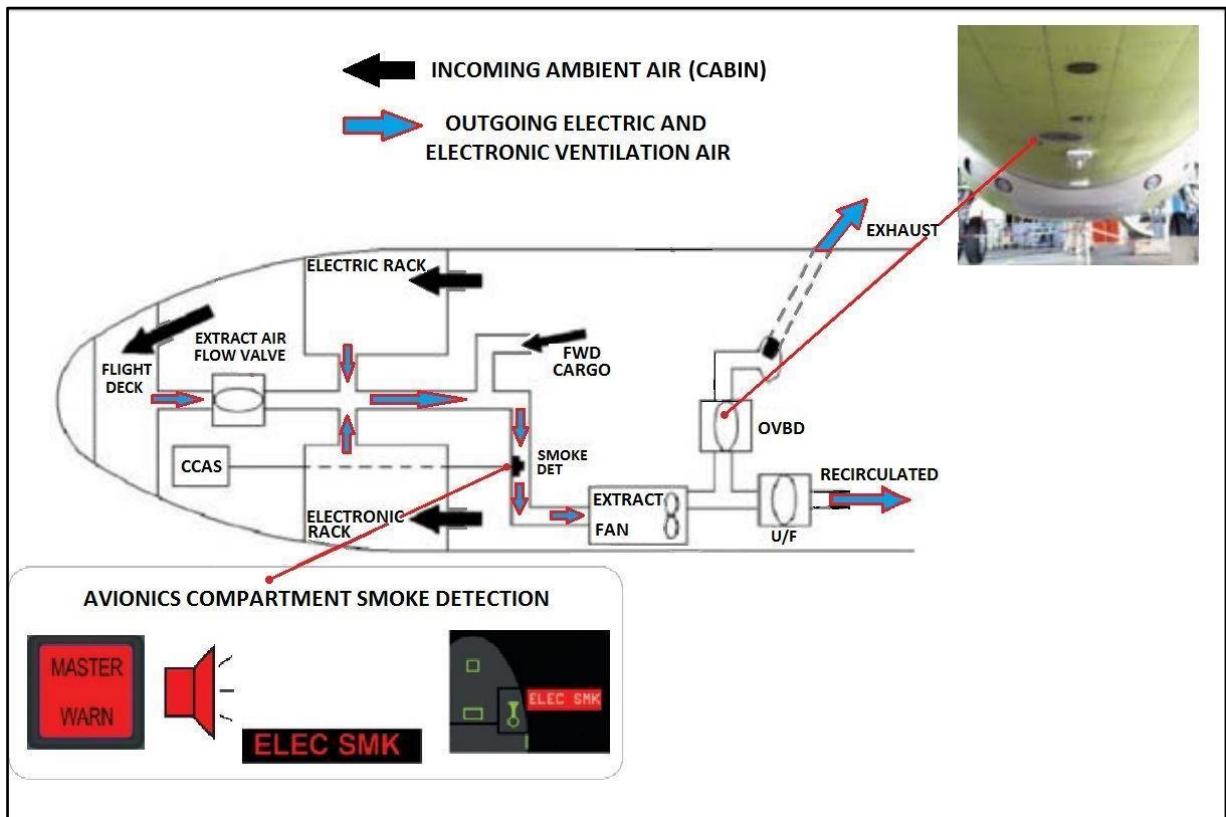
Figure No. 1: Schematic of Avionics Ventilation Air

As the smoke detector is located in the extract duct of the avionics bay, and is monitoring air from the Electric Rack, Electronic Rack and Flight Deck Electrical and Electronic Equipment, smoke detected could be from component(s) in any of these areas. A schematic diagram of the avionics ventilation air circuit is shown in **Figure No. 1**. A note in the QRH cautions flight crew that air conditioning smoke may also trigger an electrical smoke warning.
