# Air Accident Investigation Sector

### - Final Report -

AAIS Case N°: AIFN/0011/2016

# Nose Gear Tire Tread Separation and Number 1 Engine Failure

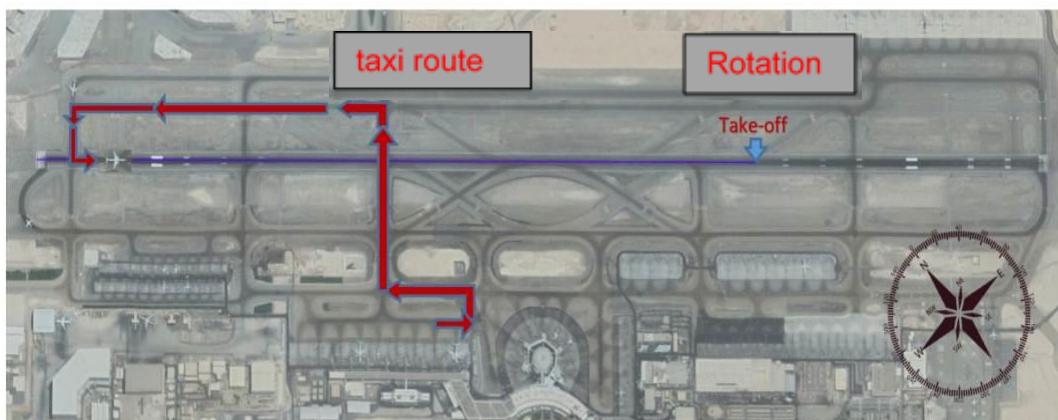
Figure 1. EY450 taxi route to runway 13R

The Aircraft was parked at parking bay 308. The pushback was conducted using a conventional tug and towbar combination. After pushback at 1120 LT, the Aircraft taxied to runway 13R (figure1), along taxiway Echo 6, crossed runway 13, turned left onto taxiway Delta, then turned left onto taxiway Delta 2 to enter runway 13R.

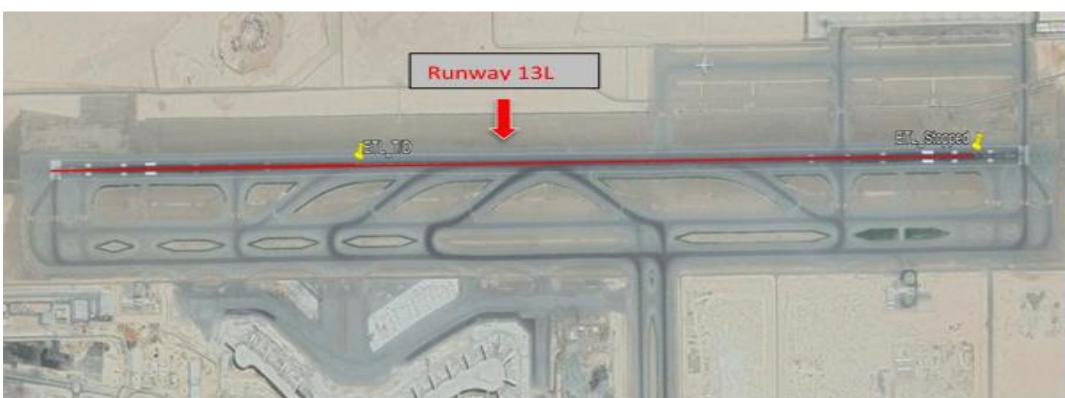
Figure 2. EY450 landing on runway 13L

The Aircraft touched down at 1205:14 LT, at an IAS of 192 kt, approximately 1,280 meters beyond the threshold, and came to a complete stop after travelling 2,590 meters. The runway remaining distance was 230 meters (figure 2).

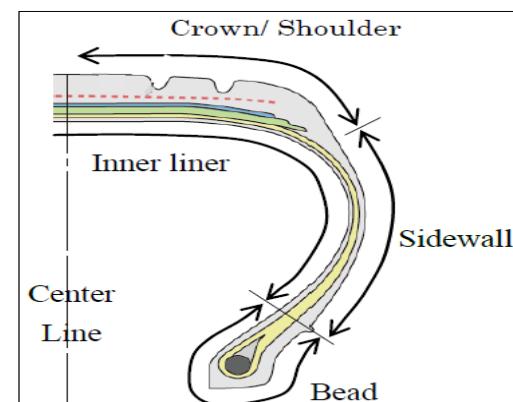
Figure 12. NLG Tire, wheel structure

- All of the tread ribs, cut-protector and part casing belt cords were detached from the tire casing (figure 10).
- About 80% of the total tread debris was collected for examination purposes (figure 11).
- Inner liner, both sidewalls and both bead areas were in a normal condition (figure 12 is showing the wheel structure).
