REPORT

HCL 47/03 - 510-000319

Date / Time (UTC):	September 8 th , 2003, at 0744 hours	
Position:	Copenhagen Airport, Kastrup (EKCH) Taxiway V2/Runway 04R	
Airspace Classification:	Maneuvering Area	
Aircraft:	A	B
Registration:	C-GIIW	OY-GRN
Type of Aircraft:	C340	A330-200
Altitude (→ ↗ ↘):	On ground	On ground
Flight Rules	IFR	IFR
Civil or Air Force:	Civil	Civil
Weather conditions:	CAVOK	
Light and visibility:	Daylight – unlimited	
ATS units:	Kastrup Ground (121,90 MHz) & Kastrup Tower (118,57 MHz)	
Source of Information:	Air Traffic Safety Report (ATSR), Air Traffic Incident Report (A), Communication Data, Radar Data and AAIB investigation	
Classification of the Air Traffic Incident:	B) Safety not assured

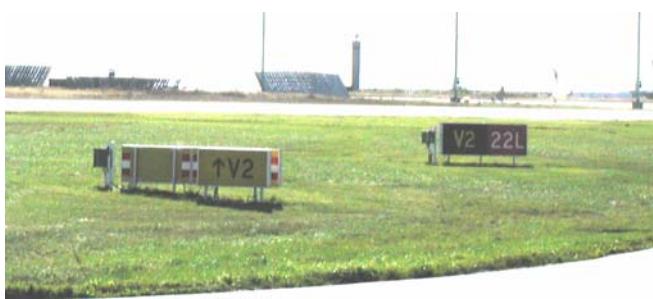
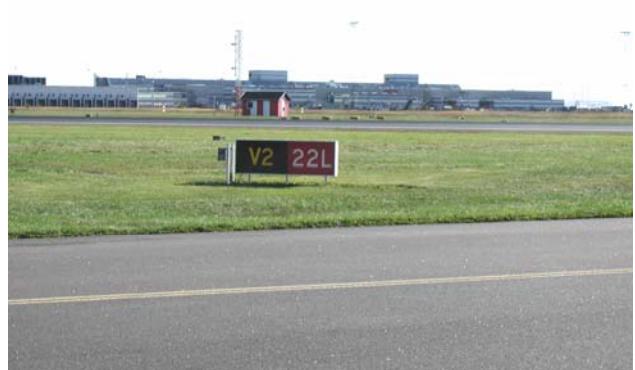
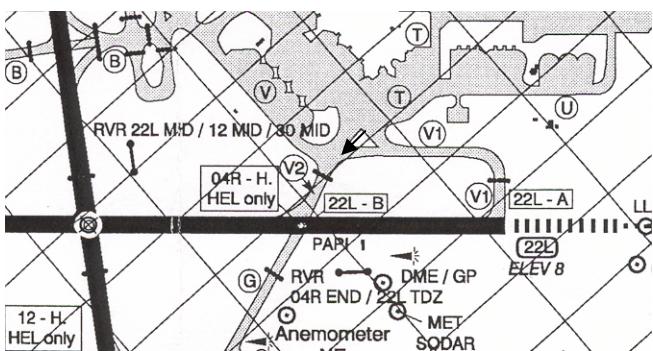
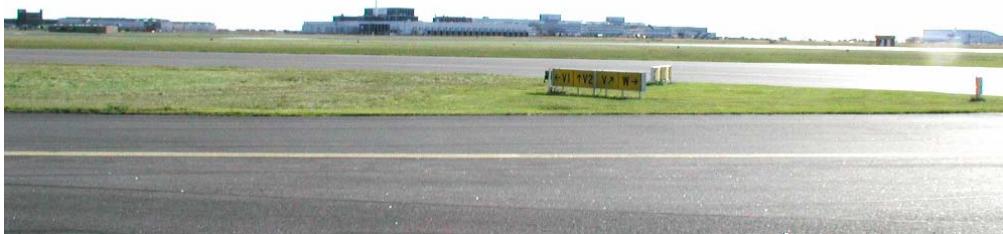
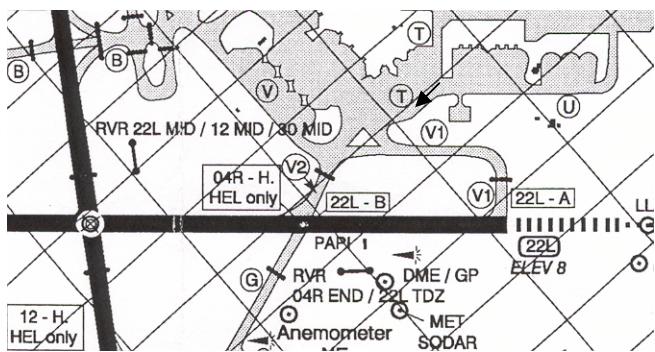
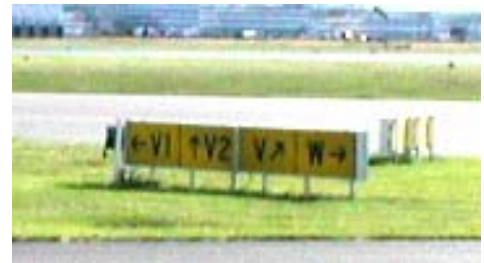
The taxiways T, V1, V2 and V were 4 separate taxiways. Taxiway V1 and V2 were not segments of taxiway V but unique and separate taxiways. (See the two photos below. The photos are taken on taxiway T in the direction of V2.).

It is the opinion of the Danish AAIB that the design and the use of certain taxiway designators at EKCH could lead to confusion and mistakes during taxiing. Flight crew might expect that the taxiways V1 and V2 would be segments of taxiway V, which could lead to misinterpretations of taxi instructions. It might be difficult during taxiing, especially for single pilot operations and/or at low visibility conditions, to be fully focused on the outside area (taxiways V, V1, V2 and T) and the taxi-chart at the same time. For that reason, the Danish AAIB finds the designators V, V1 and V2 inexpedient and latent hazard to flight safety.

The Danish Aircraft Accident Board recommends that the Danish Civil Aviation Administration should consider more suitable taxiway designators and more clear taxiways signs. (**REK-06-2006**).
