Lessons learned from Belgocontrol Power Failure

Author: Alain Du Bois
Function: Safety Advisor
Location: Brussels
Date: 29.09.2017

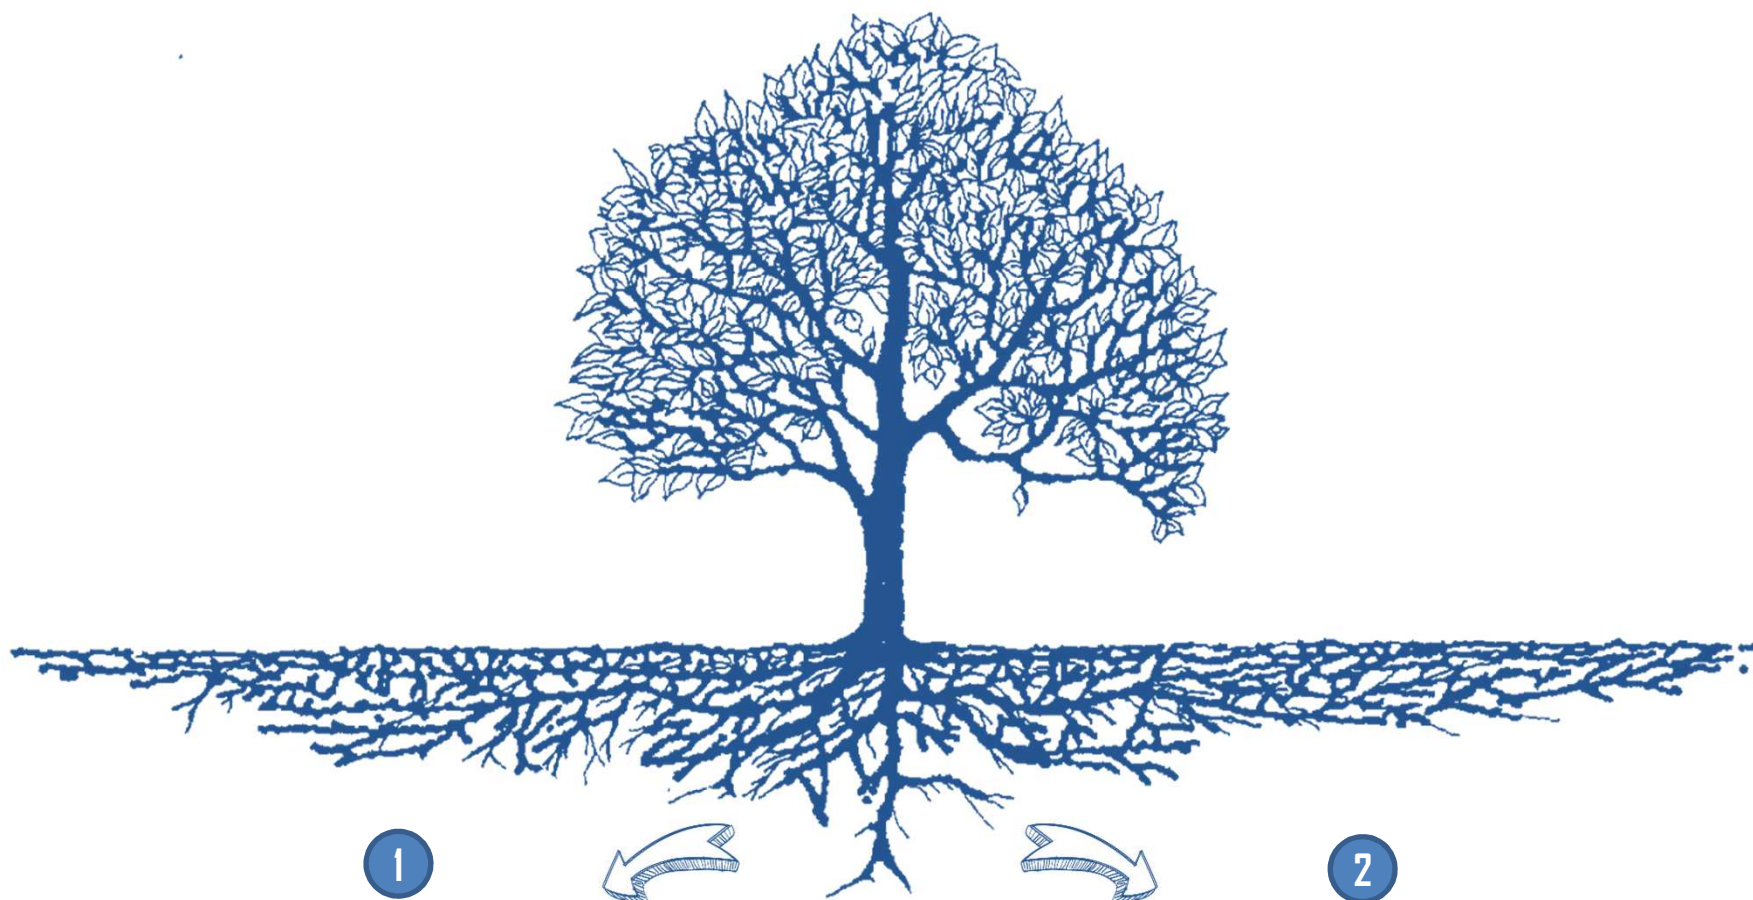
Found technical root causes

1
Absence of connection between the neutral conductor of the emergency generators and earth (diesel generators).

2
The occurrence of a coincidental fault on one of the loads (motor of the cooling installation).
