**SERIOUS INCIDENT**

| <b>Aircraft Type and Registration:</b> | Boeing 737-4Q8, G-JMCR | |

**Synopsis**

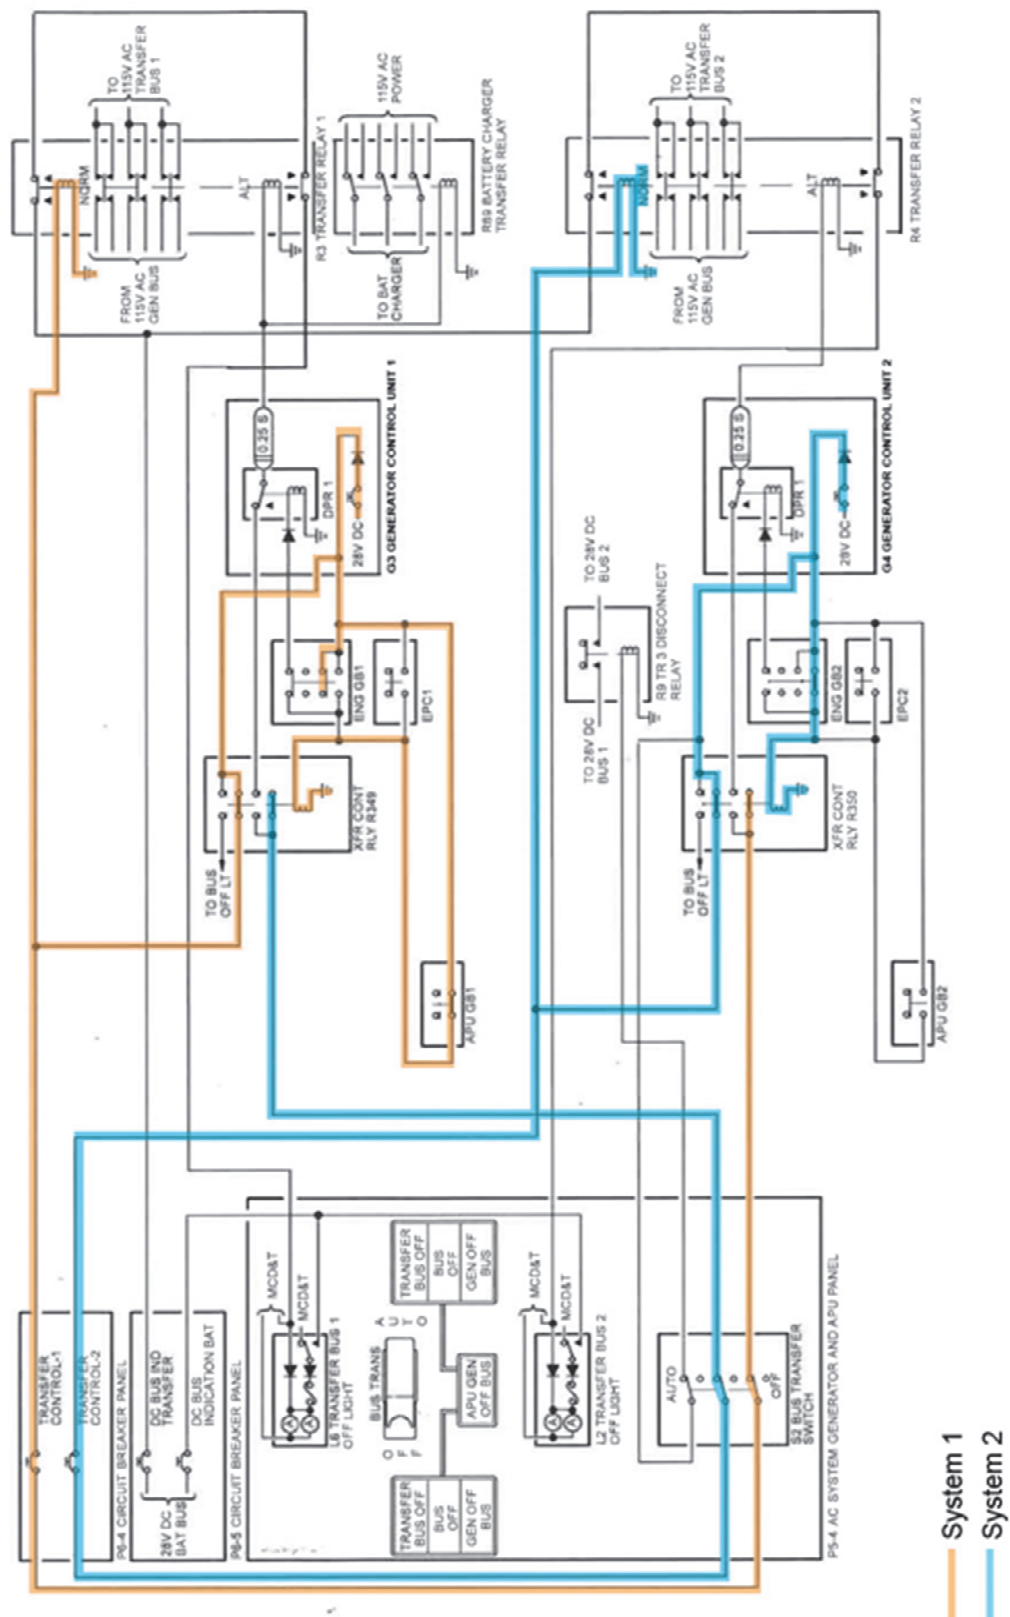
Figure 7

Each generator Bus provides power to a Transfer Bus through the NORMAL position of the Transfer Relays (R3 /R4). If one generator losses power, and provided the Bus Transfer switch is at AUTO, the remaining generator will automatically power the other generator's Transfer Bus. During the accident flight, Gen Bus 1 was powered by the APU and Gen Bus 2 by the generator on the right (2) engine. This situation is shown at Figure 7.

Routing for electrical power at start of flight
