Air Accident Investigation Sector

Incident - Final Report -

AAIS Case N°: AIFN/0004/2018

Slow Cabin Depressurization during Descent

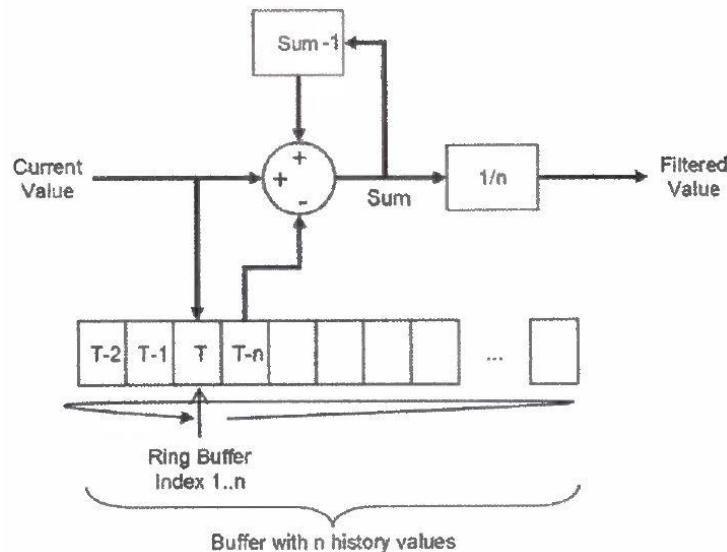
Figure 8. Flow diagram of moving average filter

It could be shown by analysis that SEU events could lead to a permanent offset of some parameters in the involved CPC. Such behavior is caused by moving average filters in the software code. The special coding of these filters in the CPC software allow that one single bit-flip in a memory cell leads to a permanent offset. This offset will only recover at the re-initialization of the filter. This recovery only happens by a hard reset (power reset).

The flow diagram (figure 8) illustrates the software code of the moving average filters, which were implemented in the CPC software. This type of moving average filter was applied for the calculation of the scheduled landing pressure.

If a bit-flip, as a result of an SEU, or an intermittent digital failure (see sub-section 1.16.4.3), occurs in one of the memory cells of the value for $T \dots T-n$, or at $Sum-1$, then this offset will be continuously active until the filter is re-initialized.
