Investigation Report

Type of Occurrence:	Accident
Date:	15 February 2013
Location:	Berlin-Schönefeld Airport
Aircraft:	Airplane
Manufacturer / Model:	Embraer / EMB-500
Injuries to Persons:	None
Damage:	Aircraft severely damaged
Other Damage:	Aerodrome equipment
State File Number:	BFU CX001-13

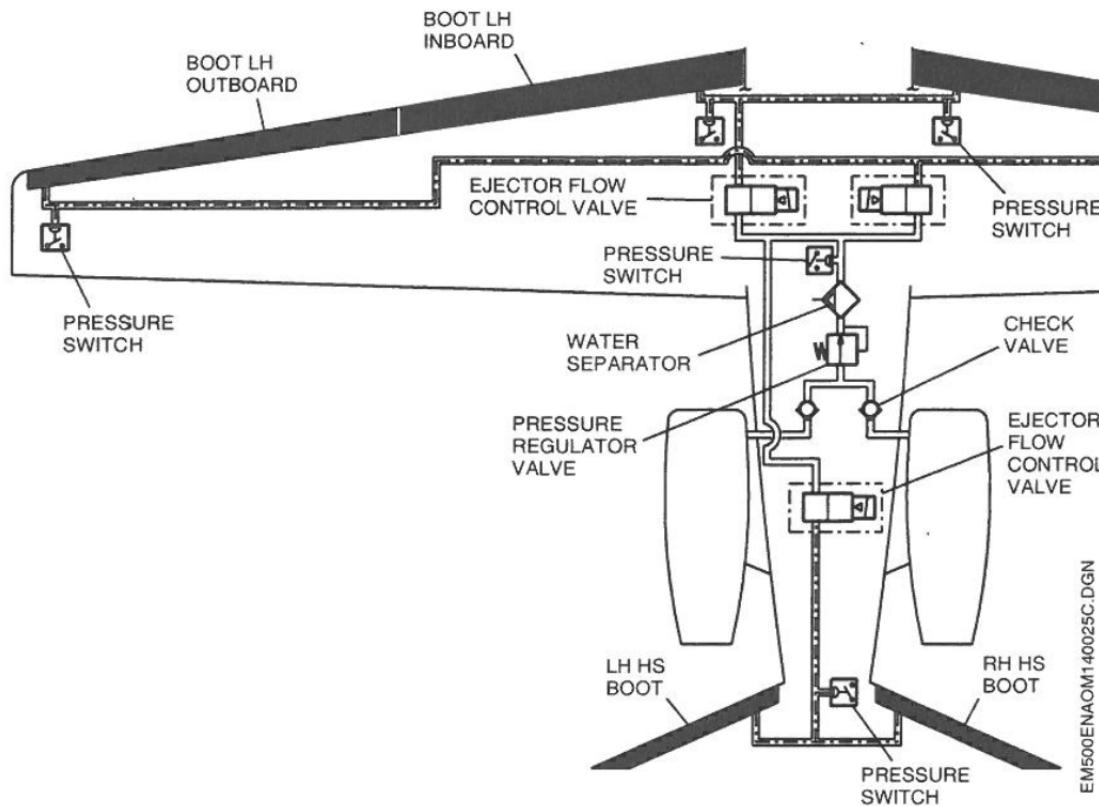
Image 1: Wing and horizontal stabilizer de-ice system

For ice protection the aircraft was equipped with a thermal engine anti-ice system for the engine inlet cowls and a pneumatic wing and horizontal stabilizer de-ice system for the wing leading edges and the horizontal stabilizer in the form of inflatable de-ice boots. The de-ice boots on wings and horizontal stabilizer had spanwise running inflatable cells and were of silver-grey colour.

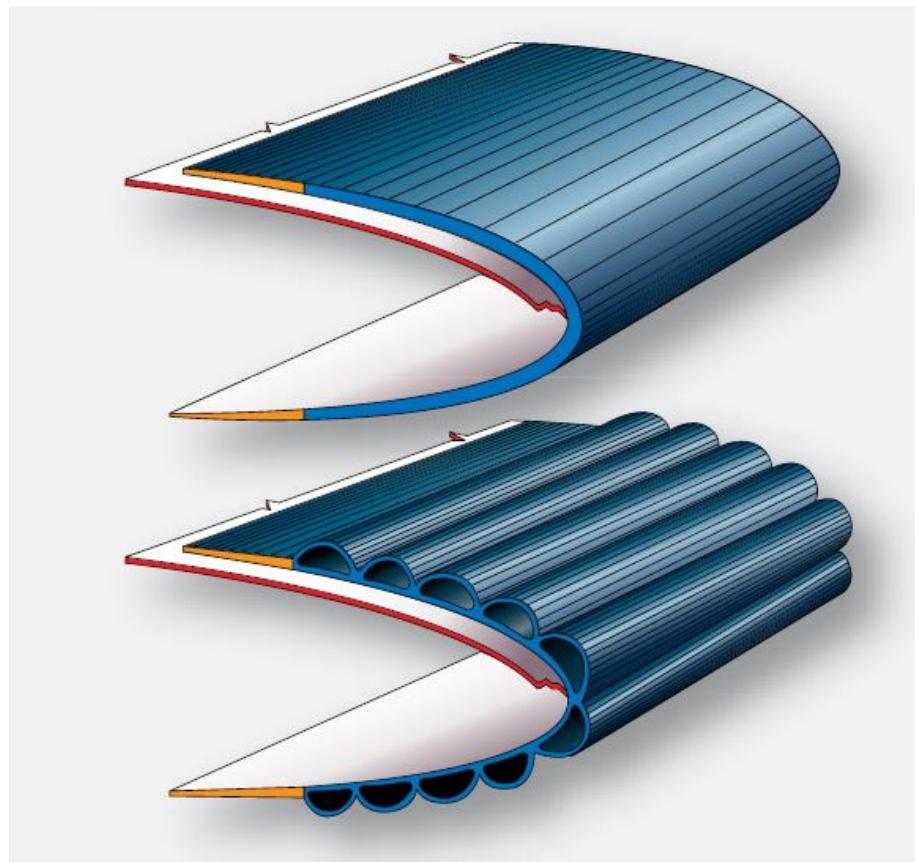
Image 11: Cross section of the de-ice boots

Whereas the wing and horizontal stabilizer leading edges of transport aircraft are heated mostly with hot air or electrically and therefore meet the requirements for anti-icing and de-icing, smaller General Aviation aircraft are mostly equipped with de-ice boots, which have to be considered as mere de-icing systems.

The inflation of the de-ice boots blows the ice accretion apart and the air stream removes the ice pieces.
