Aircraft Accident Investigation Board

Interim Report

State File Number: A961129EPATS
Type of Occurrence: Accident
Date of Occurrence: Feb 18th 2018
Place of Occurrence: Near Yasouj Airport
IRI of IRAN
Aircraft Type: ATR 72-212
Registration: EP-ATS
Operator: Iran Aseman Airlines

Aircraft ATR72-212 registered EP-ATS

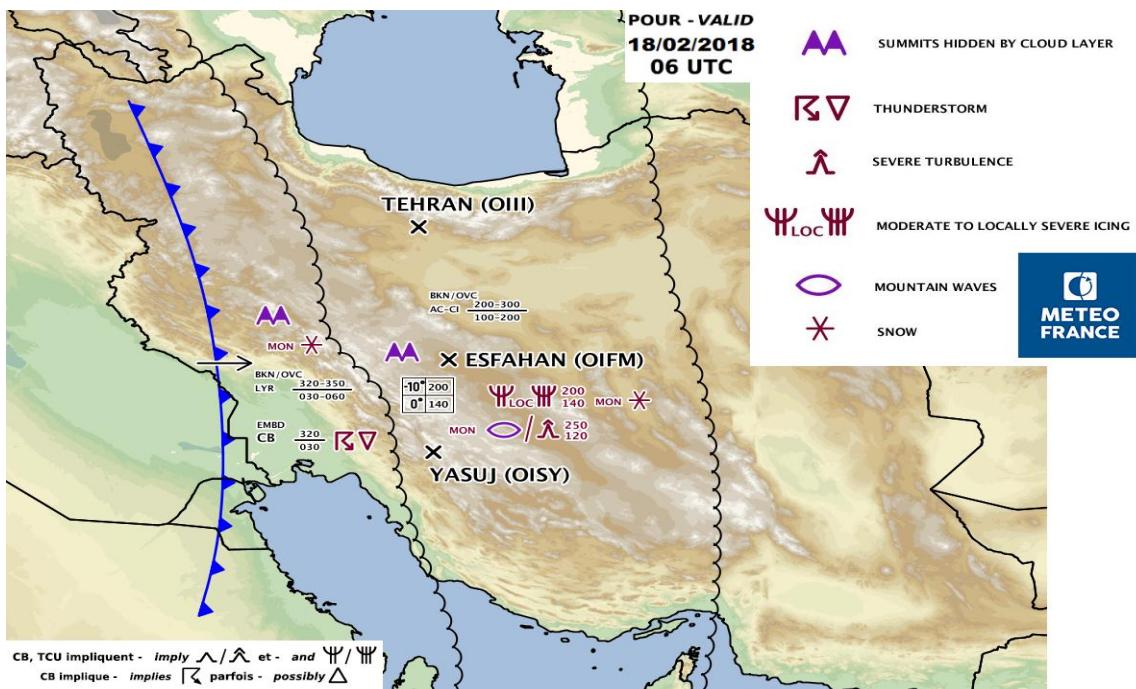
Figure No; 7 Area Forecast about Icing condition

It was estimated that the accident site had moderated turbulences with condition moderate up to locally severe icing. There was unstable conditions and stormy in the accident site and it was covered by clouds. The Area Forecast at the time of accident was received on 03/03/2018 from METEO France which shown in Fig7 .

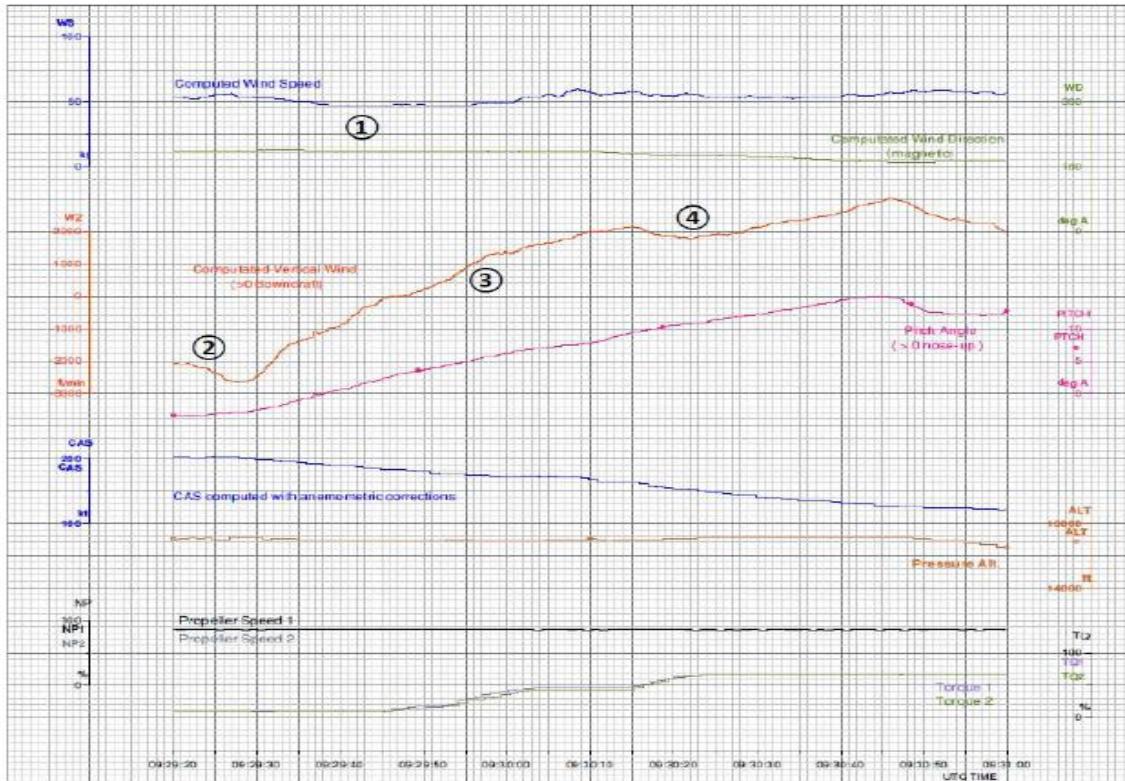
Figure No; 11 Wind computation by the manufacturer (9 h 29 min 20 s to 9 h 31 min 00 s)

From 09:31:18 to 09:31:30 UTC:

- The computed wind speed increased up to around 70 kt and the computed wind direction slightly decreased to about 195°.
- The computed vertical wind decreased.

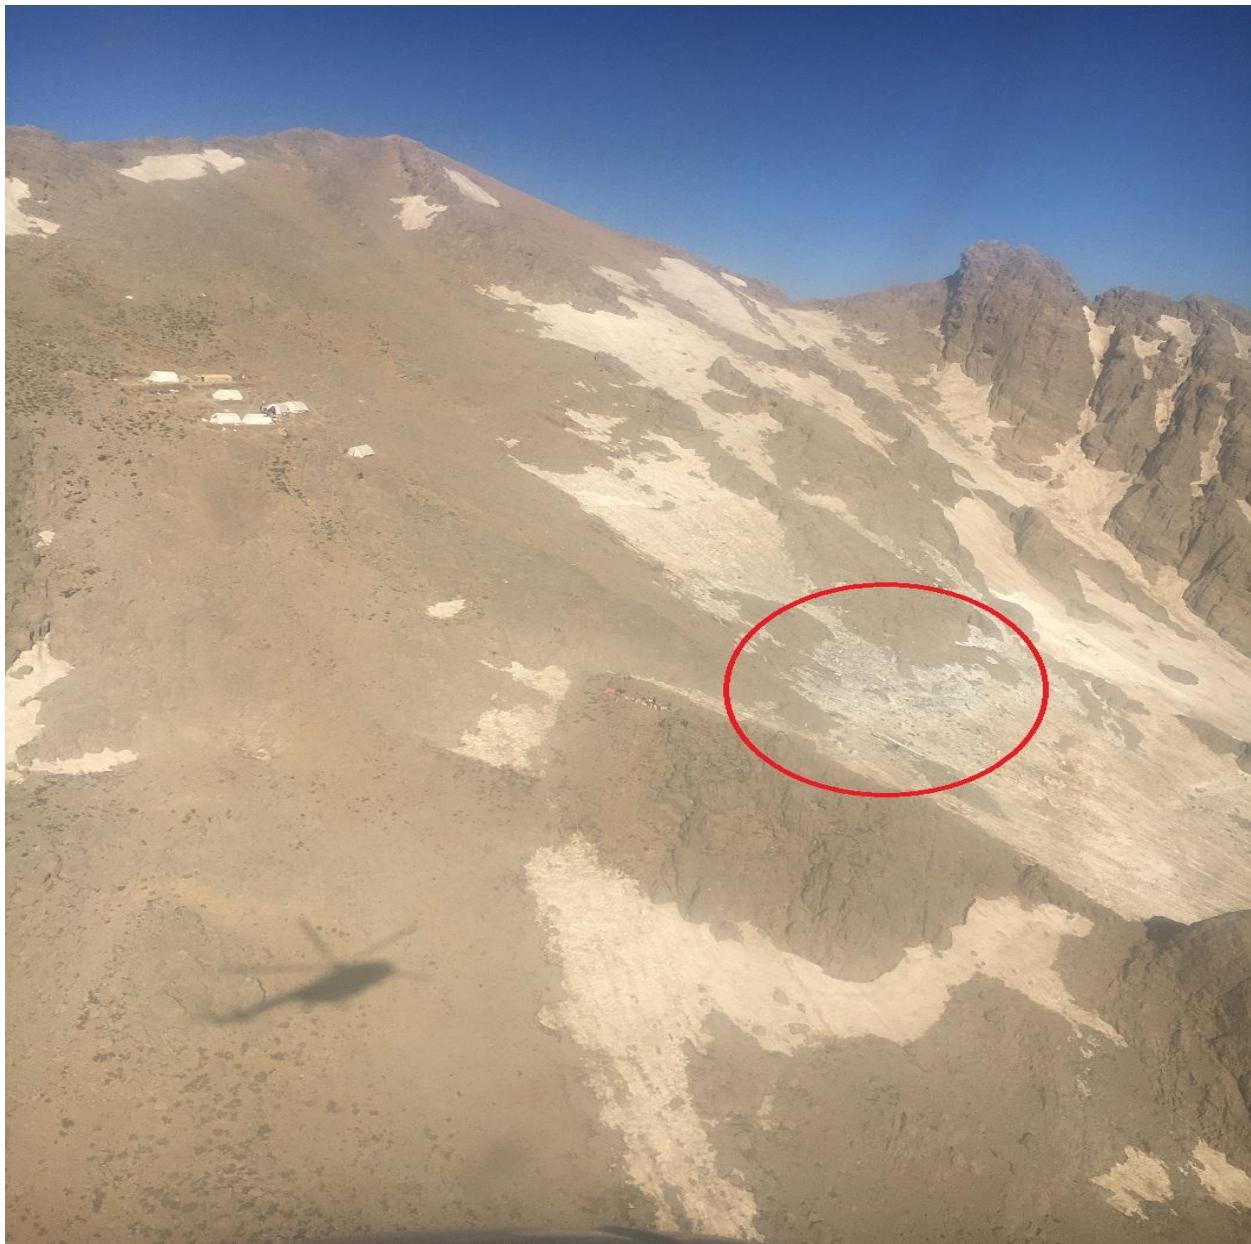
Figure No; 16 Accident Site on June 2018

The wreckage was fragmented with a large amount of debris spread over an area in a sloping rocky ravine which was covered by snow. Due to snowfall on the night after accident time, the wreckage was covered with snow completely and it was not possible to find parts of the aircraft and transfer the pieces easily. The technical investigation on wreckage parts was not possible. At the scene of the accident, the Mountain ravine and local winds have been felt to endanger any flight to the accident site to access the site.

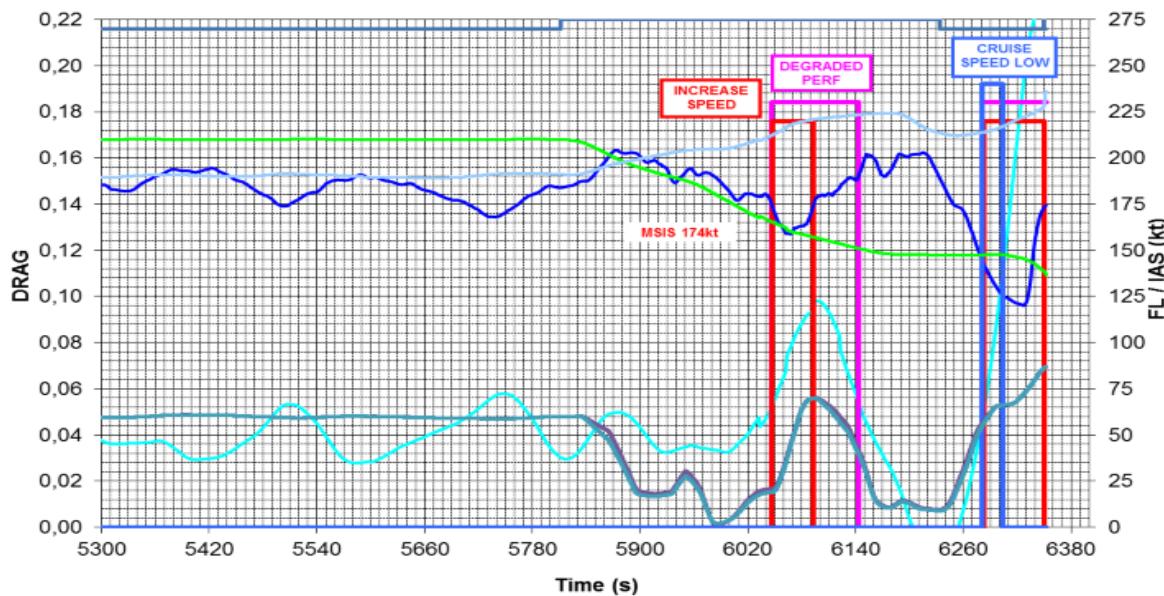
Figure No; 24 APM Simulation Analysis

The APM system was designed to monitor the energy state of the aircraft and alert the flight crew when some conditions are met, any external phenomenon having an influence on the aircraft TAS will have an influence on the total mechanical energy, and will be detected by the aircraft performance monitoring as a low aircraft energy state. The system alerts are based on calculation of Drag coefficient (C_x). The average C_x was computed from:
