Accident Investigation Coordinating Committee

Report 2018/02

Final Report on the Serious Incident to
Airbus, A320-251 (VT-EXL)
Velana International Airport, Maldives
7 September 2018

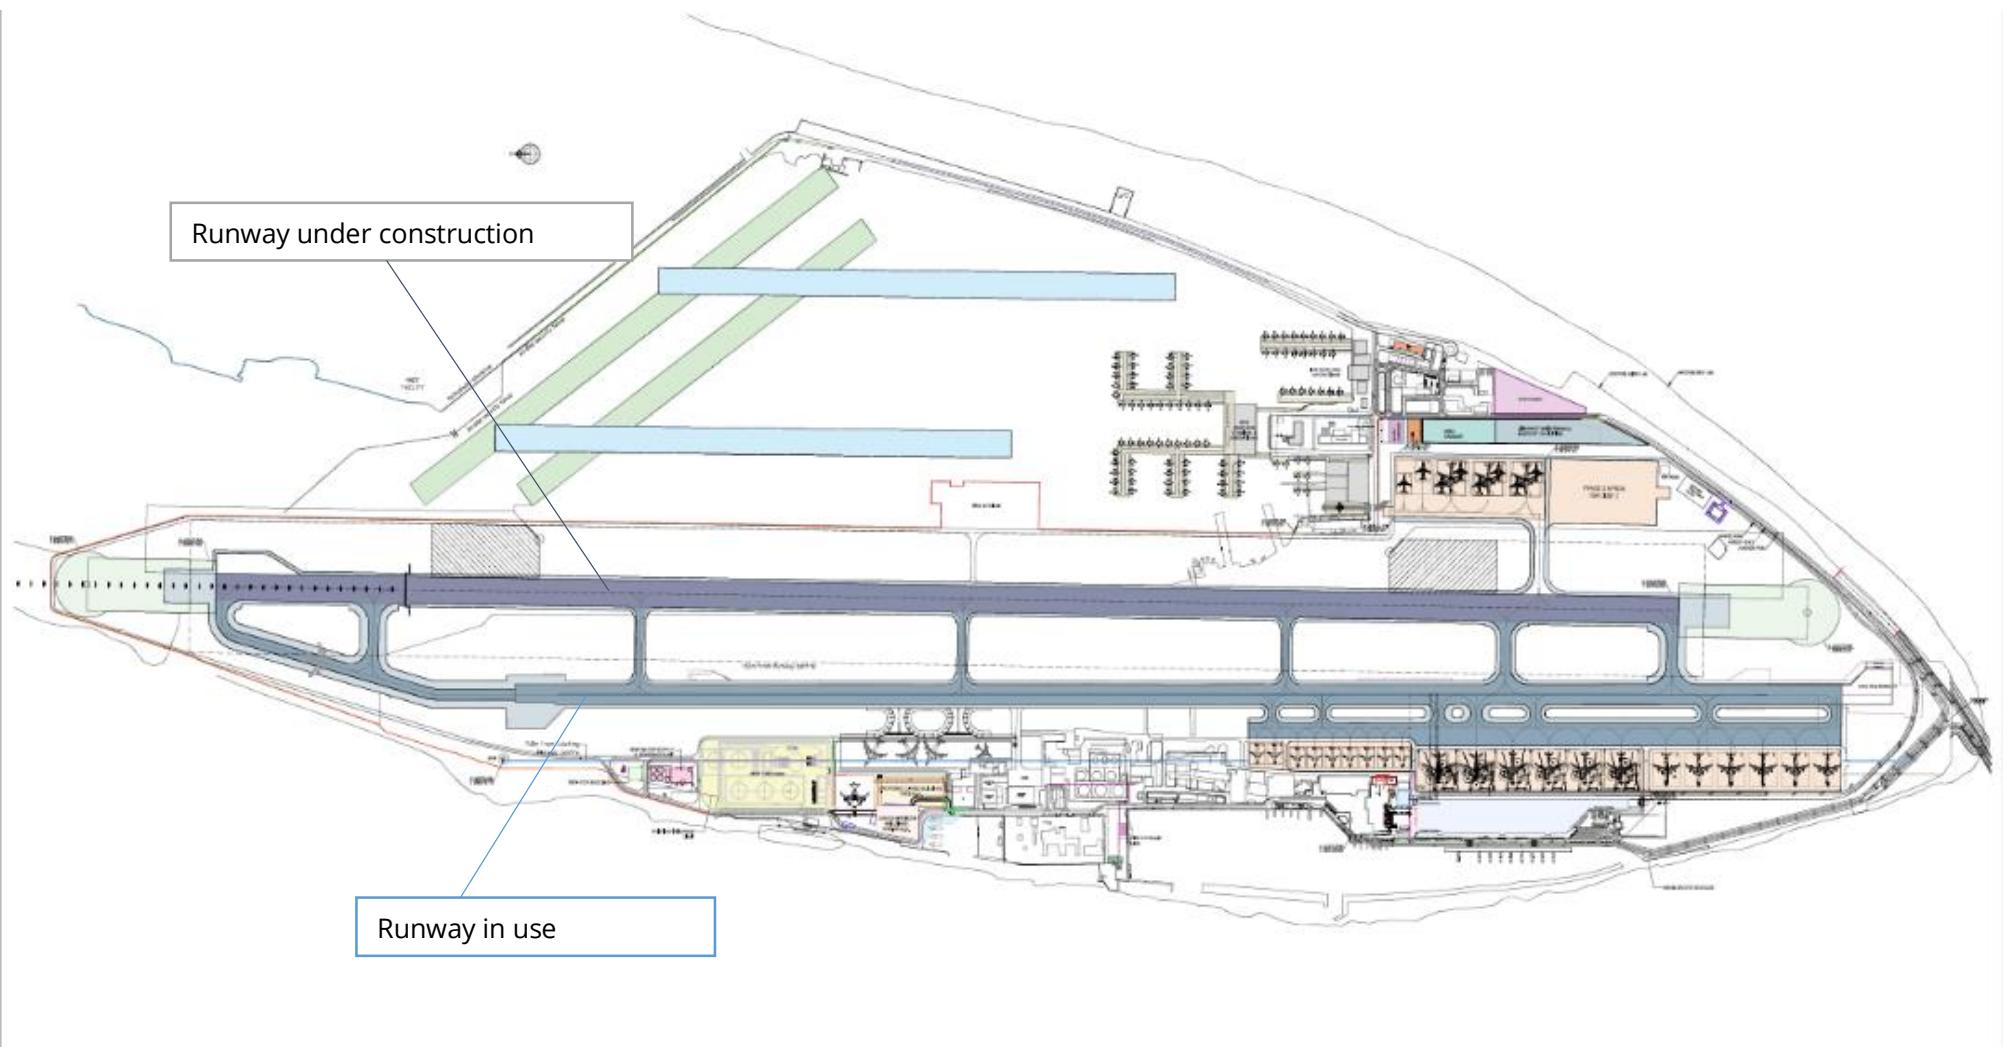
Extract from AIC 04/17 dated 20th July 2017.

Velana International Airport (VIA) is the main international airport in the Maldives. It is located in Hulhule Island, located approximately 2.8 km from the capital, Male'. The airport, with an elevation of 1.73 m, has one asphalt runway designated 18/36 measuring 3200 m length. There was a runway under construction located near-parallel, 190 meters east, to the runway that was in use.

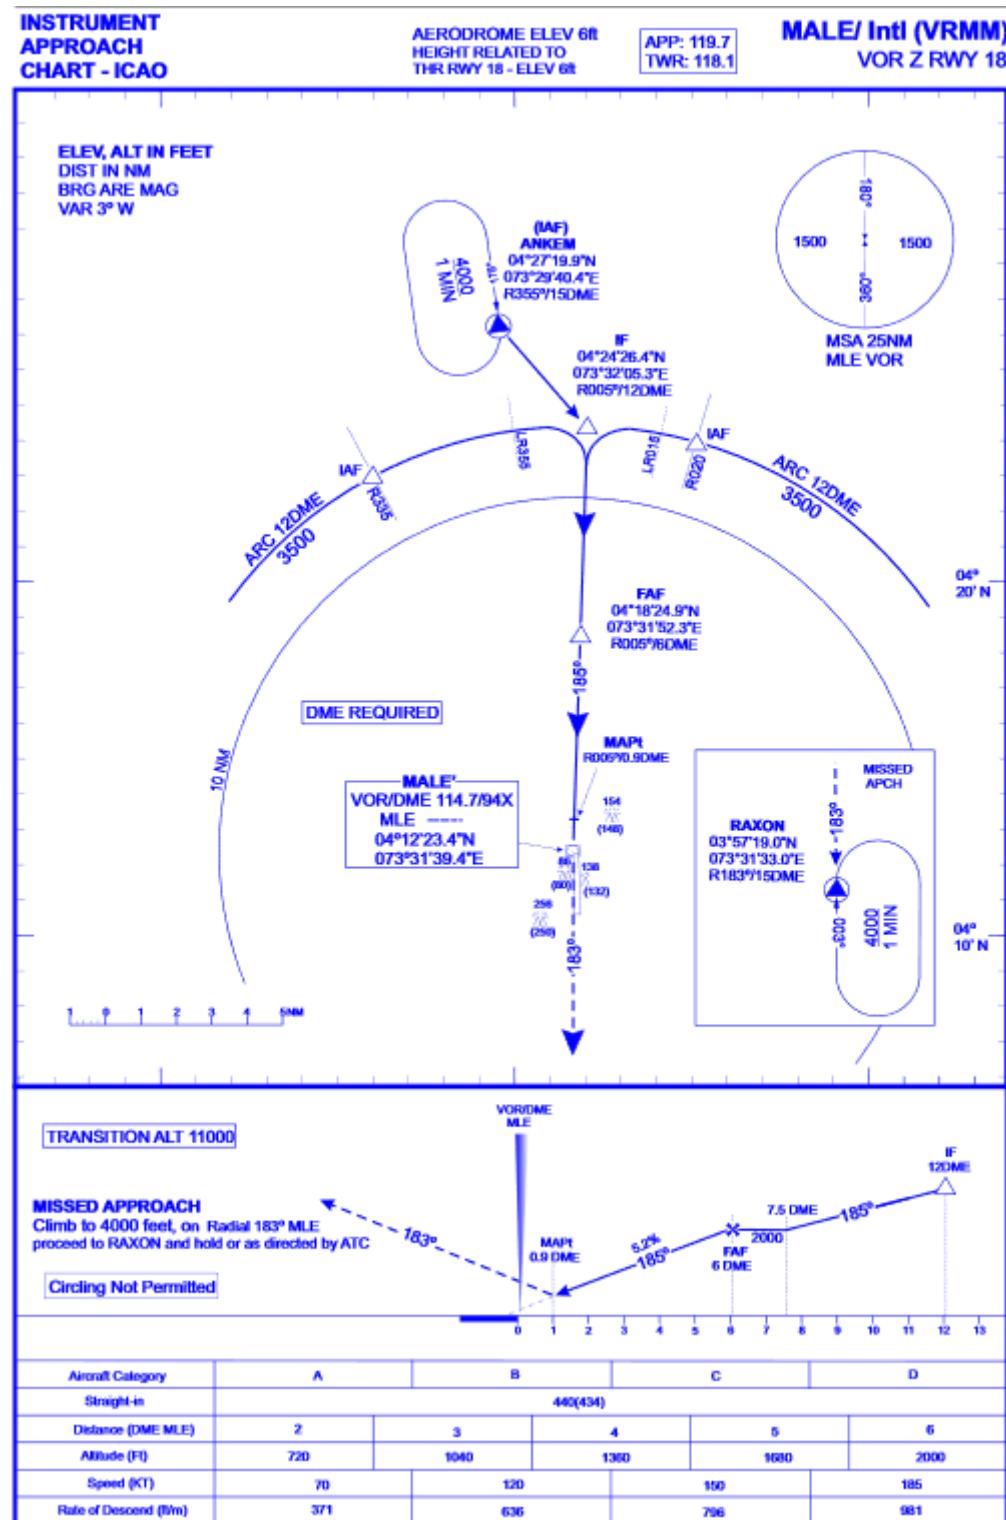
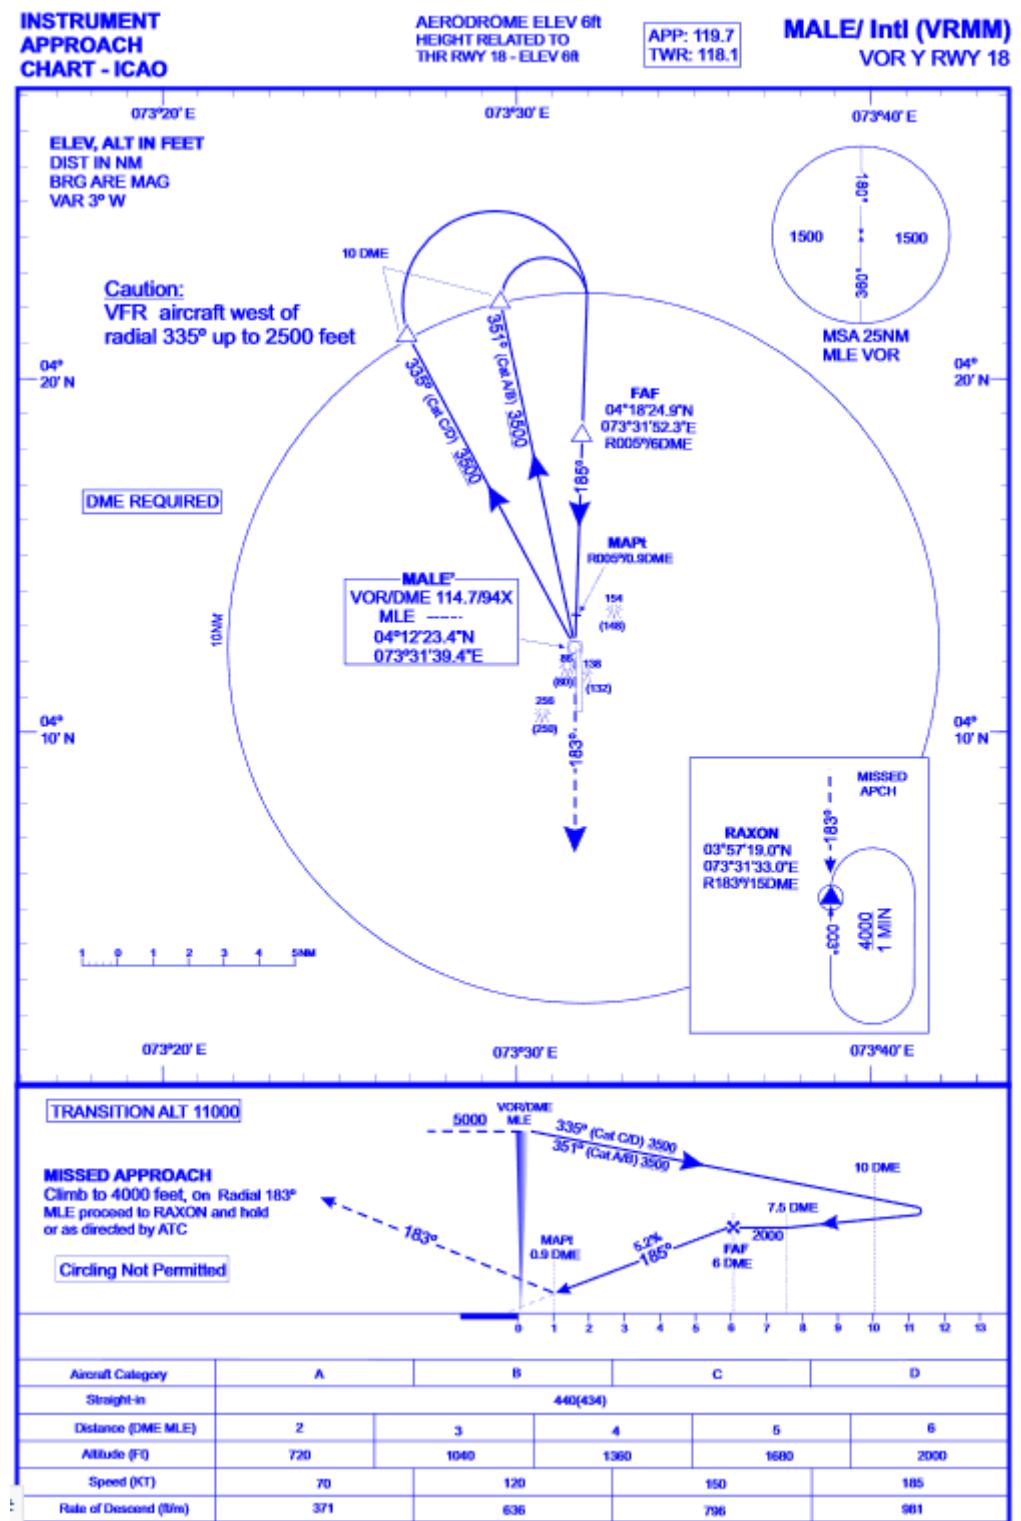
- 2.4 There are two published VOR instrument approach procedures for runway 18 at Velana International Airport designated as VOR Y RWY18 and VOR Z RWY18, both in which the final approach radial is 005° that will correspond to a magnetic track of 185° when conducting the approaches.

- 2.5 The final approach radials of both VOR Y and VOR Z approaches intersects runway extended centreline at an angle of 2°, at a distance of 1.8 NM from the displaced threshold of runway 18 at Velana International airport.

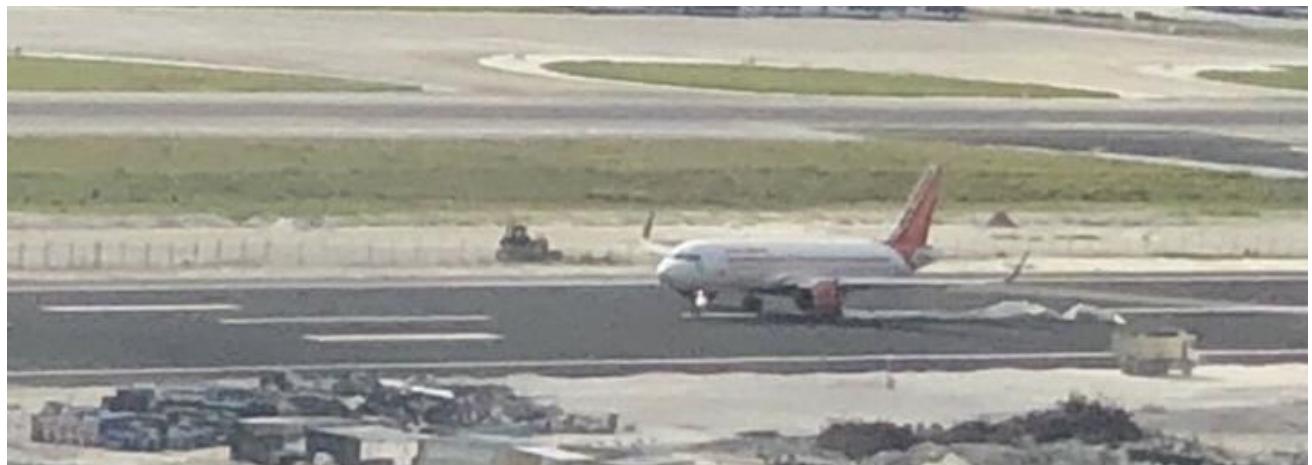
The LH main landing gear tyre was damaged.

Damage to Tyre
