AIRCRAFT ACCIDENT REPORT

BHNL/2015/08/12/F

Accident Investigation Bureau

**Report on the Accident involving Bristow Helicopters
(Nig.) Limited Sikorsky S-76C+ helicopter, Registration
5N-BGD at Latitude 6°31'54" N and Longitude 3°26'16" E,
Oworonsoki, Lagos, Nigeria
on 12th August, 2015**

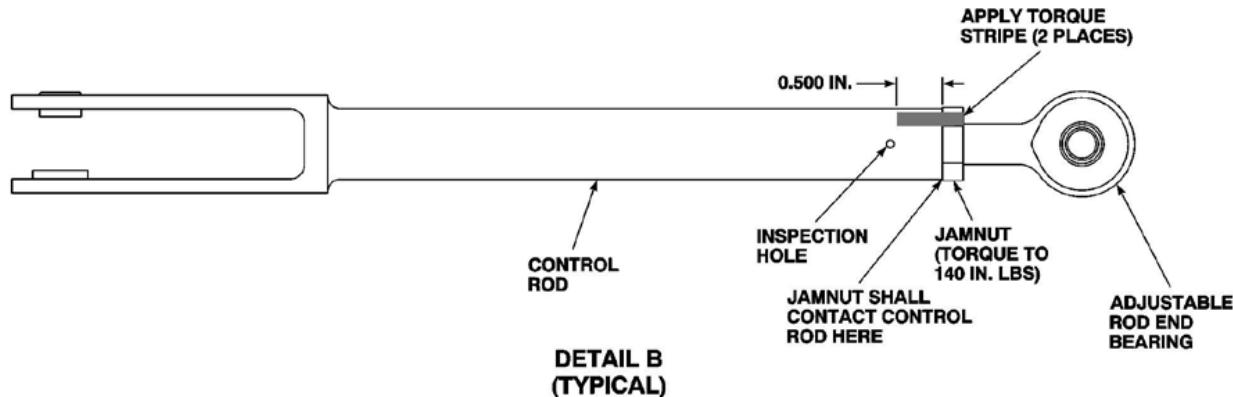
Figure 14: Control Pushrod Tube

During the preliminary investigation, the Bureau discovered that the Forward Main Servo Input Control Pushrod Assembly which is also called Forward Servo Clevis Rod and Bell crank Assembly failed. The Control Pushrod tube separated from Control rod end with the bearing and the Jam nut. The Jam nut was loose and was not seating against the Control Rod. See Figures 12 and 13.

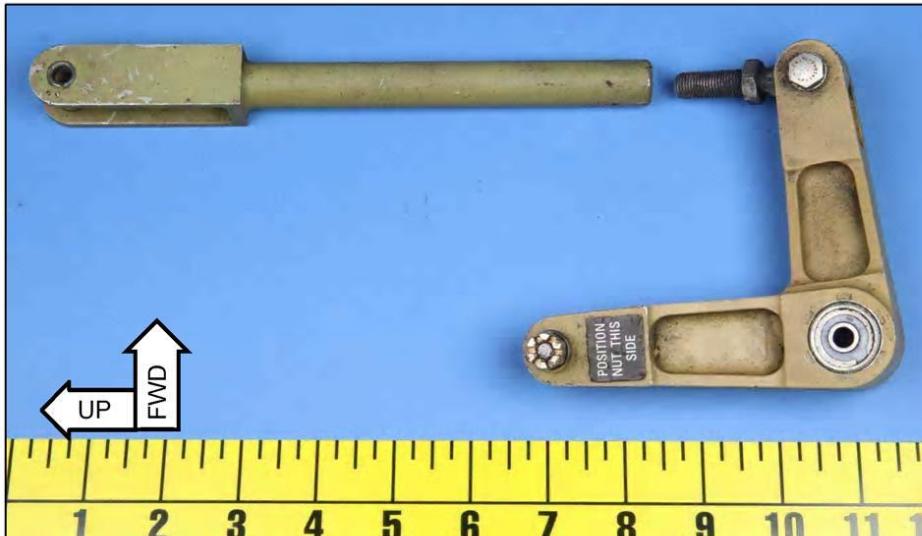
Overall views of the forward, lateral, and aft servo clevis rod assemblies with associated bellcrank assemblies are shown in figures 1 through 3, respectively. The forward servo clevis rod was separated from the end fitting at the lower end of the assembly as shown in figure 1, and the end fitting remained attached to the bellcrank assembly. The lateral and aft servo clevis rod assemblies were intact, and each remained attached to its respective bellcrank as shown in figures 2 and 3.

Figure 1. Forward servo clevis rod and bellcrank assemblies as received showing the outboard side of the bellcrank assembly.

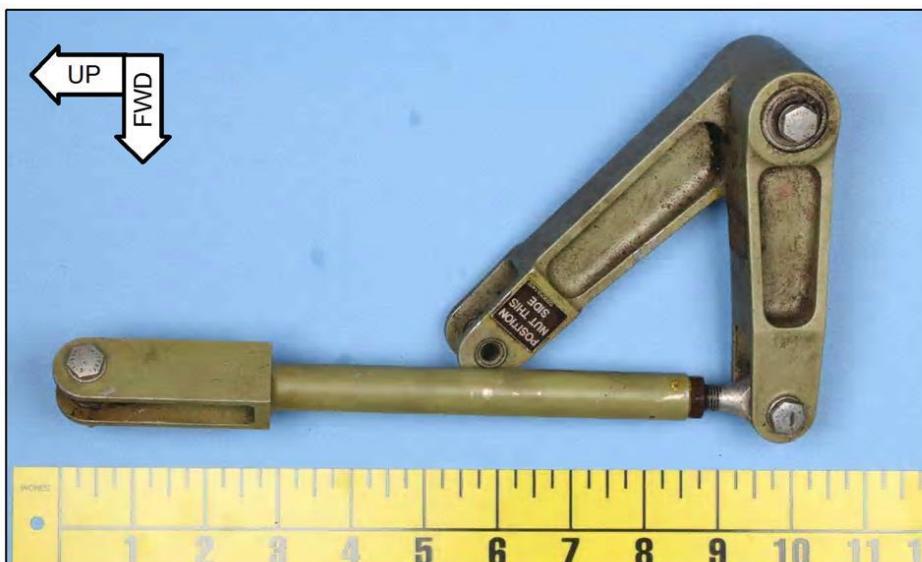
Figure 2. Lateral servo clevis rod and bellcrank assemblies as received showing the outboard side of the assemblies.

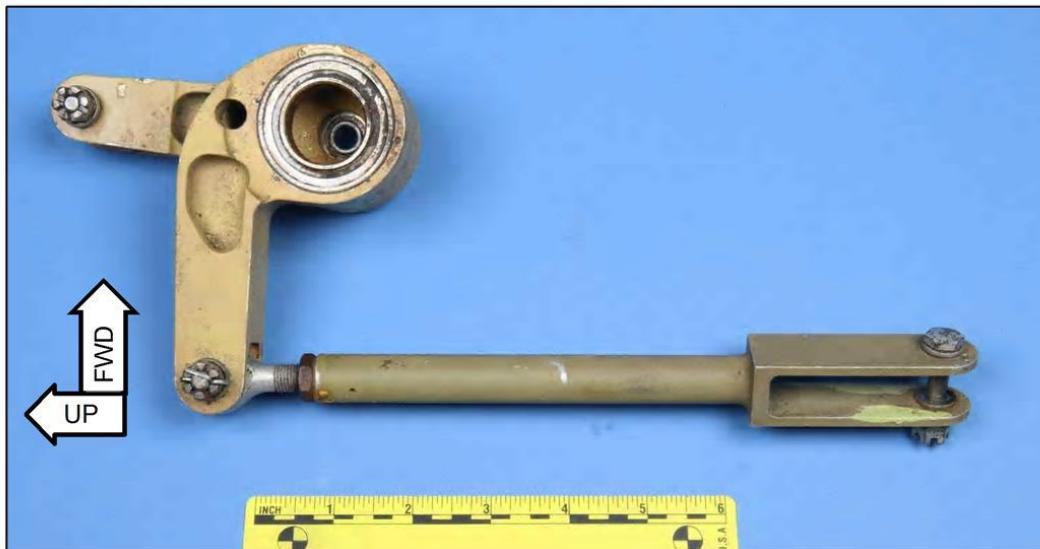
An overall view of the aft servo clevis rod assembly with attached bellcrank assembly is shown in figure 3. Identification markings "78286 ASSY", "76400-00034-058", and "P MFR 8F781" were observed on the rod clevis face. Markings "78286/76400-09502-104", "-044 ASSY MFR 3S611", and "F/L 301918 "P" "ALT"" were vibrapeneened on the lower surface.

Figure 3. Aft servo clevis rod and bellcrank assemblies as received showing the inboard side of the assemblies. Directional arrows point to the orientation of the bellcrank assembly. As installed, the clevis rod assembly extends upward from the bellcrank assembly.

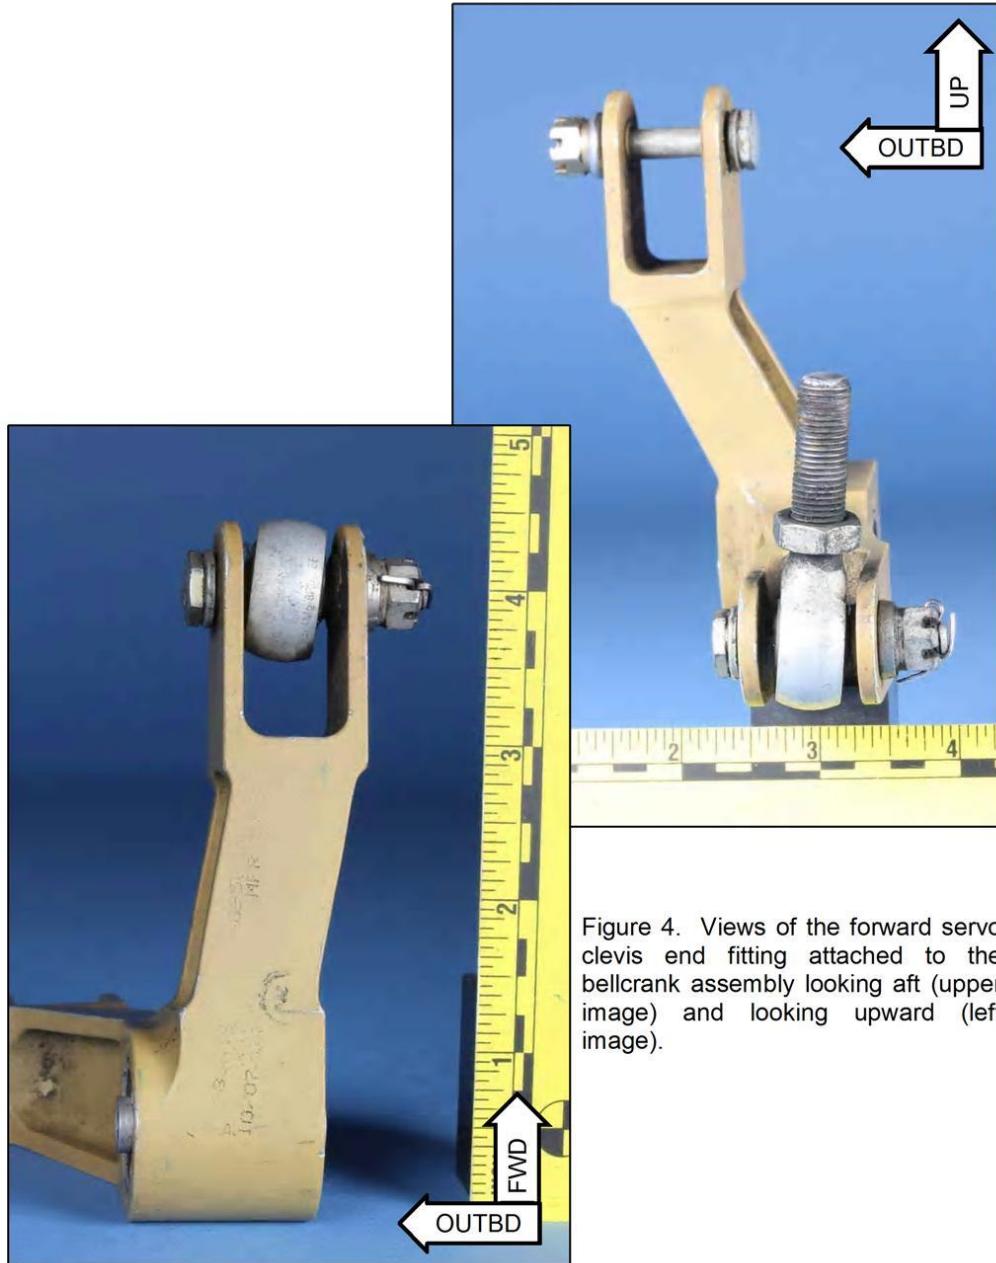
Views of the forward servo clevis rod bellcrank assembly with attached rod end fitting are shown in figure 4. The rod end fitting did not move by light hand forces as-received. The upper end of the end fitting as-received was rotated inboard relative to the bellcrank plane of rotation (see upper image in figure 4). Additionally, the end fitting as-received was rotated clockwise, as viewed from below, relative to the transverse plane of the bearing attachment bolt (see left image in figure 4).

Figure 4. Views of the forward servo clevis end fitting attached to the bellcrank assembly looking aft (upper image) and looking upward (left image).

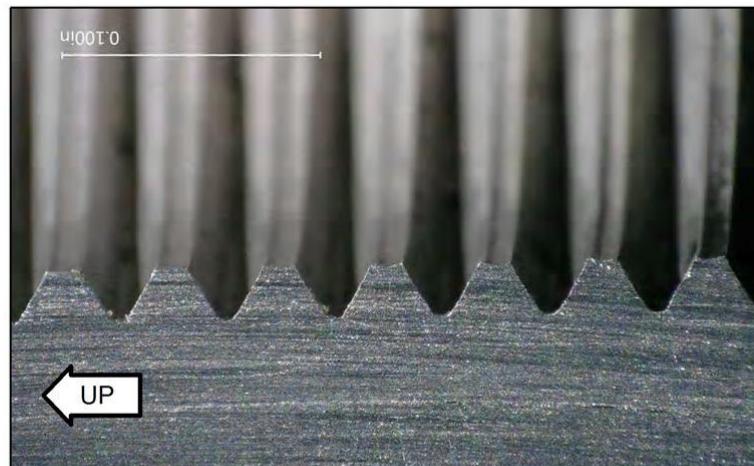
Figure 9. Internal thread profile of intact threads in the area of the forward servo clevis rod indicated in figure 9.

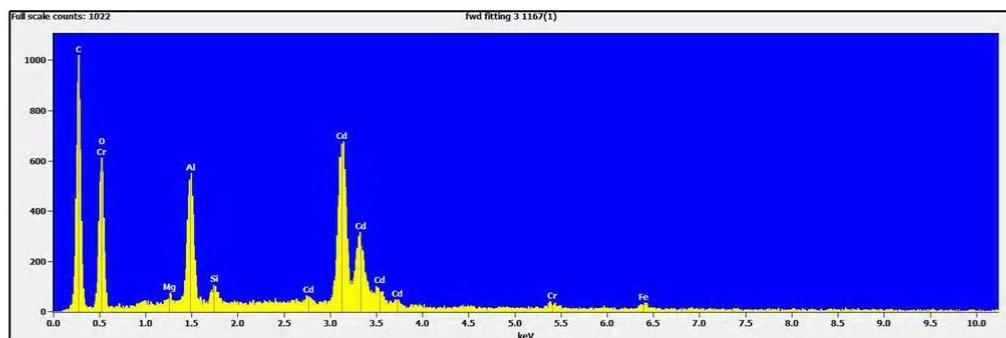
Figure 11. Typical EDS spectrum for samples of the black deposit collected from the forward servo clevis rod end fitting. An image of the deposit that produced this spectrum is shown in figure 13.

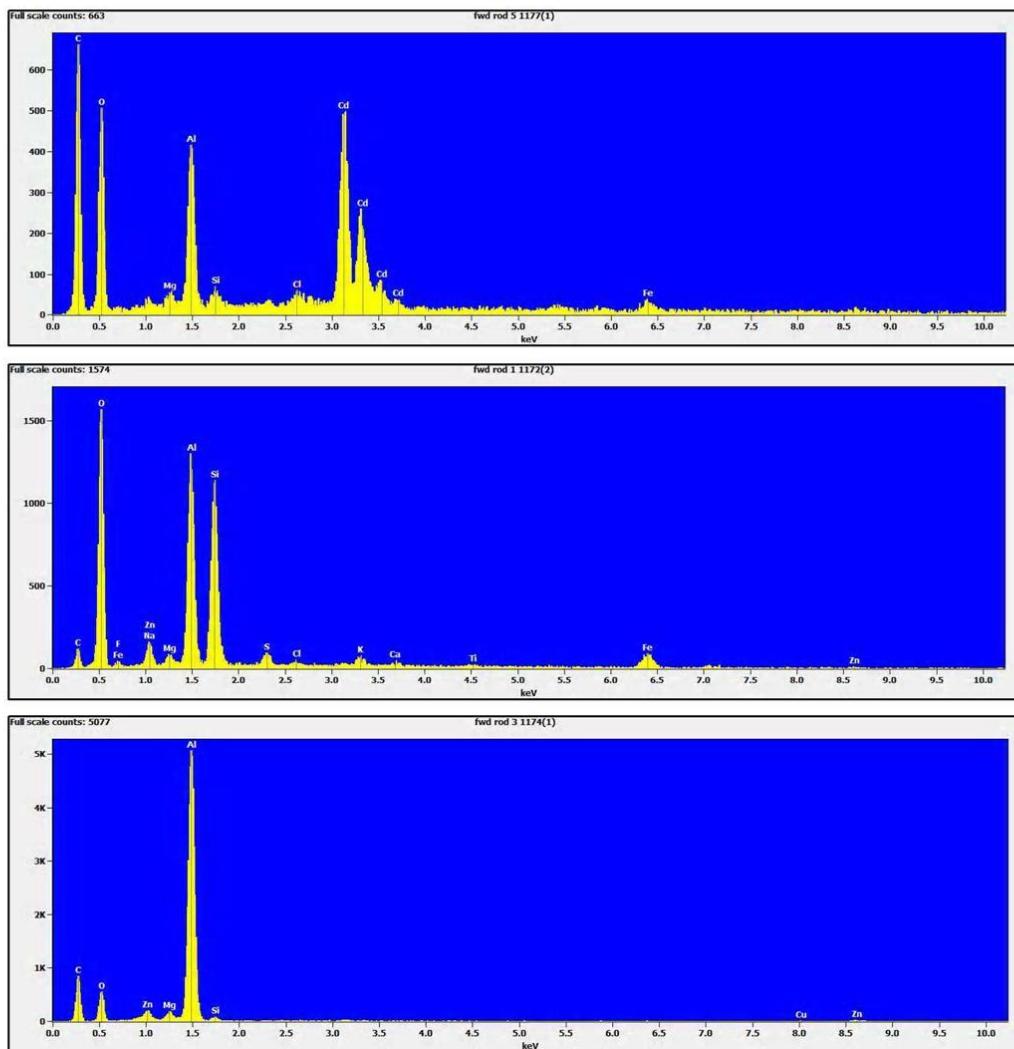
Figure 12. Typical EDS spectra obtained from deposits collected from the internal threads of the forward servo clevis rod. The upper spectrum is an overall area scan at low magnification. The middle spectrum is an area at higher magnification where a particle with a high silicon peak covered a large portion of the scan area. The lower spectrum was taken from a long segment of metal consistent with an internal thread remnant (see figure 14).

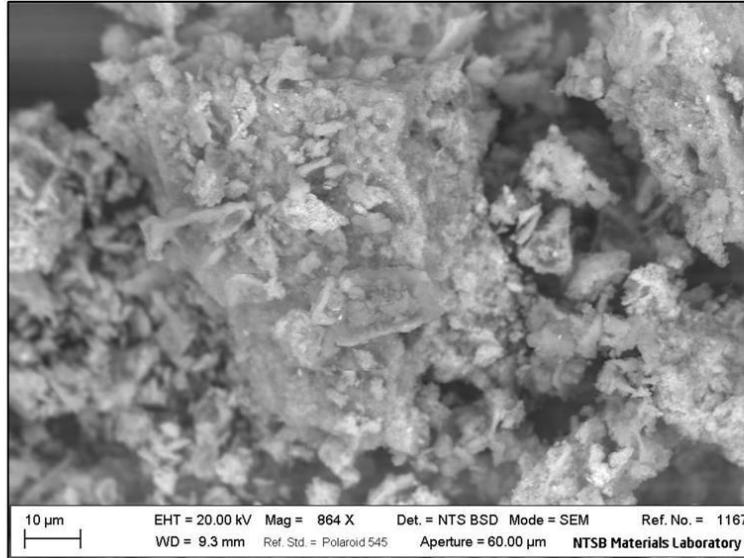
Figure 13. SEM image using backscattered electrons showing a typical deposit sampled from the forward servo clevis rod producing the spectrum shown in figure 11.

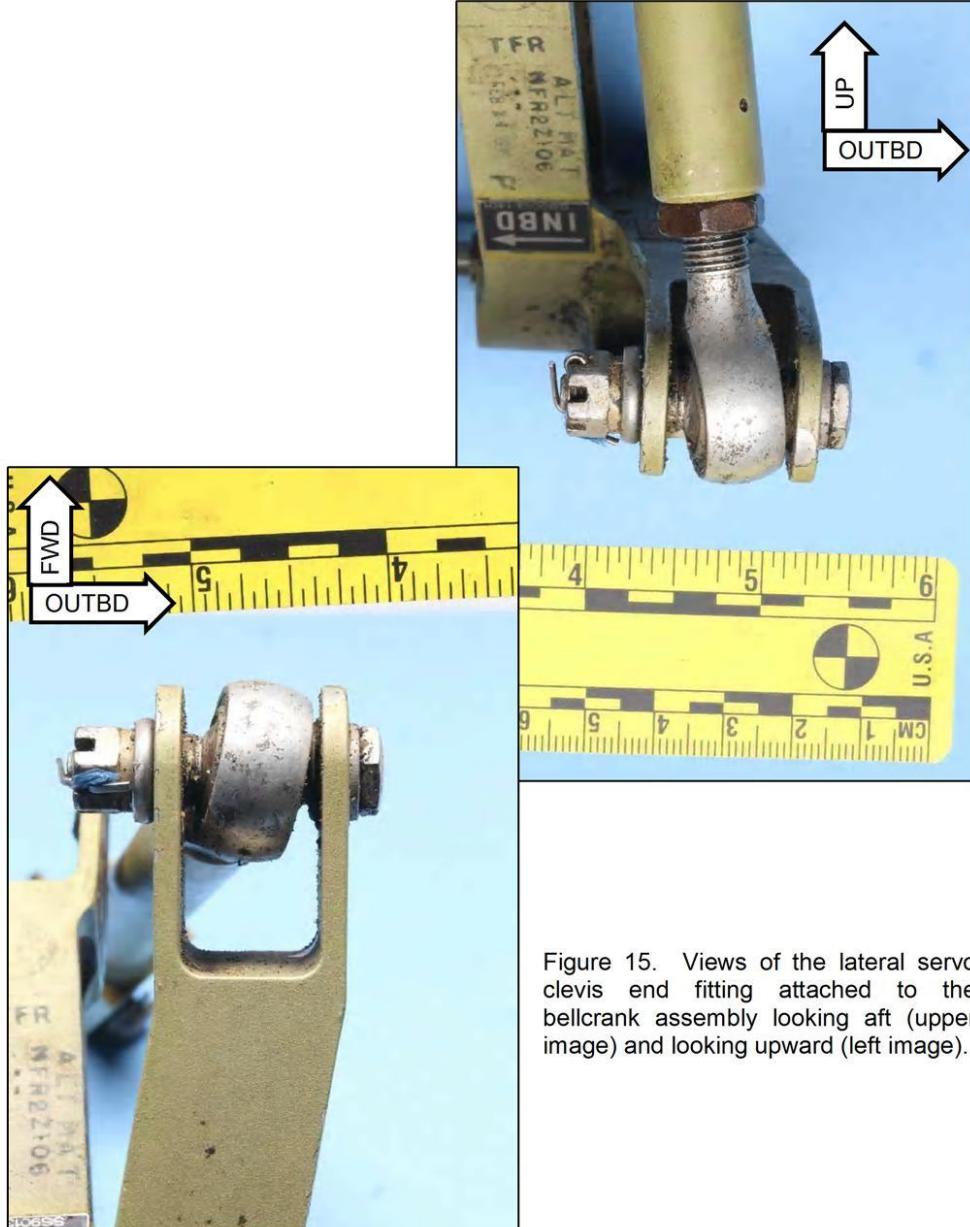
Figure 15. Views of the lateral servo clevis end fitting attached to the bellcrank assembly looking aft (upper image) and looking upward (left image).

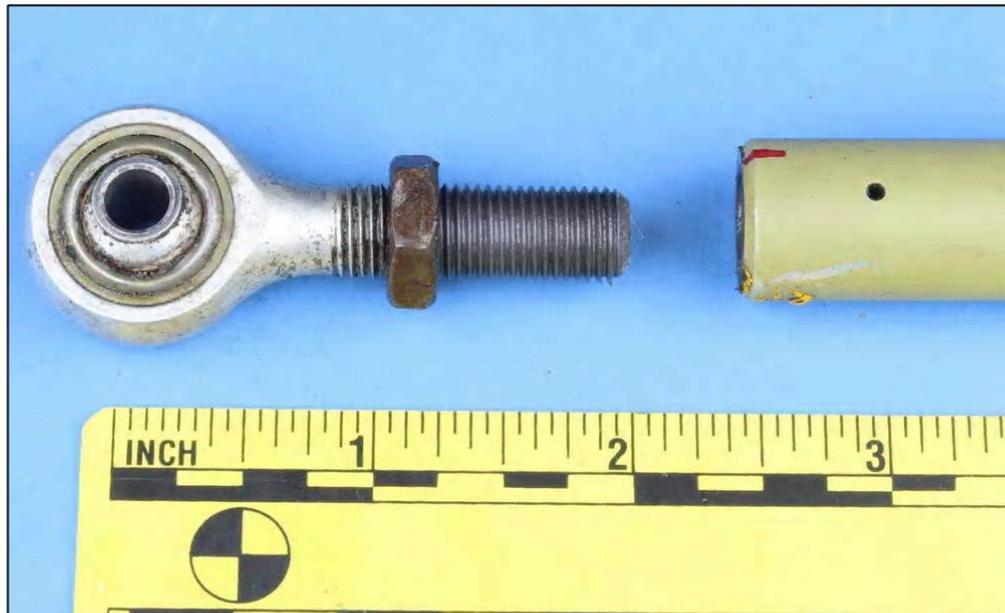
Figure 16. Lower end of the lateral servo clevis rod assembly after the end fitting was disassembled from the rod.

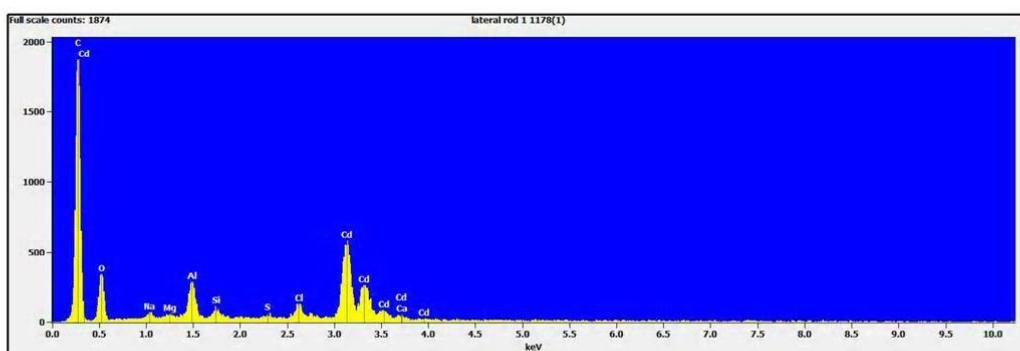
Figure 17. Typical EDS spectrum of black material sampled from the lateral servo clevis rod end fitting threads.

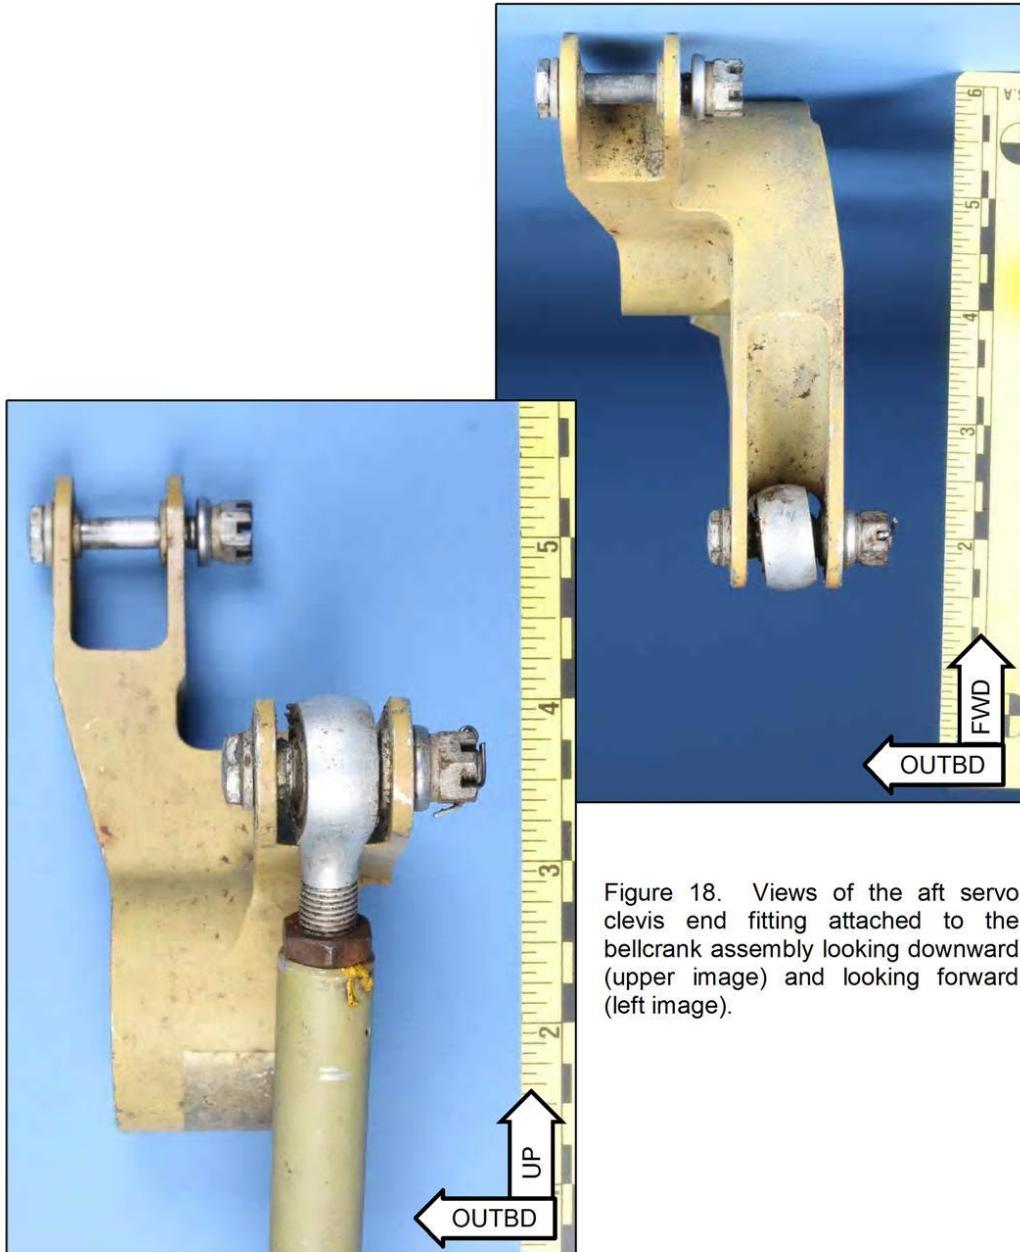
Figure 18. Views of the aft servo clevis end fitting attached to the bellcrank assembly looking downward (upper image) and looking forward (left image).

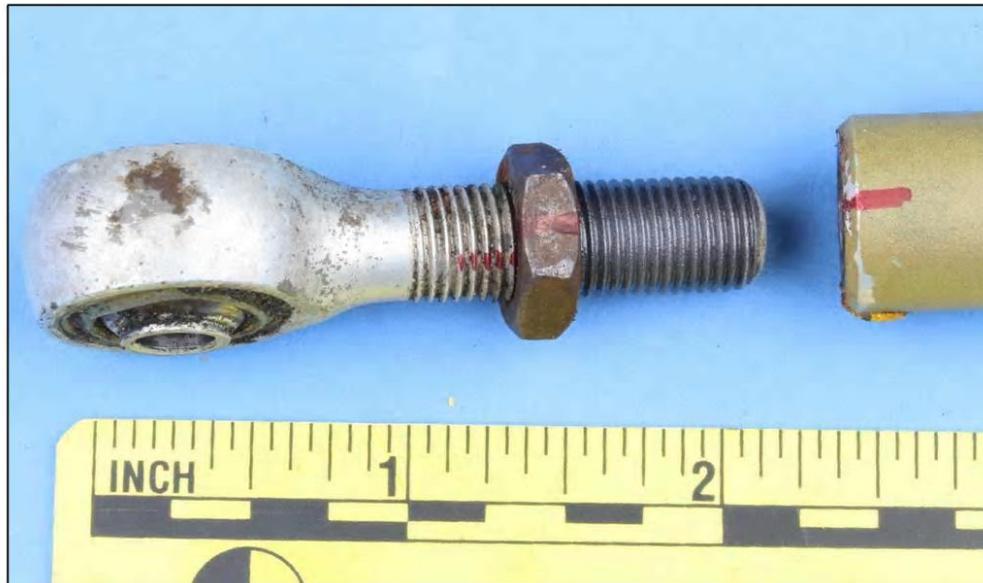
Figure 19. Lower end of the aft servo clevis rod assembly after the end fitting was disassembled from the rod.

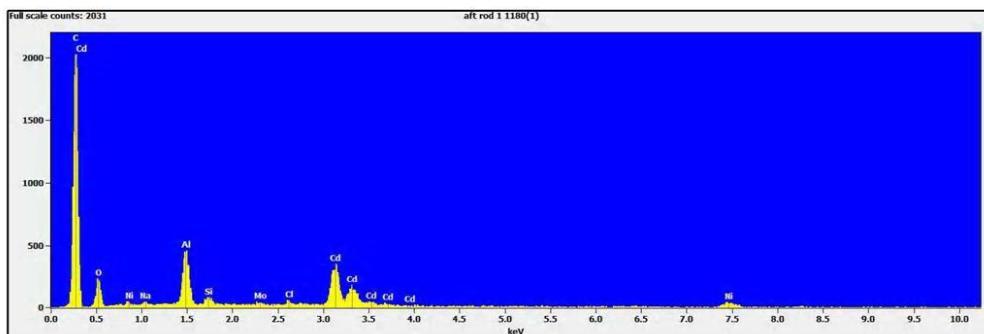
Figure 20. Typical EDS spectrum of black material sampled from the aft servo clevis rod end fitting threads.
