**Islamic Republic Of Iran**  
**Civil Aviation Organization**  
**Aircraft Accident Investigation Board**

**Final Report**

Aircraft Model: Bombardier CL604 Challenger

Registration: TC-TRB

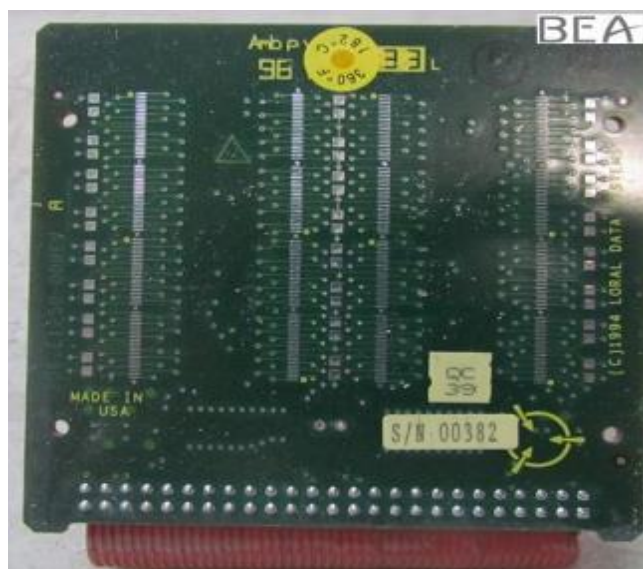
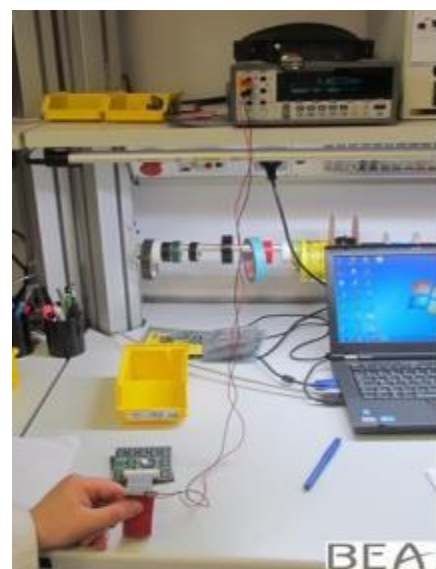
The metallic casing was removed, the memory board was visually inspected, a new fifty-pin connector was installed on the ribbon cable and electrical checks were performed on the new connector.

The values of electrical checks were coherent with the BEA database values.

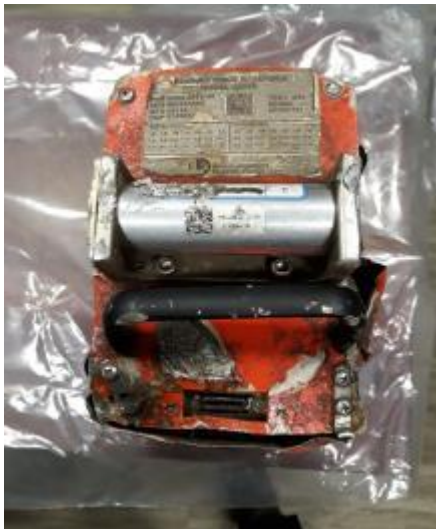
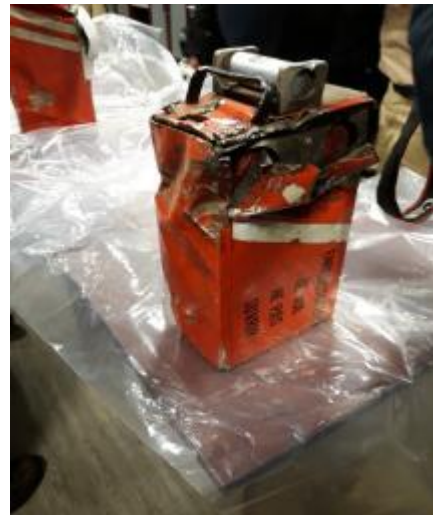
The CVR opening operations took place in BEA facilities. A visual Assessment of the CVR was performed. The recorder was damaged. The ULB was still attached to the chassis.

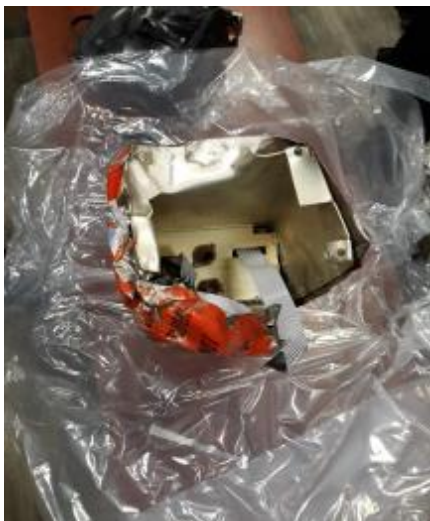
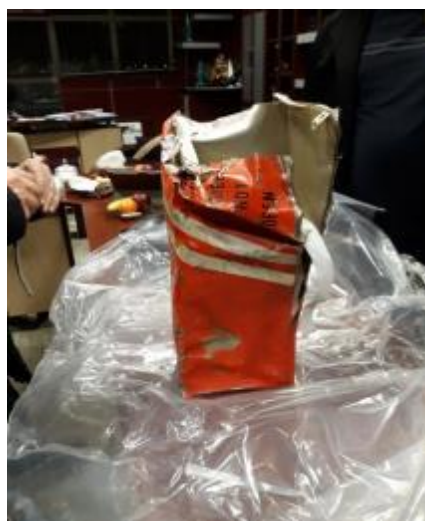
The FDR FCSSU was visually checked. The connector of the memory board was damaged.
