Serious incident

to the Bombardier CRJ700 registered **F-GRZL**
and to the Airbus A319-111 registered **G-EZAZ**
on 17 March 2017
at Lyon Saint-Exupéry (Rhône)

Near incursion of an aeroplane cleared to cross the runway during the take-off of another aeroplane

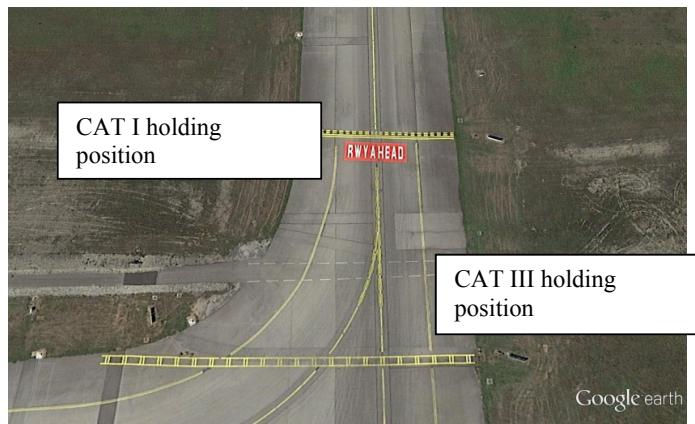
The taxiways leading to the runway have two runway-holding position markings. The CAT I holding position is situated 90 m before the runway centre line. It is shown by two yellow solid lines and two yellow dashed lines painted on the ground. When not in LVP conditions⁽¹⁰⁾, an aircraft or vehicle situated before this holding position is outside the runway OFZ. The CAT III holding position is situated at 150 m from the runway centre line. It is shown by a "*ladder*" marking painted on the ground. In LVP conditions, crossing this holding position marks entry on the runway.

Figure 2: holding position markings on Lyon Saint-Exupéry taxiway B4.

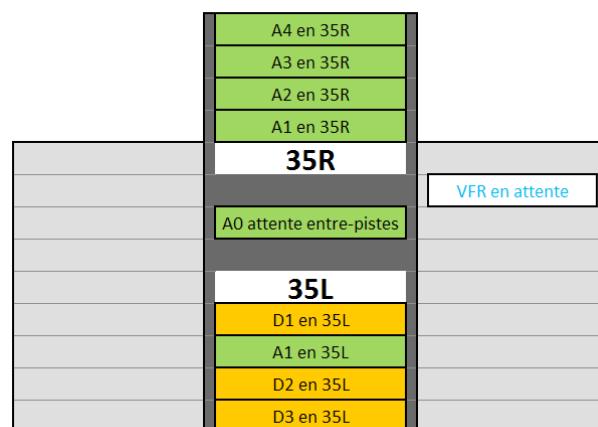
Figure 4: strip board (excerpt from Lyon Saint-Exupéry operations manual)

An aeroplane which has just vacated runway 35R and which is not yet cleared to cross runway 35L will have its strip positioned as the “A0” strip in the above figure.

During the occurrence, the meteorological conditions were good and the controller said that he did not use the ground radar display. When he gave the crossing clearance to HOP83AJ, he positioned the latter's strip on the EZY748Z strip which was positioned in the runway 35L bay. This positioning was carried out "mechanically" and the placing of one strip over the other did not allow the controller to detect the conflicting clearance.
