Report

IN-015/2019

Incident involving a BOEING B-737-524, registration LY-KLJ, at the Getafe Air Base (Madrid) on 5 April 2019

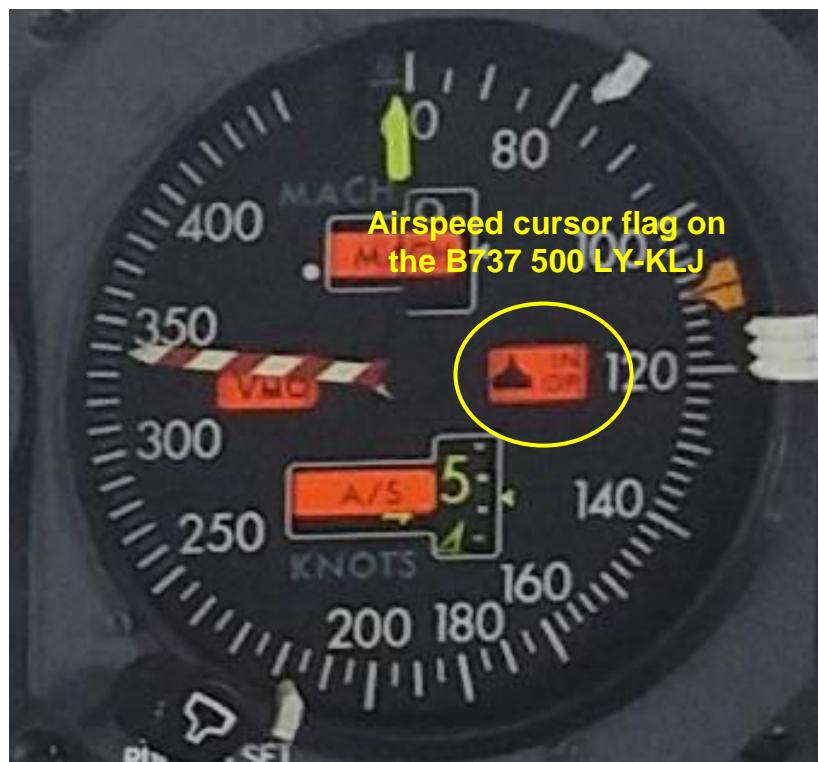
Figure 4. Photograph of the airspeed indicator

In manual mode, it is retracted, and in automatic mode, it is visible when the airspeed cursor signals determined by the AFDS FCC are not reliable.
