Air Accident Investigation Sector

Incident - Final Report -

AAIS Case N°: AIFN/0008/2019

Aircraft Struck Runway Edge Lights on Landing

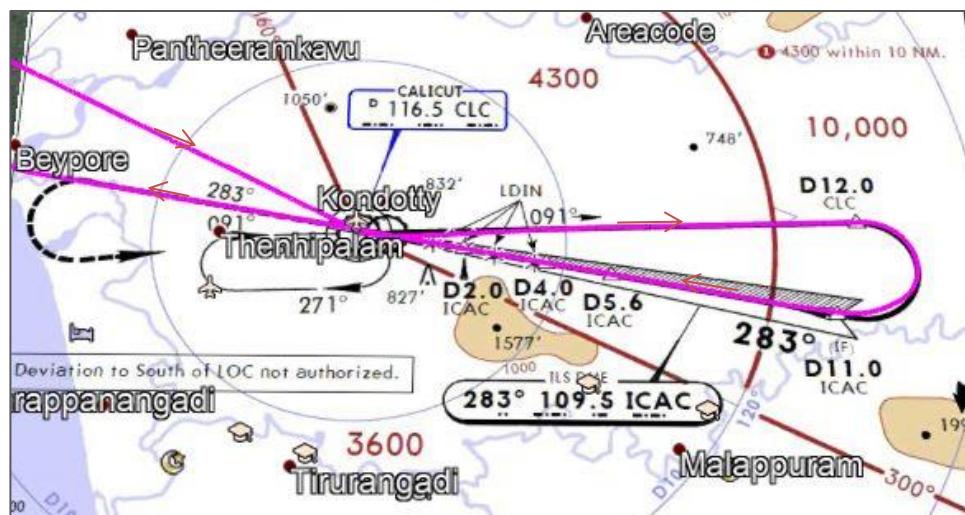
The flight crew briefed for the approach before reaching the top of descent. The Aircraft started to descend from flight level (FL) 350 at 2242:27. EY250 then proceeded for an ILS approach to runway 28 VOCL, as shown in figure 6.

Figure 6. First approach flight path of EY250 on the Calicut ILS Z runway 28 approach chart

It revealed that the APP mode was engaged after the localizer was established, however, it was prior to the correct sensing of the glideslope indications. This was not in accordance with the recommendation of when to select the APP mode", as given as *Caution* in the *Route Information Manual* (see Sub-section 1.17.5), however, this non-conformity did not affect the further approach.

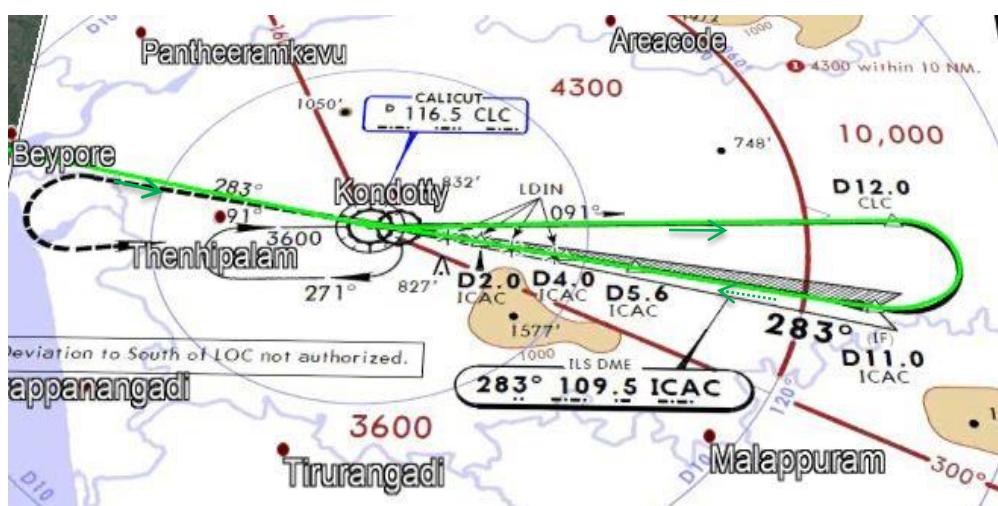
As the Aircraft was passing the IF, in a straight and level condition just after turning to the right, the APP mode was engaged. The Aircraft was in an altitude hold mode (ALT) at a selected altitude of 3,100 feet, and the localizer was captured.

Figure 8. EY250 second approach flight path on approach chart of Calicut ILS Z runway 28

The APP mode was activated prior to the Aircraft establishing on the localizer, but the localizer had already been captured. This activation was prior to the sensing of the glideslope indications, which was not in accordance with the *Caution* as recommended in the *Route Information Manual*. However, this non-conformity did not affect the approach.
