Final Report No. 2370 by the Swiss Transportation Safety Investigation Board STSB

on the accident involving
the Junkers Ju 52/3m g4e
commercial aircraft, HB-HOT,

operated by Ju-Air,

on 4 August 2018

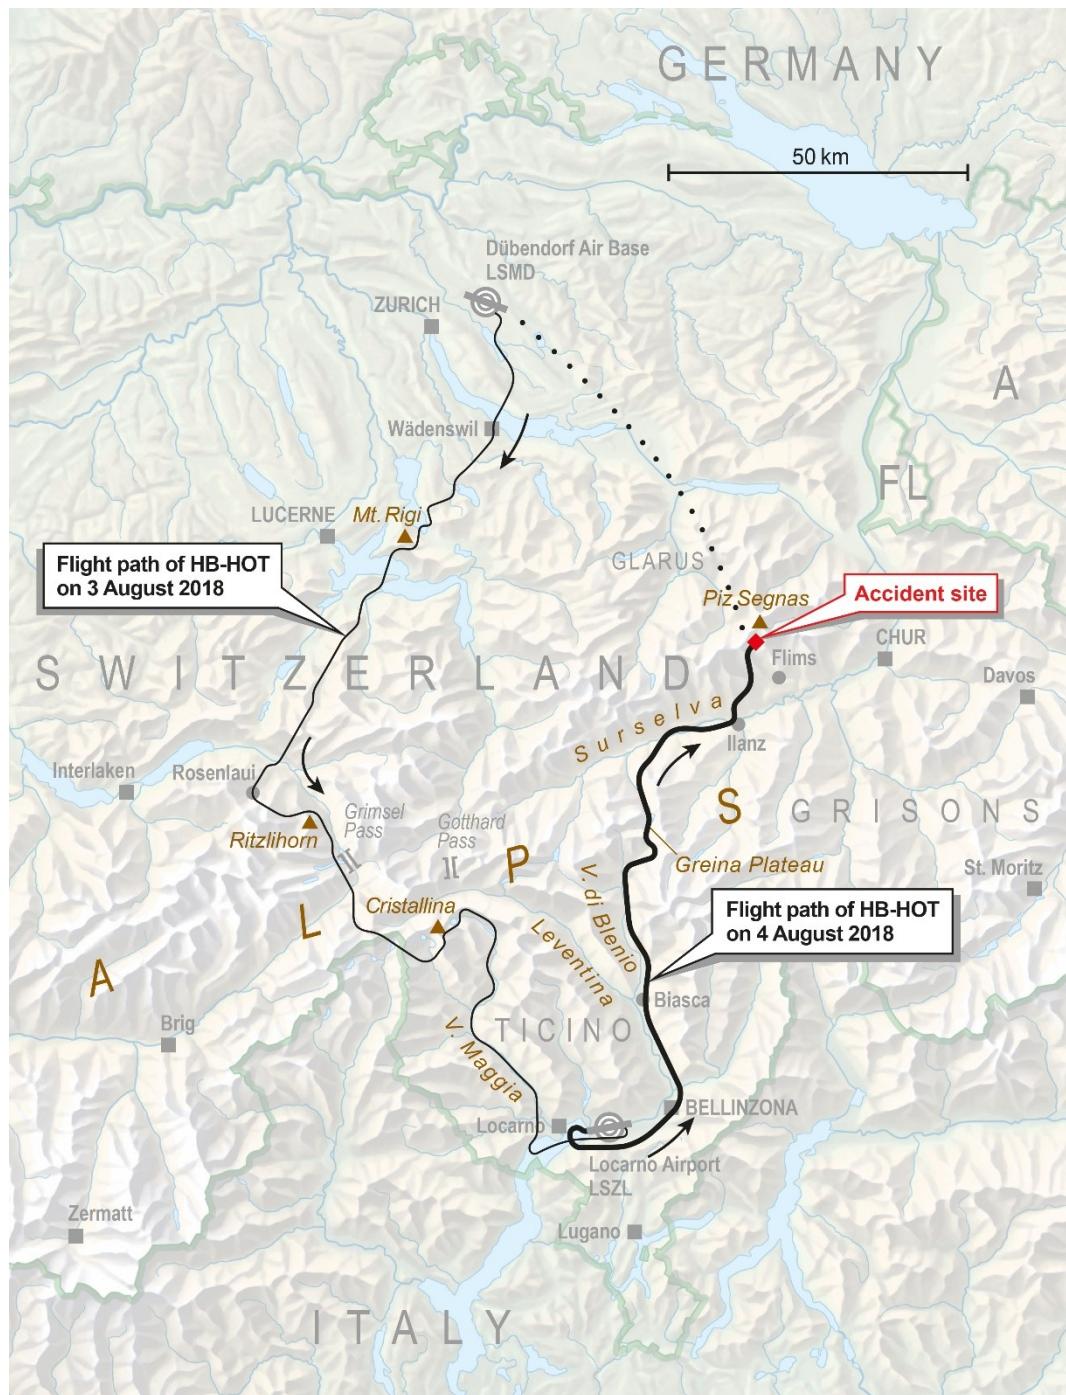
From Dübendorf, the flight initially passed Wädenswil. It then continued in a south-westerly direction past Mount Rigi and over the Roselaui region (see figure 1). It eventually reached an altitude of approximately 2,990 m AMSL². At 09:37, the flight crew navigated HB-HOT past the Ritzlihorn at a separation of 30 to 50 m from the rock face. The flight continued over the Grimsel pass and through the Cristallina region, passing various parts of the terrain in close proximity. After a descent along the Maggia valley, HB-HOT landed at Locarno Aerodrome at 10:13 (see annex [A1.1](#)).

Figure 1: Overview of the flight on 3 August 2018 from Dübendorf Air Base to Locarno Aerodrome and the accident flight on 4 August 2018. Source of the base map: relief map from the Swiss Federal Office of Topography.

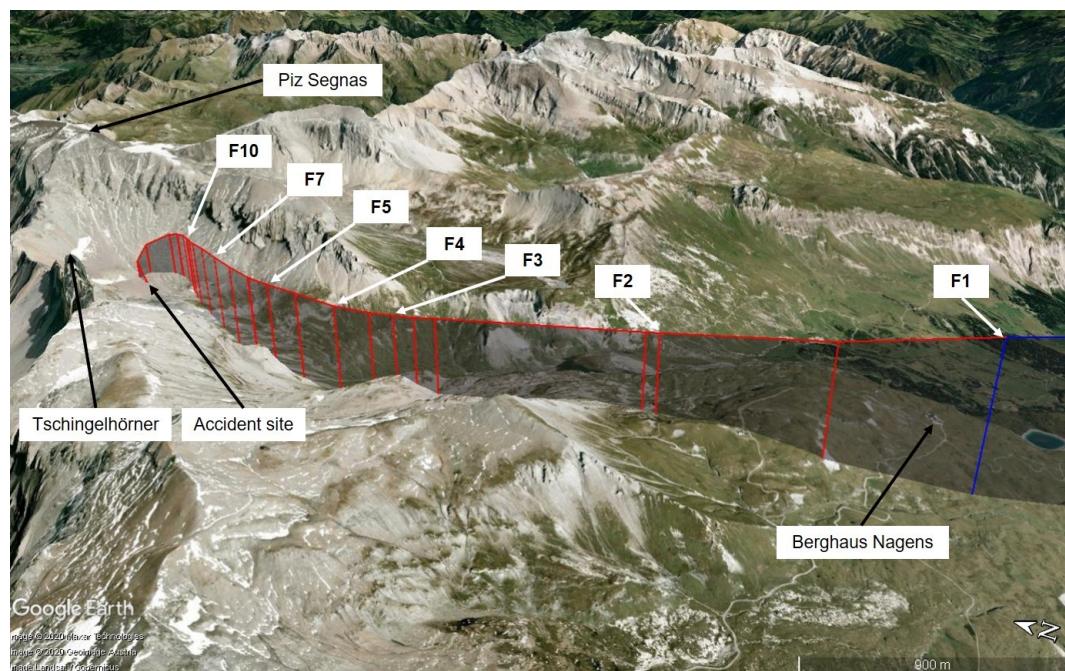
The aircraft made a slight right turn when flying past the Berghaus Nagens lodge (see figure 2). During this phase, at 16:55, one of the pilots informed the passengers of the scenery over the speakers in the cabin and through the passengers' personal headphones.

Figure 2: Reconstructed flight path of HB-HOT (red) from the Berghaus Nagens lodge to the site of the accident on 4 August 2018, shown on Google Earth. Point F1 is the first of a total of 29 points determined through photogrammetry. The flight altitude at point F1 was 2,833 m AMSL.

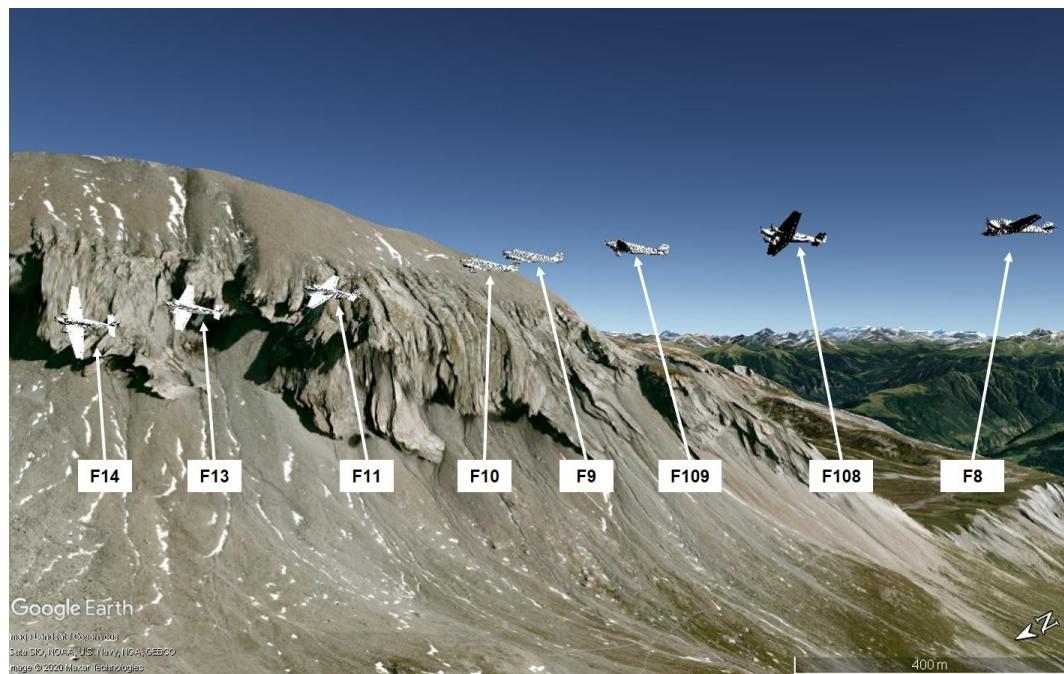
When the aircraft was approximately abeam the Martinsloch and at an altitude of approximately 2,766 m AMSL (point F8), the flight crew initiated a right turn during their descent and then made a left turn (point F109, see figure 5). The ground speed was approximately 170 km/h and the difference between the aircraft's pitch and flight path angles increased to approximately 15 degrees during the right turn. When transitioning into the left turn (between points F9 and F10), the pitch angle was approximately 11 degrees and the flight path angle was around -10 degrees. At this time, the aircraft was flying at approximately 125 m above the elevation of the Segnes pass (see figure 3).

Figure 5: Photogrammetrically reconstructed flight attitude at example positions, shown on Google Earth. The aircraft has been enlarged by a factor of 2 to make it easier to see.

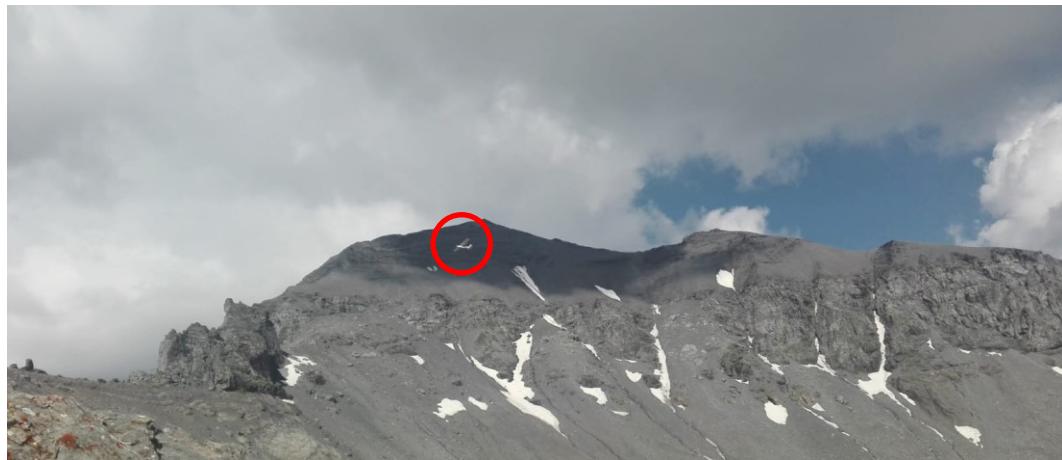
At 16:55 on 4 August 2018 – immediately before the accident involving HB-HOT – a single-engine, two-seater Cessna 152 aeroplane flew over the Segnes pass from the south. A trainee pilot on an alpine familiarisation flight and their flight instructor were on board. The aircraft encountered areas of downdraught in the Flims region and the crew decided to fly along the east side of the basin south-west of Piz Segnas, so that it would have been possible to turn back at any time even if the downdraught continued. At the selected altitude of 9,100 ft AMSL (2,800 m AMSL) the Cessna 152 flew into updraughts, which were interrupted again briefly by a weak area of downdraught just before the Segnes pass. The aircraft could cross the crest of the Segnes pass without any problems. No shear or turbulence was encountered at this altitude (see figure 10 and annex [A1.7](#)).

Figure 10: Photograph of the Cessna 152 (red circle) in front of Piz Segnas shortly before crossing the crest to the east of the Segnes pass with the aircraft flying west on 4 August 2018 at 16:55. The cloud over Piz Segnas is the same as that on the webcam images (see annex [A1.7](#)). Although it is not possible to ascertain the situation behind the pass based on this photo, the webcam footage from Elm as well as the flight instructor's statement and figure 3 in this report indicate that there was good visibility above and behind the Segnes pass shortly before HB-HOT approached.

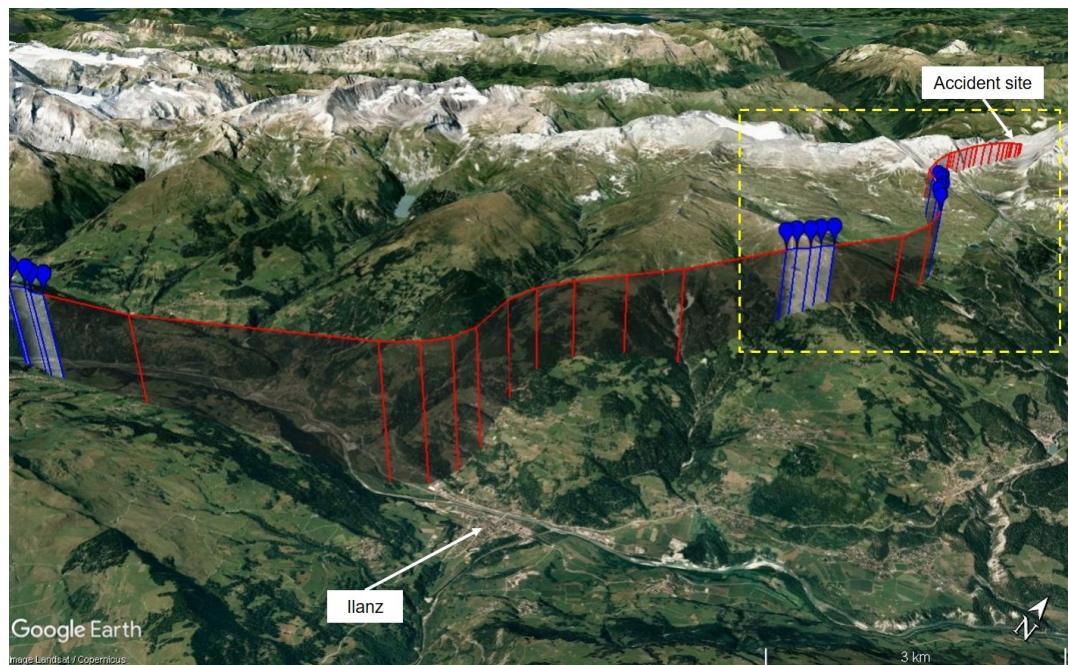
Based on the height-corrected MRT data points (blue dots in figures 11 and 12), HB-HOT flew past the mountain station on Crap Sogn Gion (2,215 m AMSL, see figure 12) at 16:54 on 4 August 2018. The aircraft had a flight altitude of approximately 2,740 m AMSL and was following a slight left turn. At the first photogrammetric point, F1²⁶, HB-HOT was at an altitude of 2,833 m AMSL on a true track (TT) of 335 degrees (see figure 12). The ground speed (GS) calculated by the MRT a few seconds before point F1 was 94 kt (corresponding to 48.4 m/s, or 174.1 km/h).

Figure 11: Reconstructed flight path of HB-HOT on 4 August 2018 near Ilanz (canton of Grisons) and leading up to the location of the accident with height-corrected MRT data points (blue), flight path sections reconstructed from witness statements and image material as well as photogrammetrically determined flight path sections (red), plotted on Google Earth. The area shown below in figure 12 is marked by the yellow dashed rectangle.

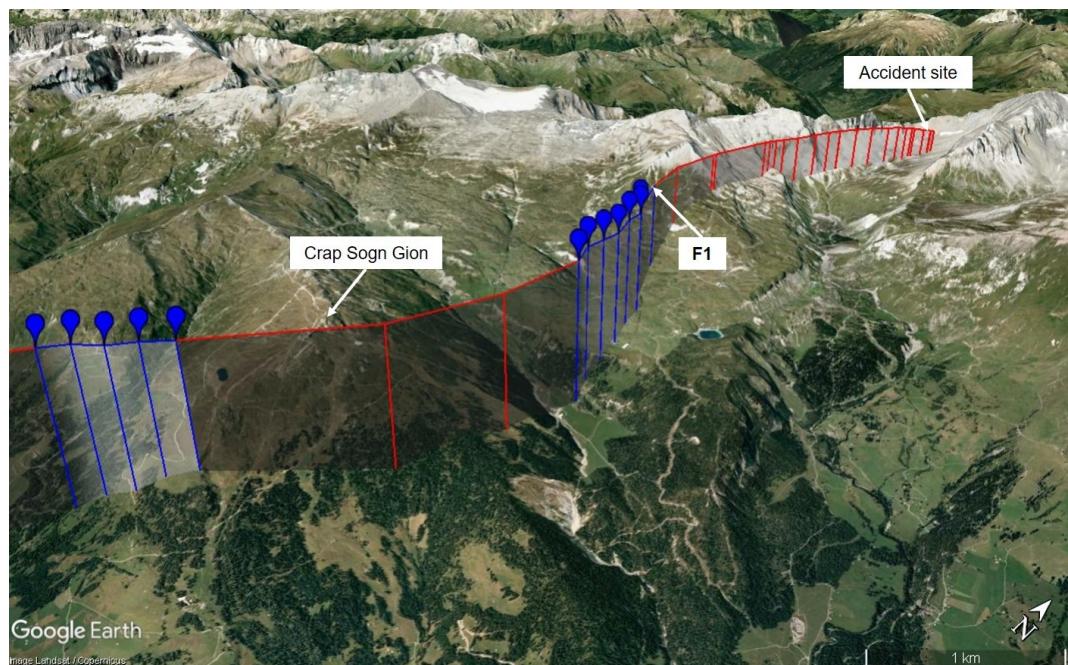
Figure 12: Reconstructed flight path of HB-HOT on 4 August 2018, shown on Google Earth. F1 denotes the first photogrammetrically determined point.

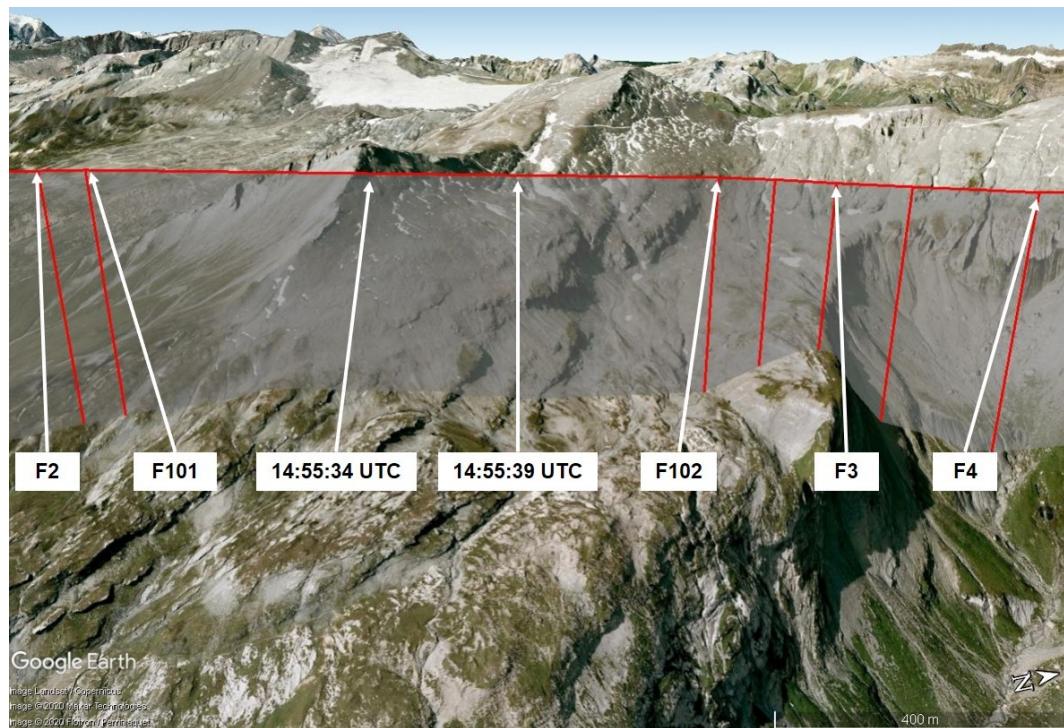
The first video recording ends shortly after point F101 and the second begins at point F102 (see figure 13).

- 14:55:34 UTC: TT = 353 degrees, GS = 74 kt (38.0 m/s or 137.0 km/h);
- 14:55:39 UTC: TT = 354 degrees, GS = 76 kt (39.1 m/s or 140.8 km/h).

Figure 13: Photogrammetrically reconstructed flight path of HB-HOT on 4 August 2018 (red) between points F2 and F4, shown on Google Earth. The two additional data packets at 14:55:34 UTC and 14:55:39 UTC were transmitted by the transponder.

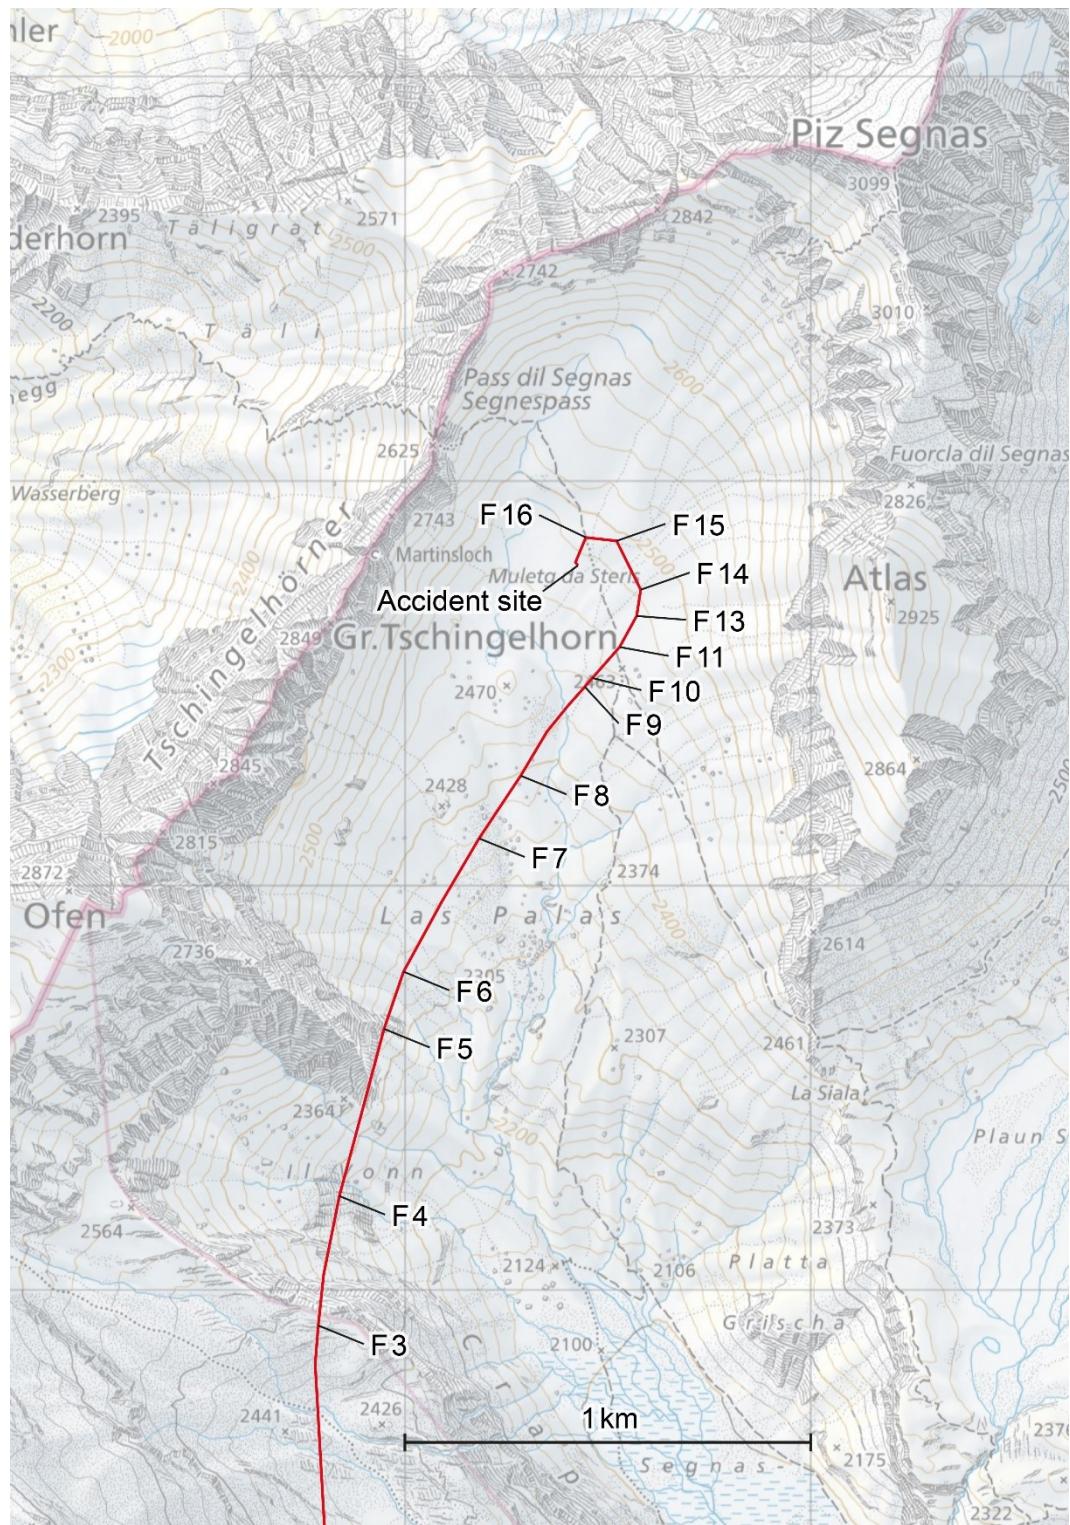
At 16:56:02, shortly after point F4, the speed of each of the three engines increased by approximately 40 rpm. At 16:56:09, HB-HOT entered the basin southwest of Piz Segnas at an altitude of 2,755 m AMSL (point F5, see also figure 14) and was therefore approximately 130 m above the elevation of the Segnes pass. The flight crew then navigated the aircraft on a north-north-easterly heading almost in the centre of the valley. HB-HOT climbed slightly during this phase and its flight path angle was approximately 2 degrees; its pitch angle remained at 5 to 7 degrees. At 16:56:17, the aircraft reached an altitude of 2,767 m AMSL at point F7 and was therefore approximately 140 m above the elevation of the Segnes pass.

Figure 14: Reconstructed flight path of HB-HOT on 4 August 2018 (red) between point F3 and the site of the accident. Source of the base map: Swiss Federal Office of Topography.

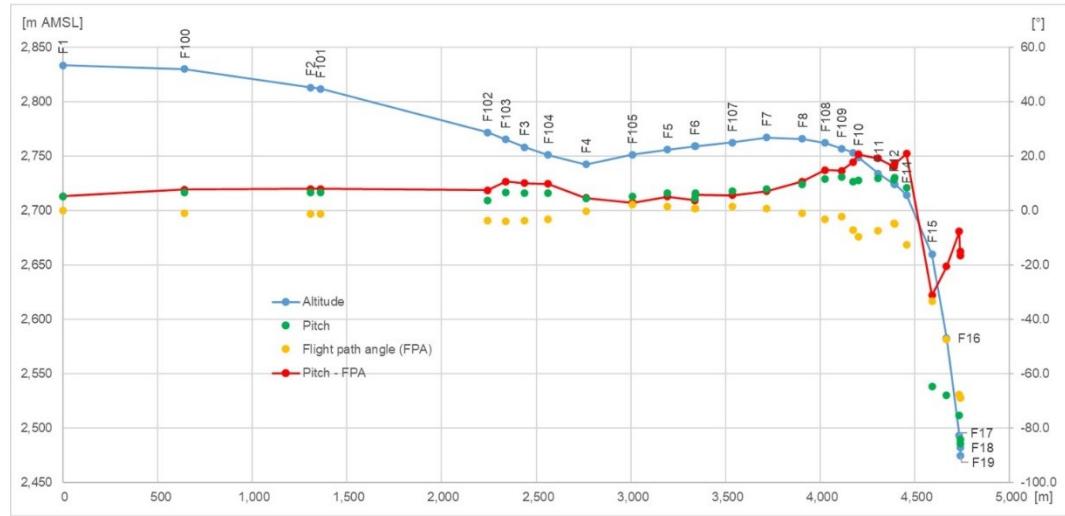
Figure 15 shows the altitude, pitch and flight path angles as well as the difference between these two angles.

Figure 15: Altitude, pitch and flight path angle (FPA) in relation to the horizontal distance travelled. The left-hand y-axis shows the values for altitude and the right-hand y-axis shows the values for the angles.

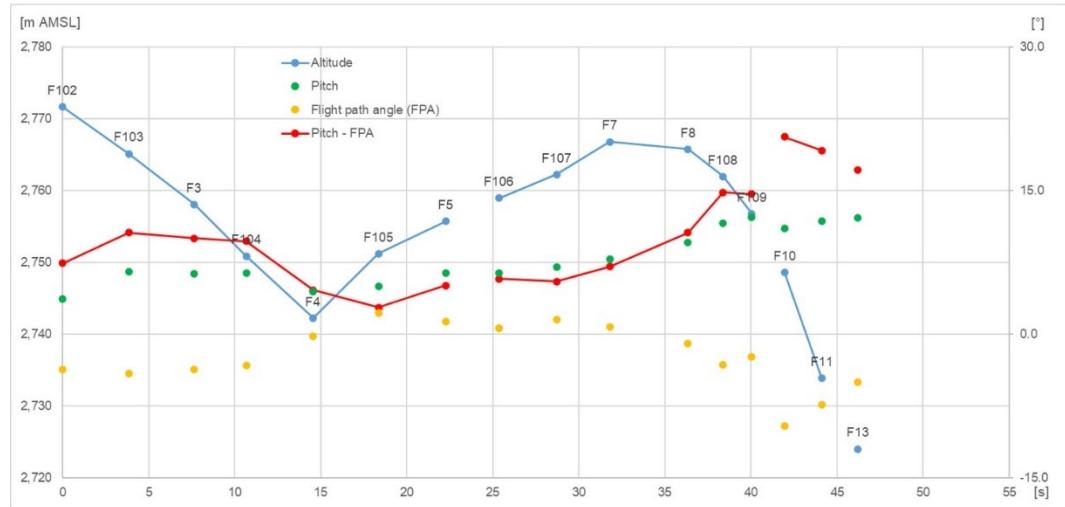
The parameters in figure 16 are shown in relation to the runtime of the video footage. F102 is the first point determined using this video. This is shown in figure 15 at a horizontal distance of 2,243 m. There are other points which have been determined from other data sources (e.g. F6 between points F5 and F106) between the unconnected points in figure 16. They are not illustrated as no runtime can be assigned to them.

Figure 16: Altitude, pitch and flight path angle in relation to the video runtime. The left-hand y-axis shows the values for altitude and the right-hand y-axis shows the values for the angles.

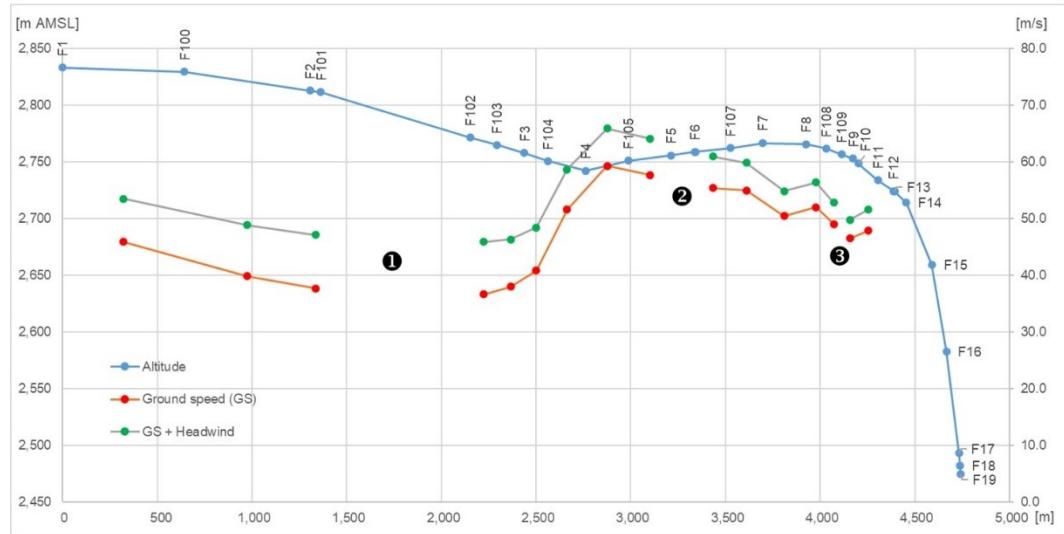
Figure 17 shows the calculated course of the ground speed (GS). The three values for the GS received from HB-HOT's transponder were also considered.

Figure 17: Altitude, calculated ground speed and ground speed + headwind in relation to the accumulated horizontal distance.

In area ❶ (see figure 17) where the ground speed graph is interrupted, no time difference – and thus no ground speed – could be calculated, because the data points were determined using two different, unconnected videos. For the other gaps (areas ❷ and ❸), the points have been determined from other data sources. They are not shown as no runtime can be assigned to them.

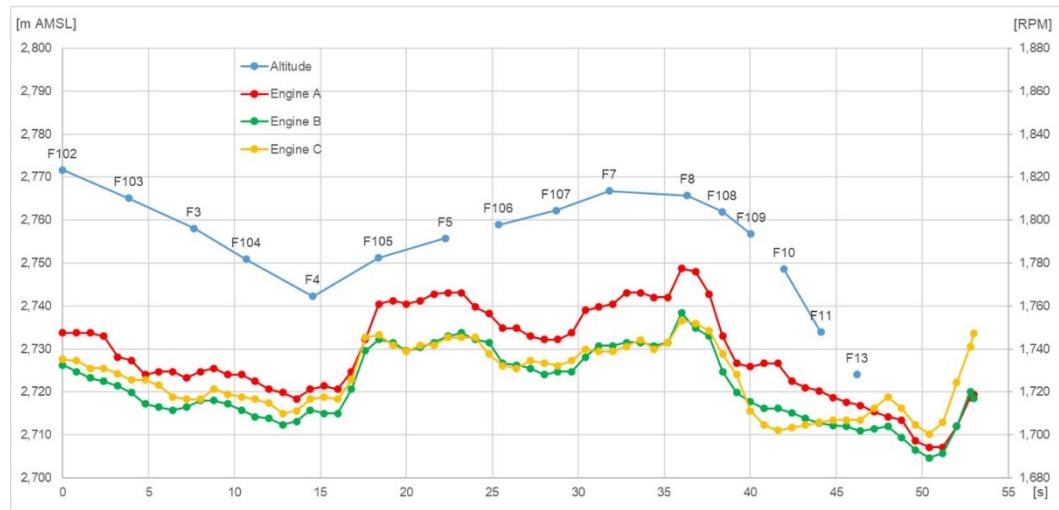
Figure 18 shows the course of the three engine speeds in relation to the video runtime. It was not possible to assign the speeds of engines A, B and C to the position of the engines (left, centre, right).

Figure 18: Altitude and engine speed in relation to the video runtime.

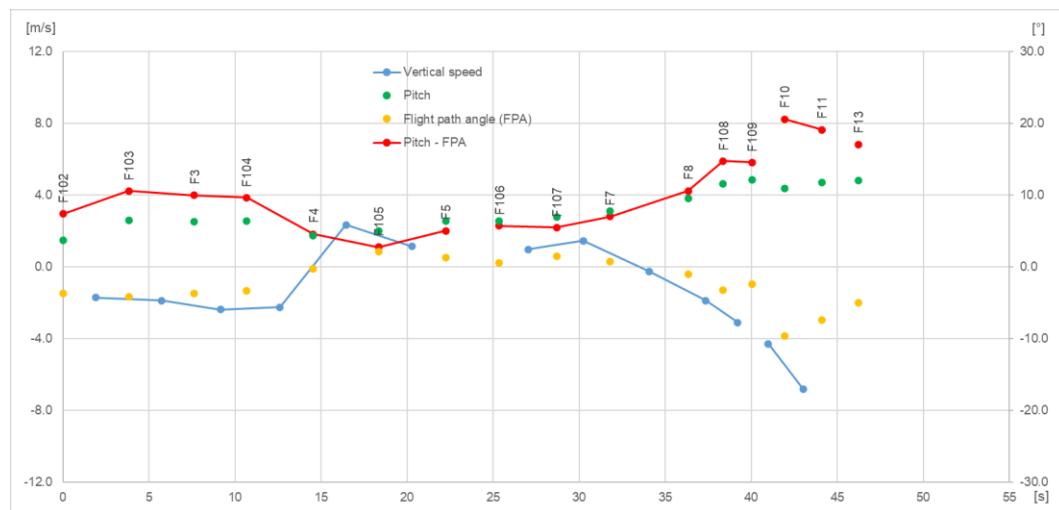
In addition to the pitch and FPA, figure 19 also shows the rate of ascent and descent in relation to the video runtime.

Figure 19: Vertical speed, pitch and flight path angle in relation to the video runtime.

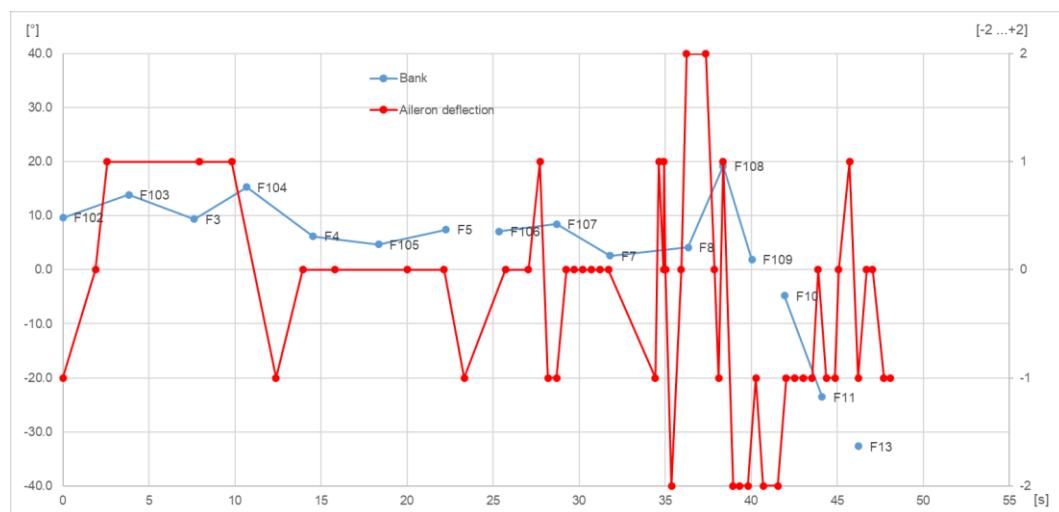
Figure 20: Bank and aileron deflection in relation to the video runtime. Positive values on the y-axis indicate bank to the right and aileron deflections for a right turn respectively. The bank angles were determined photogrammetrically.

The aileron deflections were qualitatively evaluated with values of - 2, - 1, 0, + 1 and + 2 (figure 20, right-hand y-axis) based on a video recorded from inside the aircraft. Positive values indicate an aileron deflection for a clockwise roll as seen in the direction of flight, i.e. for a right turn, whilst negative values indicate an aileron deflection for a left turn and a value of zero means the aileron position was neutral.
