Technical report

IN-014/2019

Incident involving a Boeing 737-800 aircraft,
registration G-TAWA, at Lanzarote Airport on
25 March 2019

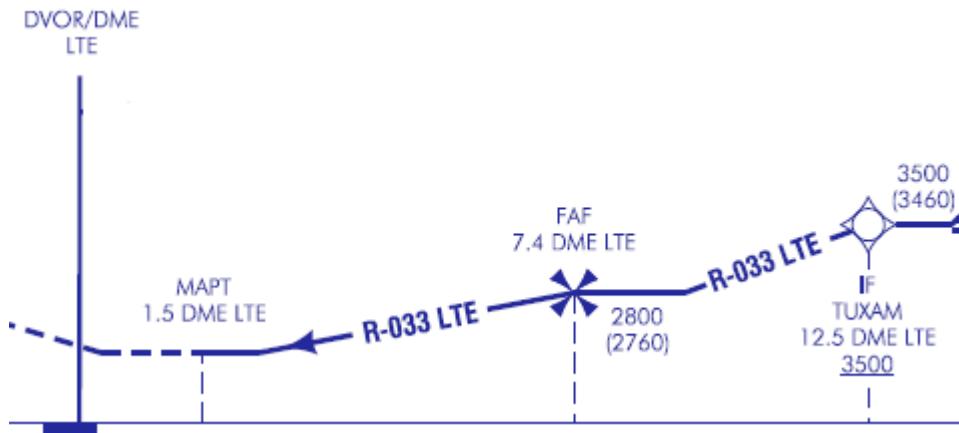
Illustration 2: Vertical profile of the VOR A approach to Lanzarote Airport

When the aircraft was at mile 9.5 DME LTE and descending through 3,136 feet, the flight crew selected the MDA rounded up to the higher hundred of 2,100 feet in the MCP altitude window.

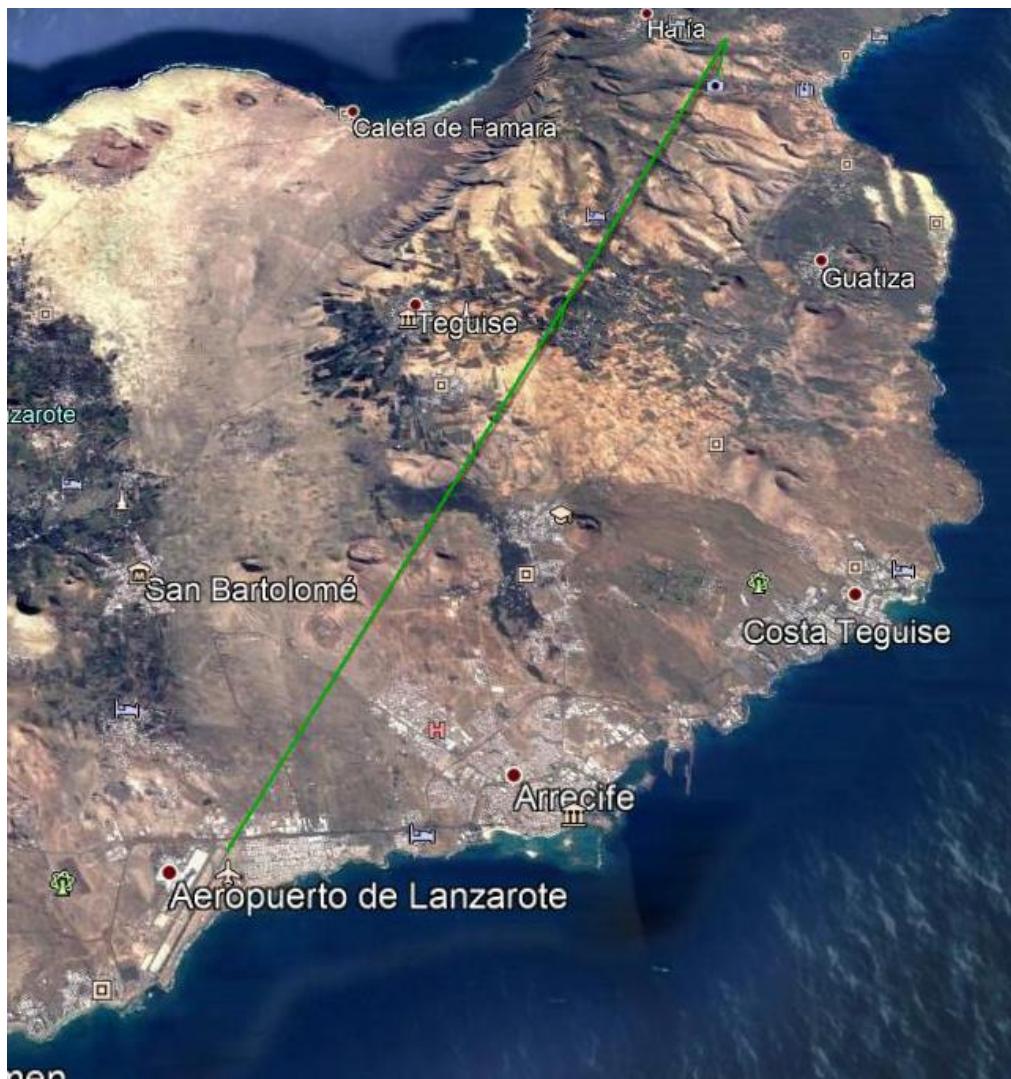
Illustration 3: Image of the terrain that is flown over during the VOR A approach (indicated by a green line)

The orography that is flown over during the approach to runway 21 at Lanzarote airport (See Annexe II) is characterised by:

- the rising terrain level and
- the height of volcanic formations.

Because of these obstacles, ENAIRE developed two non-precision procedures for the approach to runway 21: IAC VOR A and IAC VOR B. The IAC VOR A approach (see Annex I), which the aircraft involved in the incident was following, is subject to a circling OCA/H due to infringement of the VSS (visual segment surface).⁵

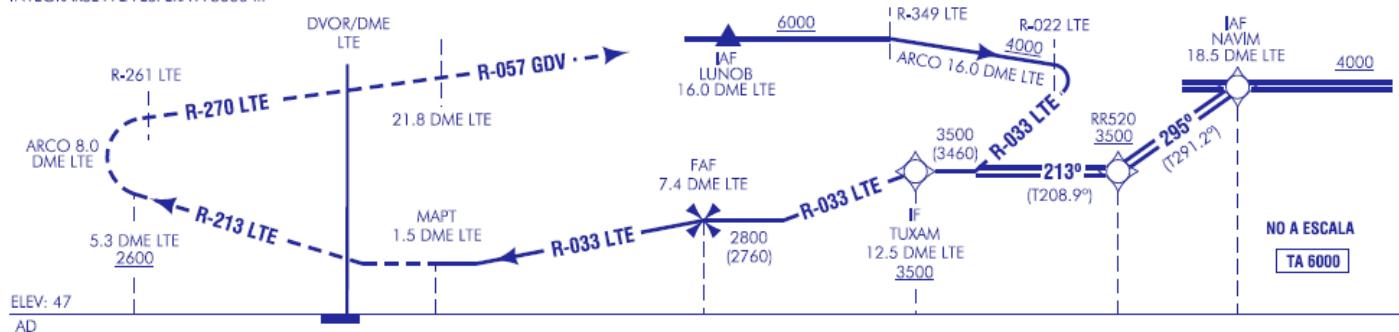
The vertical profile of the VOR A approach sheet published in the AIP-Spain is shown below.

OCA/H		A	B	C	D	
STA	2.5%	RESTRINGIDA A OCA/H DE CIRCUITO POR VULNERACIÓN VSS				
En circuito (H) sobre		1780 (1740)	2020 (1980)
