# Investigation Report

Type of Occurrence: Serious Incident

Model: Jetstream 3200

State File Number: BFU19-1422-EX

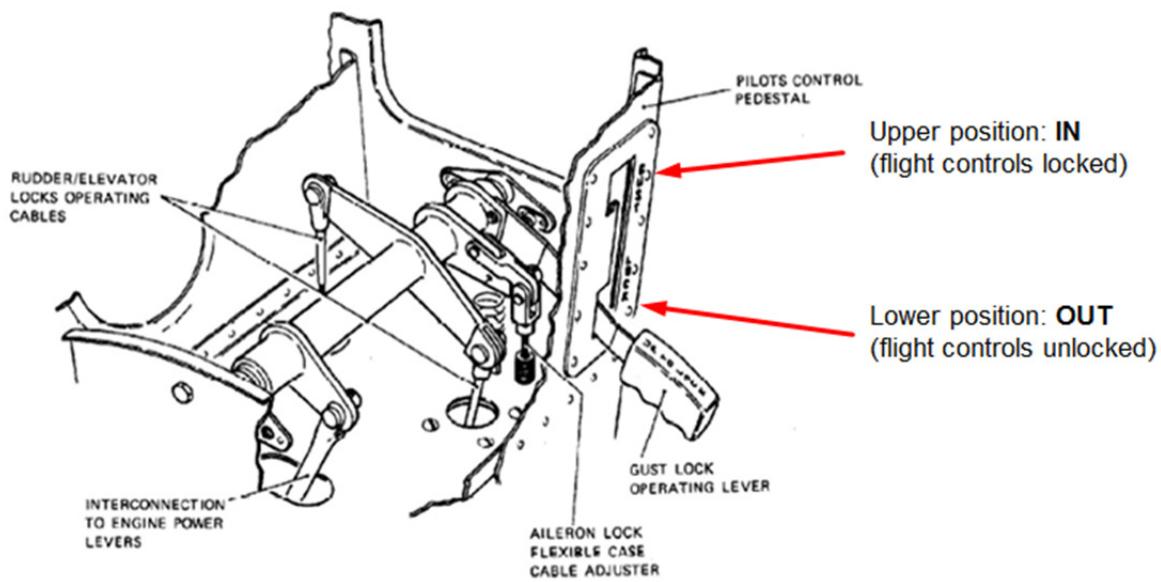
The control surfaces are locked in their neutral positions via a gust lock lever. This lever is located on the right-hand side of the center console (Fig. 6). If the lever is in the upper position (IN) (Fig. 6 and 7), spring-loaded locking pins lock, via corresponding cables and levers, the aileron, rudder and elevator controls. In order to prevent take-off with locked flight controls it is normally not possible to move both power levers simultaneously beyond the flight idle position. This is mechanically prevented through a special locking mechanism of bars and levers. Individually the power levers can be moved to the MAX position.

Fig. 7: Gust Lock lever mechanism

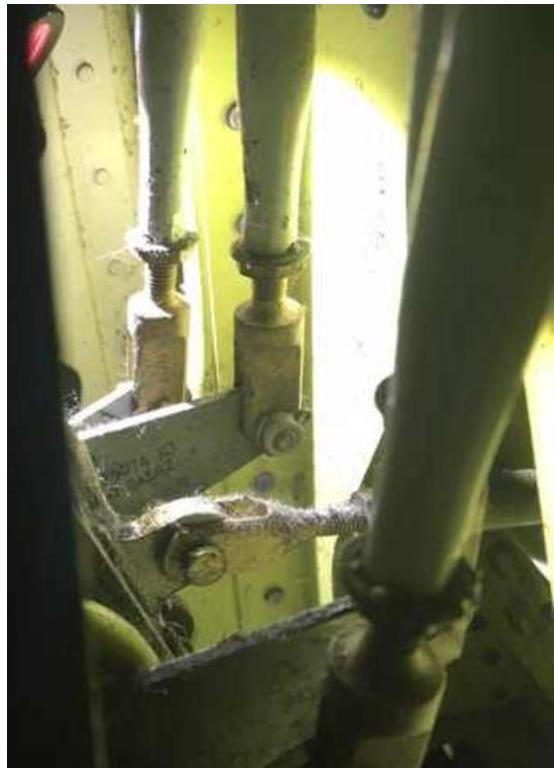
Fig. 12: Connection intact
