FINAL REPORT

ON THE ACCIDENT OF 6 NOVEMBRE 2002
AT LUXEMBOURG
TO THE LUXAIR FOKKER 27 MK050
REGISTERED LX – LGB

December 2003

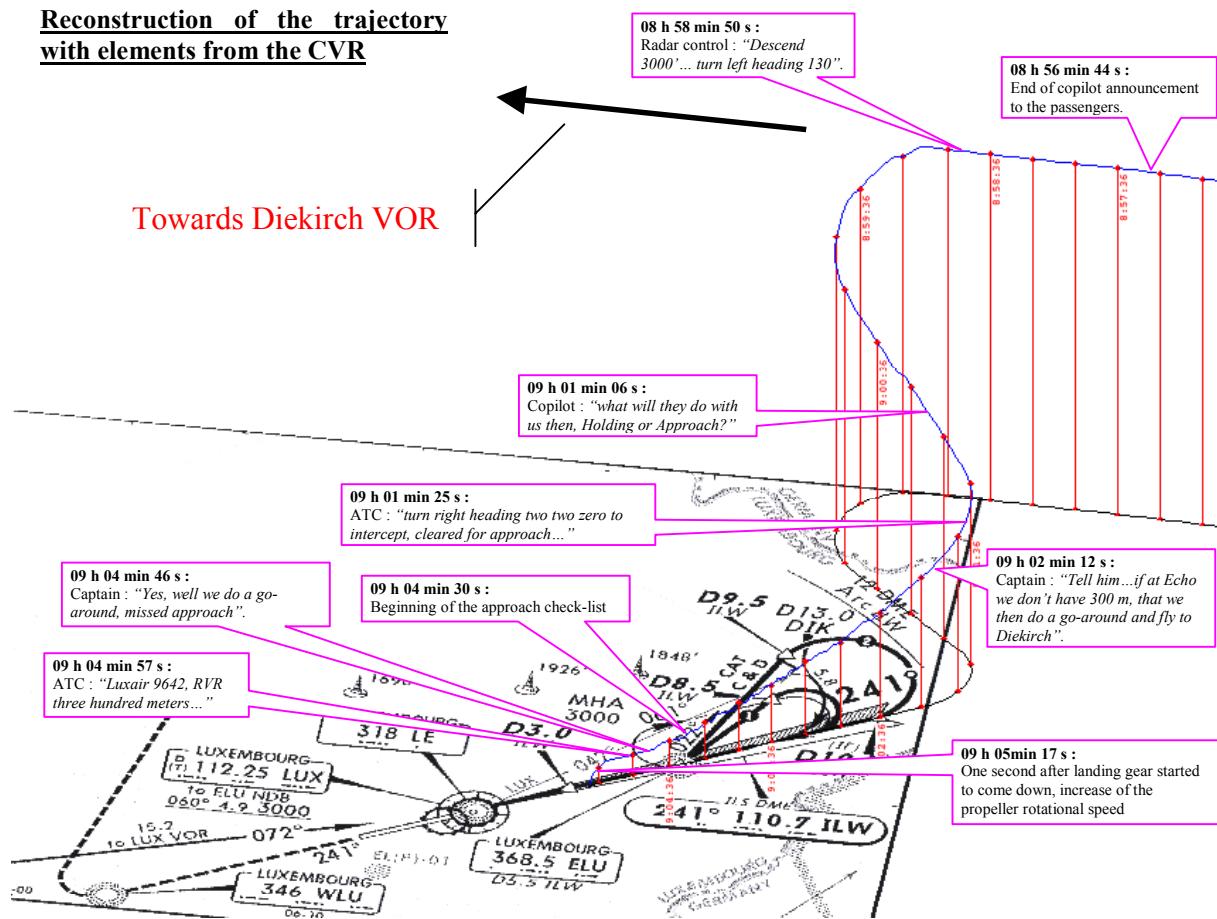
Reconstruction of the trajectory with elements from the CVR

This three dimensional trajectory has been made up on the basis of Luxembourg radar data. Synchronisation precision between FDR and CVR is one second.

The vertical profile of the trajectory shown in appendix 17 represents radar data illustrating that the final descent of the aircraft started markedly after the ELU beacon.

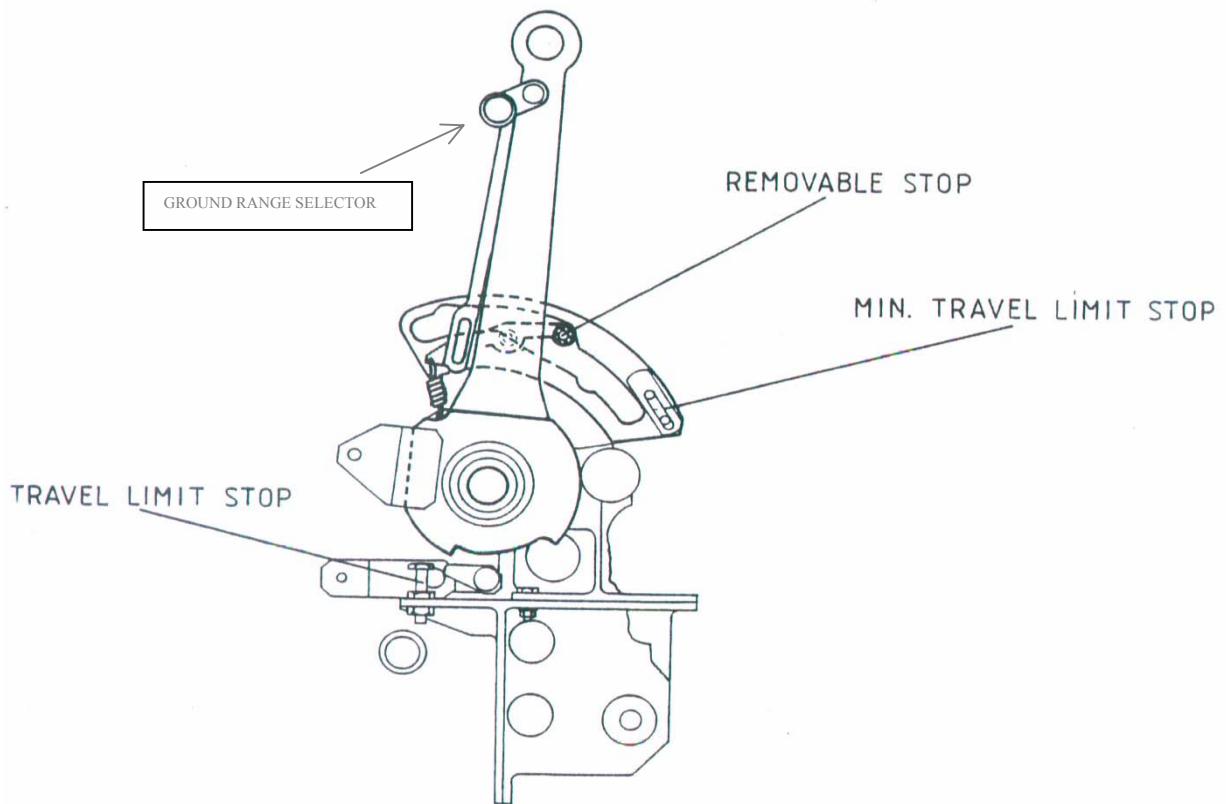
Power levers and ground range selector

In flight, power lever positions below flight idle are prevented by two means:

- a mechanical primary stop (ground range selector) on the power levers

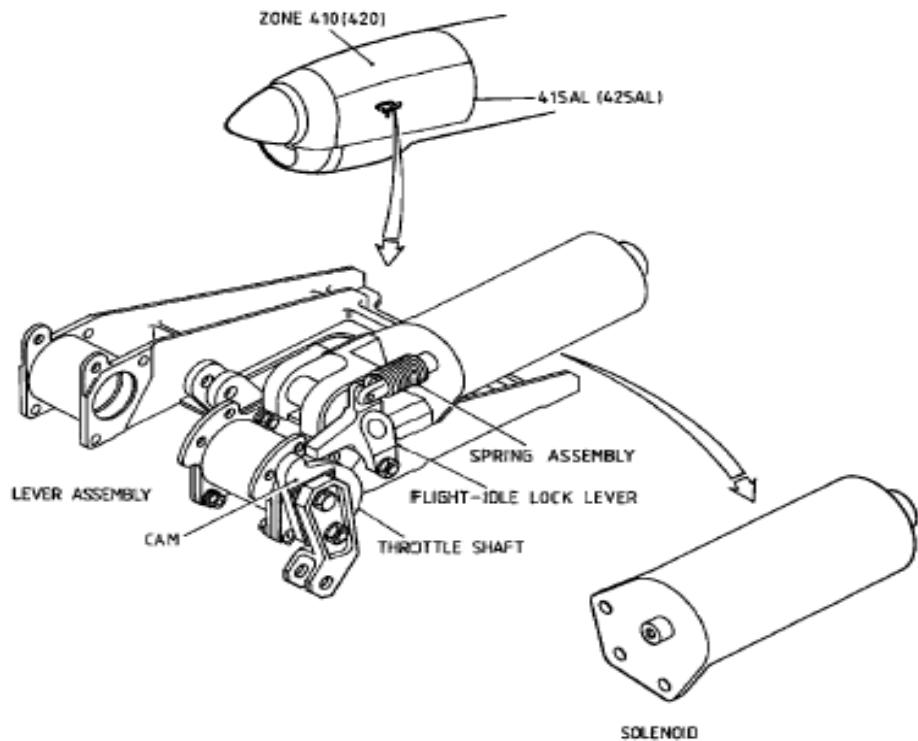
- an electrical secondary stop (flight idle stop solenoid) on each engine.

To select the beta mode after landing, with the power levers in the flight idle position one has to grab and lift the ground idle selectors fixed to the power levers and move the levers backward. This first mechanical stop on the power levers is doubled by a flight idle stop fixed to each engine and activated by solenoids.

Once the solenoids are powered up, the flight idle stops are released and power levers may be moved backwards below the lever range for flight.

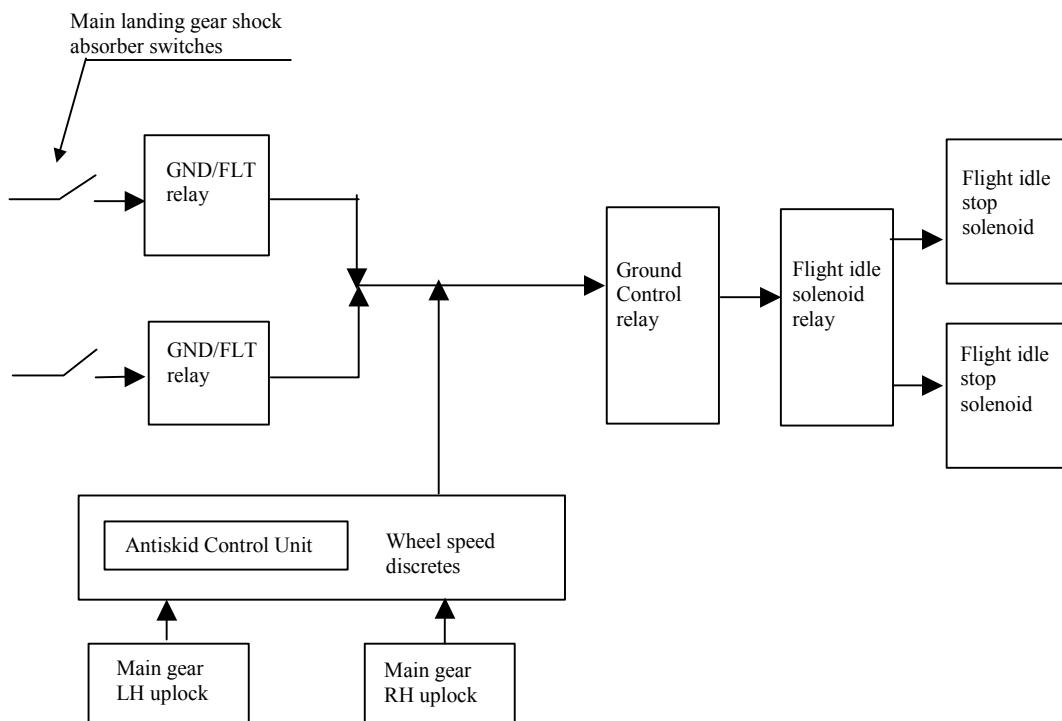
The wheel spin-up signals or the GND/FLT relays switches energise the flight idle stop solenoids through the ground control relay. The antiskid control unit senses the wheel spin-up signals. The main gear switches initiate the transmission of GND/FLT signals.

The following illustration shows, how these signals are carried to the flight idle stop solenoids.

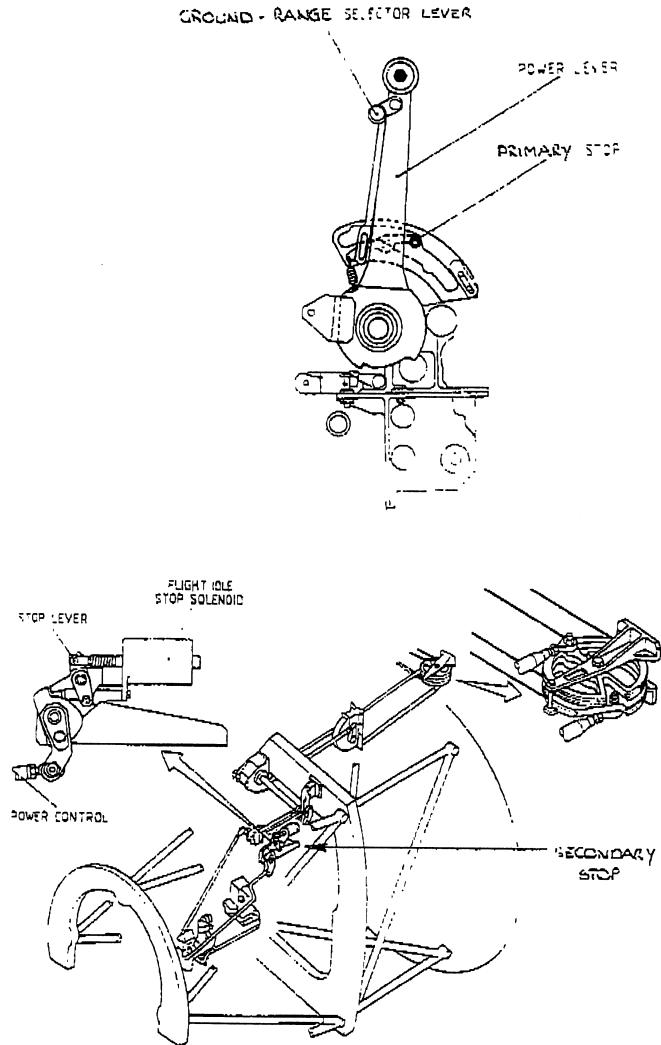
The Automatic Flight Idle Stop
Figure 1

Primary stop (Refer to figure 1)

Secondary stop (Refer to figure 1 and 2)
