دُولَةِ الْإِمَارَاتِ الْمُهَرَّبِيَّةِ الْمُتَّدَّلَةِ
الْهَيْئَةُ الْعُلَامَىُّ لِلطَّيْرَانِ الْمُهَرَّبِيِّ
UAE General Civil Aviation Authority

AIRCRAFT ACCIDENT 01/04

***FINAL REPORT
ON THE ACCIDENT INVOLVING
KISH AIRLINES FOKKER F27 MK.050,
IRANIAN REGISTERED AS EP-LCA ON
APPROACH TO
SHARJAH INTERNATIONAL AIRPORT,
UNITED ARAB EMIRATES
ON 10 FEBRUARY, 2004***

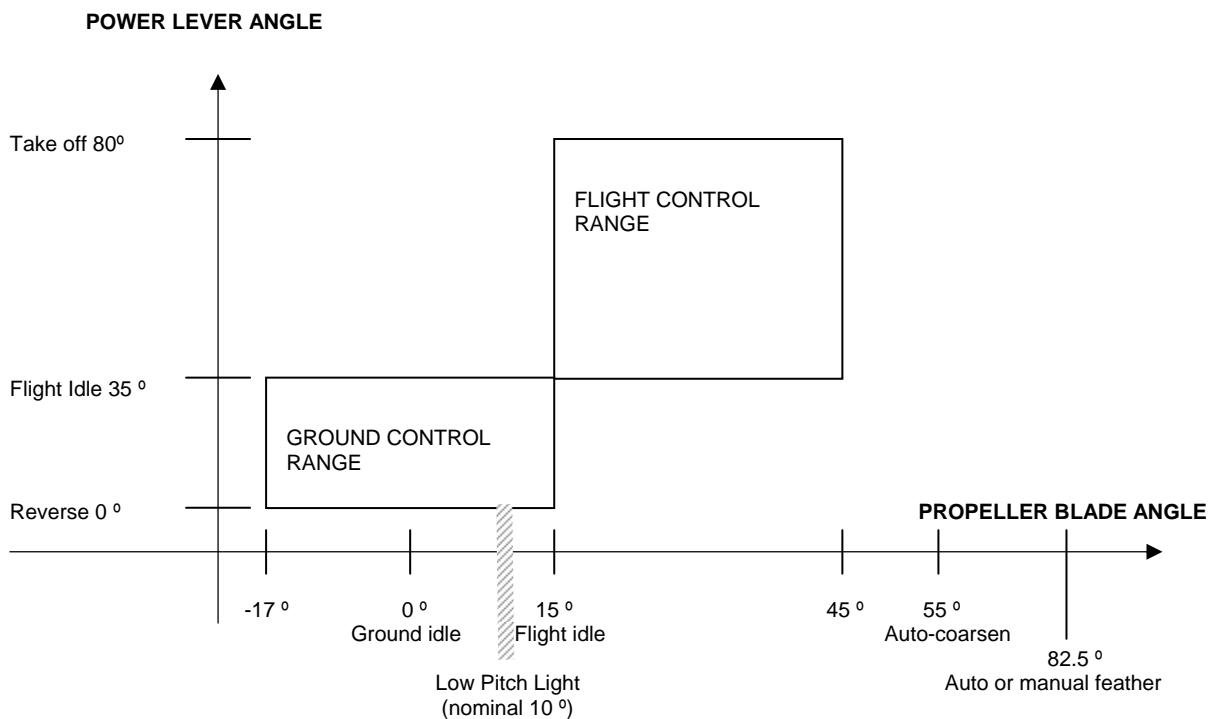
ILLUSTRATION 1

1.16.2.1 Description. The engine drives a variable-pitch, constant speed propeller. The pitch ranges from feathered, through zero pitch to full reverse. The propeller pitch angle varies in flight from $+15^\circ$ to approximately $+45^\circ$. Propeller pitch is controlled by balancing oil pressure provided by a high pressure pump driven by the propeller gear box, against the coarse pitch seeking force provided by counterweights attached to the blade roots. Should the oil pressure fail, such as after an engine failure, the counterweights assist the propeller blade angle to auto-coarsen to $+55^\circ$, which is a low drag windmilling condition. Automatic or manual feathering would achieve a blade angle of $+82.5^\circ$. The propeller pitch angle in the ground control range varies on the ground from $+15^\circ$ to -17° . Please refer to the Dowty Propeller report at Appendix 6 for a more detailed explanation of the propeller system, normal operation and analysis. Illustration 1 below indicates the power lever angle (PLA) and propeller pitch angle relationship.

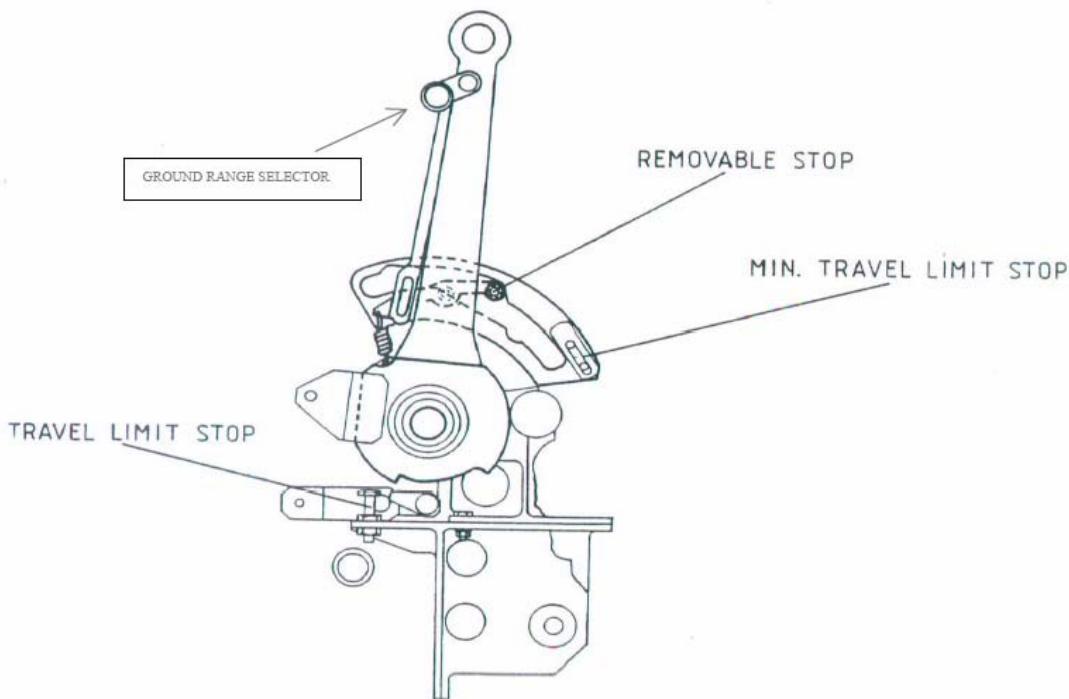
ILLUSTRATION 3

- (a) Mechanical flight idle stop (primary stop). To select ground control range after landing, the power levers must be in the flight idle position. The Ground Range Selector, which is fixed to the power levers, must be then physically lifted by a pilot to remove the mechanical stop so that the power lever can be moved backwards. This mechanism is designed to require a positive action by a pilot and cannot be accidentally moved. Refer to Illustration 3.

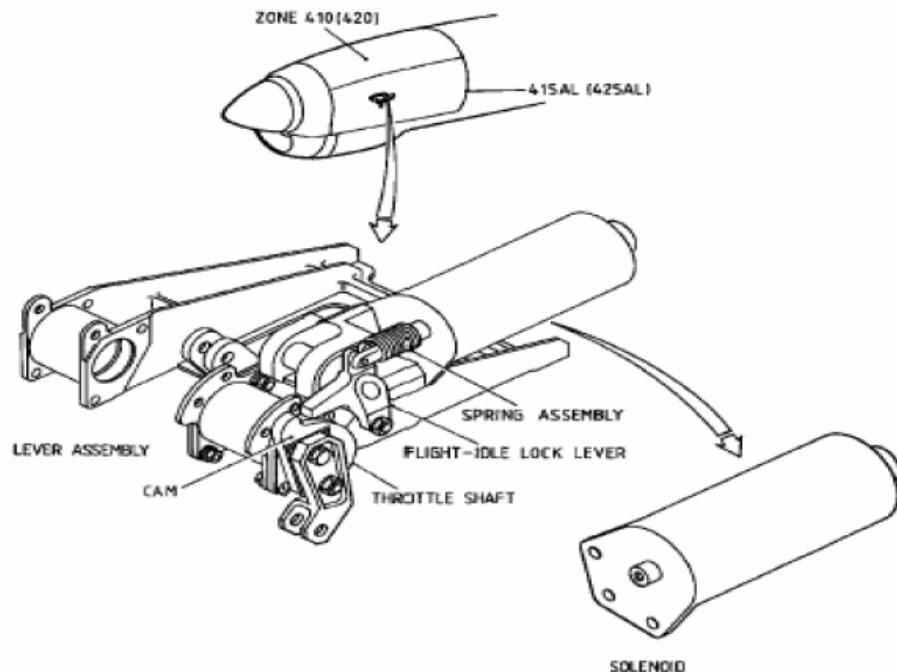
**ILLUSTRATION 4**

- (b) Electrical flight idle solenoid (secondary stop). Although not a requirement at the time the Fokker F27 Mk.050 was type certificated, there is an electrical flight idle solenoid (secondary stop) for each propeller located on each engine. Once energized the solenoid removes a flight idle lock lever. Each solenoid is powered through one Skid Control Unit and/or the Ground/Flight switches (refer paragraph 1.16.5 and Illustration 5). The solenoid prevents the corresponding power lever from moving from the flight idle position into a ground control range. Refer to Illustration 4.

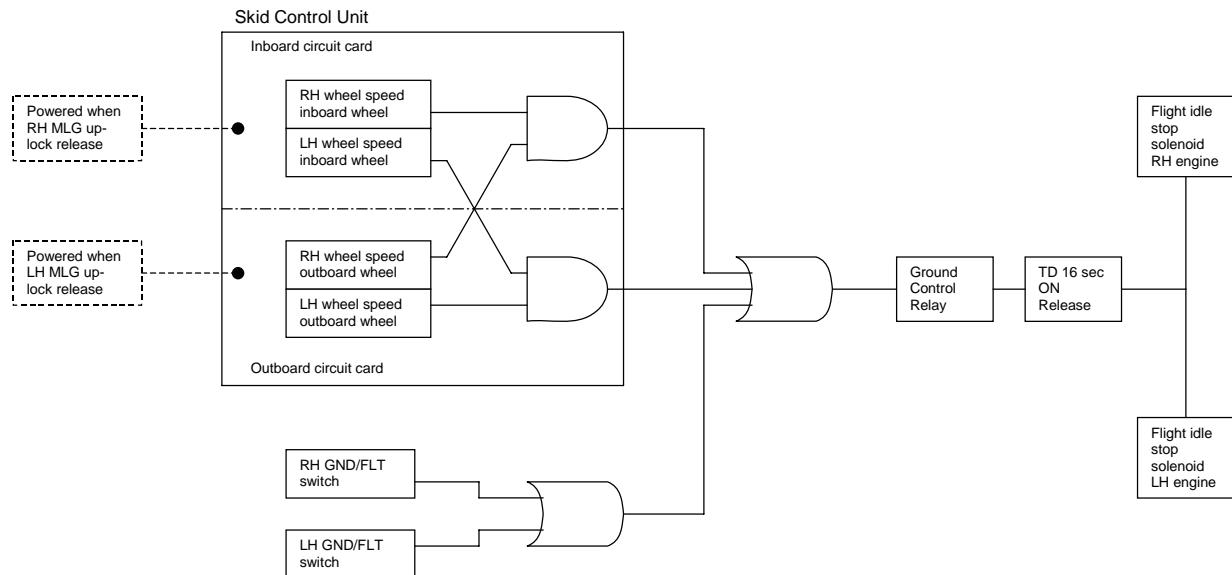
ILLUSTRATION 5

The latter two wheel speed signals are obtained from the Skid Control Unit. The Skid Control Unit is basically designed to provide optimum brake operation for all runway conditions. One of the basic inputs for this is the wheel speed of the different MLG wheels, sensed by the wheel speed sensors in each wheel axle. Hence, by using the wheel speed discretes from the Skid Control Unit, the Skid Control Unit forms a part of the system to control the Flight Idle Stop solenoids. The following Illustration 5 shows the relationship between the SCU and an electrical flight idle solenoid.

1.16.5.3 Undesired System Behaviour. The Skid Control Unit contains two channels which are electrically powered separately. The inboard card is powered when the RH MLG comes out of the up lock position and the outboard card when the LH MLG comes out of the up lock position.
