## ***Report RL 2008:01e***

### **Aircraft incident to SE-DSP in airspace south-west of Stockholm, AB county, Sweden, on 22 March 2007.**

Case L-04/07

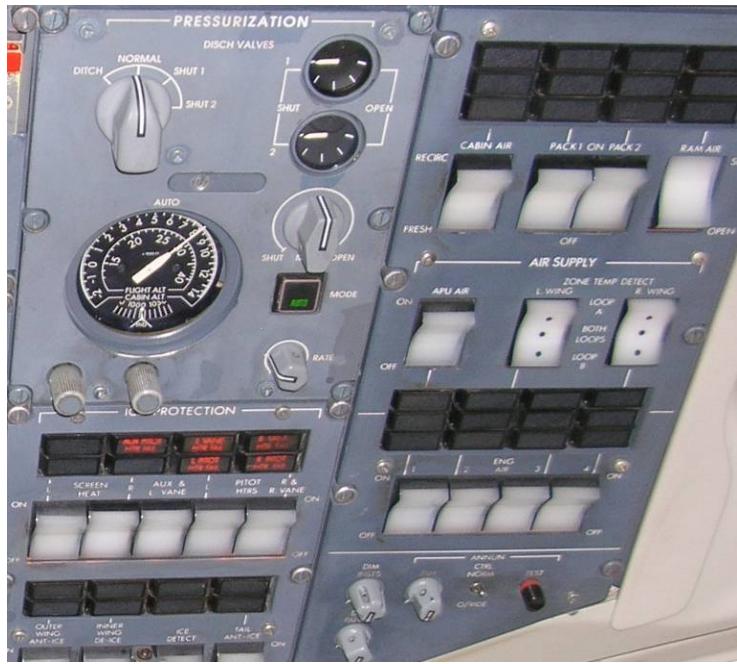
Fig. 1

The system is controlled by the pilots from two control panels located on the overhead panel the cockpit. From there the pilots can select the source

of the cabin air, activate the packs and set the desired cabin pressure and temperature. See fig. 1.

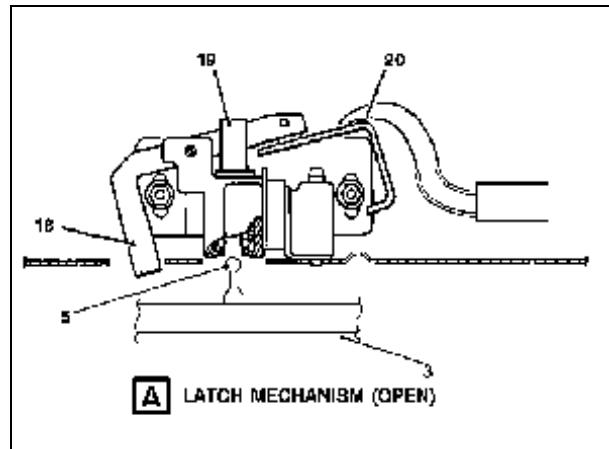
The hatches have a latching mechanism that consists of a ball-shaped plunger on the hatch cover that projects into the hatch frame and is locked by a spring-loaded catch that can be electrically opened. See Fig. 3 below.
