Investigation Report

EX006-1-2/04
February 2009

Type of Event: Serious Incident
Date: 3 May 2004
Location: Munich Airport
Aircraft: 1. Commercial Air Transport
 2. Commercial Air Transport
Manufacturer / Type: 1. Boeing / B737-306
 2. Aerospatiale / ATR 42-500
Injuries to persons: None
Damage to Aircraft: None
Third Party Damage: None
Source of Information: Investigation by BFU

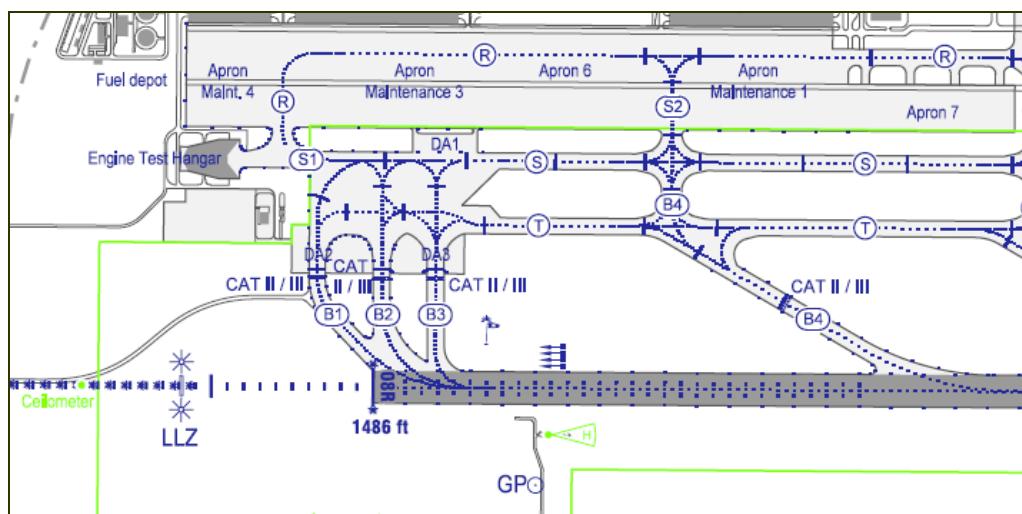
Illustration 9: Plan View Taxiway B4

Taxiway B4 enters into Runway 08 R at an angle of 30°. The CAT-1 Hold Line is 90 m wide. The taxiway is 90 m wide.

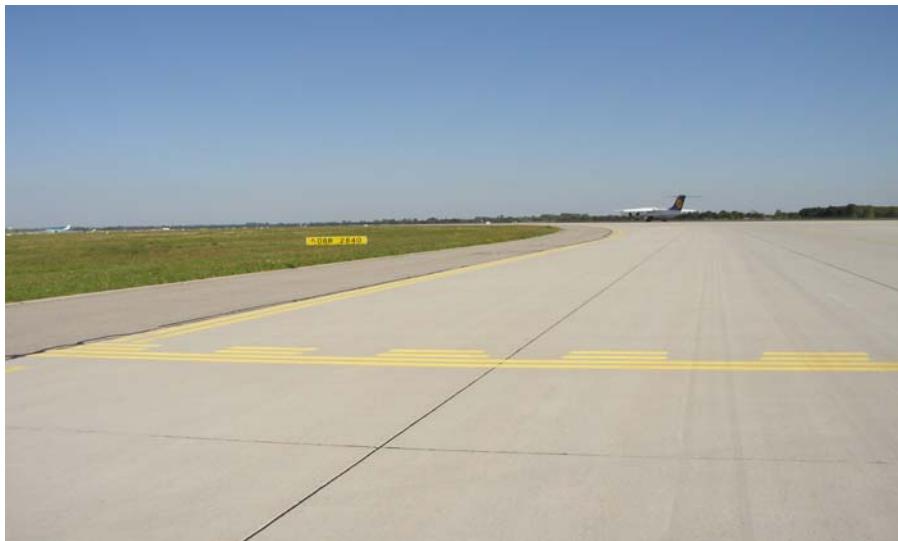
Illustration 10: CAT-I Taxi Hold Point B4 Runway 08R

During the course of a site visit by a BFU inspector, it was evident that the Approach to Runway 08 R could only be observed with difficulty from the B4 Cat-1 Hold position.

In addition, the inspector observed the night view of runway 08 R as seen from the cockpit of an aircraft at the B4 Cat-1 Hold. At night it was not possible to tell clearly whether an aircraft moving along Runway 08 R was landing or taking off until it had rotated or slowed down.
