Incidents in Air Transport

Aerodrome Traffic

Runway Confusion at Montpellier

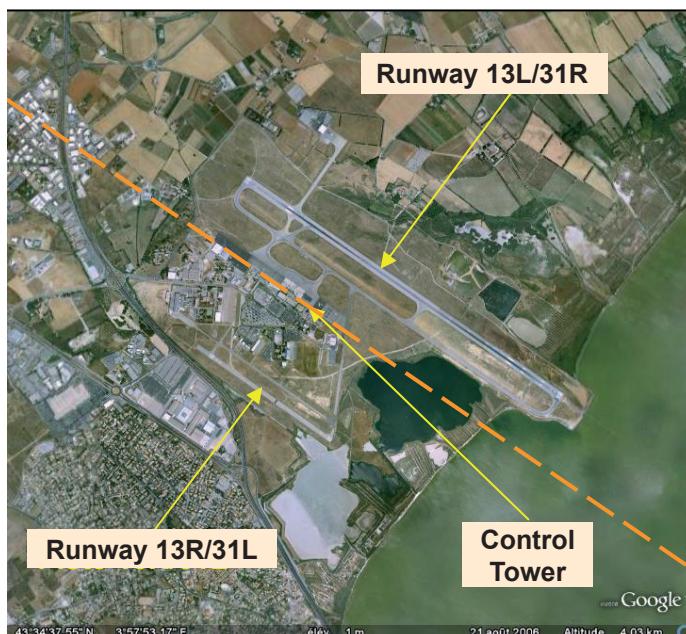
Montpellier Méditerranée airport has parallel runways, 1,115 metres apart. Main runway 13L/31R is 2,600 metres long and 50 metres wide. The secondary runway 13R/31L is 1,100 metres long and 30 metres wide. The latter is dedicated to aircraft with maximum takeoff weight under 5,700 kg. The «31» runways are used in preference.

The boundary separating these two sectors is parallel to the runways and goes through the control tower.

The controller in each LOC position has no knowledge of traffic in the other sector. An assistant LOC controller can provide coordination between the two LOC controllers when it is necessary, for example in the event of possible interference between traffic in the two sectors. Given the distance between the two runways, under VMC conditions, aircraft on final approach for the two runways are considered separated.
