ATSB TRANSPORT SAFETY REPORT
Occurrence Investigation Report AO-2007-036
Final

Fuel-related event – 50 km NW of
Swan Hill, Vic.
11 August 2007
VH-TJE
Boeing Company 737-476

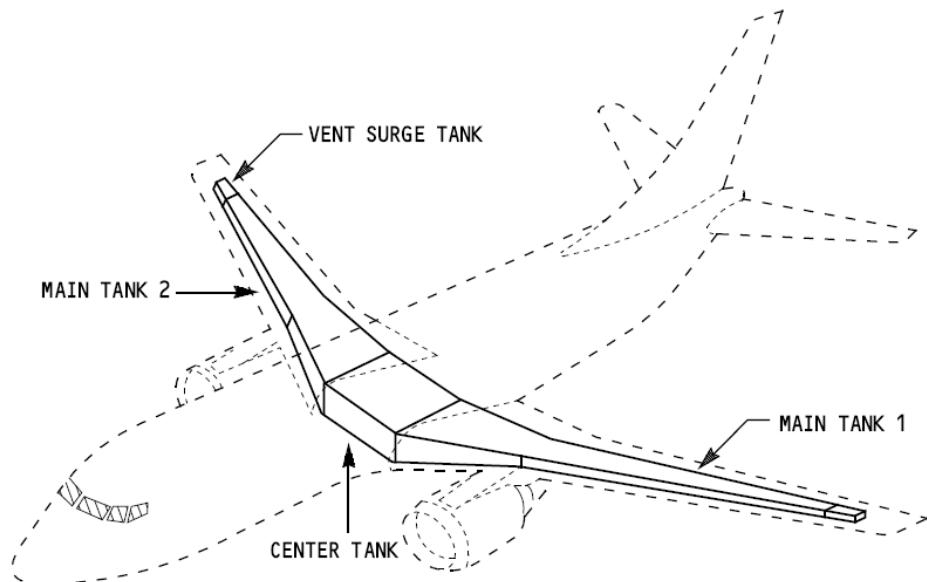
Figure 4: Position of fuel tanks in B737-400 aircraft

The aircraft's fuel system included three integral fuel tanks; the main fuel tanks in each wing and a centre fuel tank in the wing centre section for carrying additional fuel for long range flights (Figure 4). The aircraft had also been originally fitted with an auxiliary fuel tank located in the rear cargo compartment, but that tank had been deactivated.

Check valves regulate the output pressure from the fuel pumps. The centre tank check valves open at a lower pressure than the main tank check valves. Because of this, under normal operations with all pumps on, the engines would receive centre tank fuel first. When only residual fuel remains in the centre tank, the pumps in the main tanks then supply fuel to the engines. Thus, the aircraft would normally be operated and landed with fuel in the main tanks, with little or no fuel remaining in the centre tank.
