**Statens haverikommission**  
Swedish Accident Investigation Board

## ***Report RL 2009:14e***

### **Incident involving aircraft OE-LRW at Åre/Östersund airport, Z län (Jämtland county), Sweden on 9 September 2007**

Case L-27/07

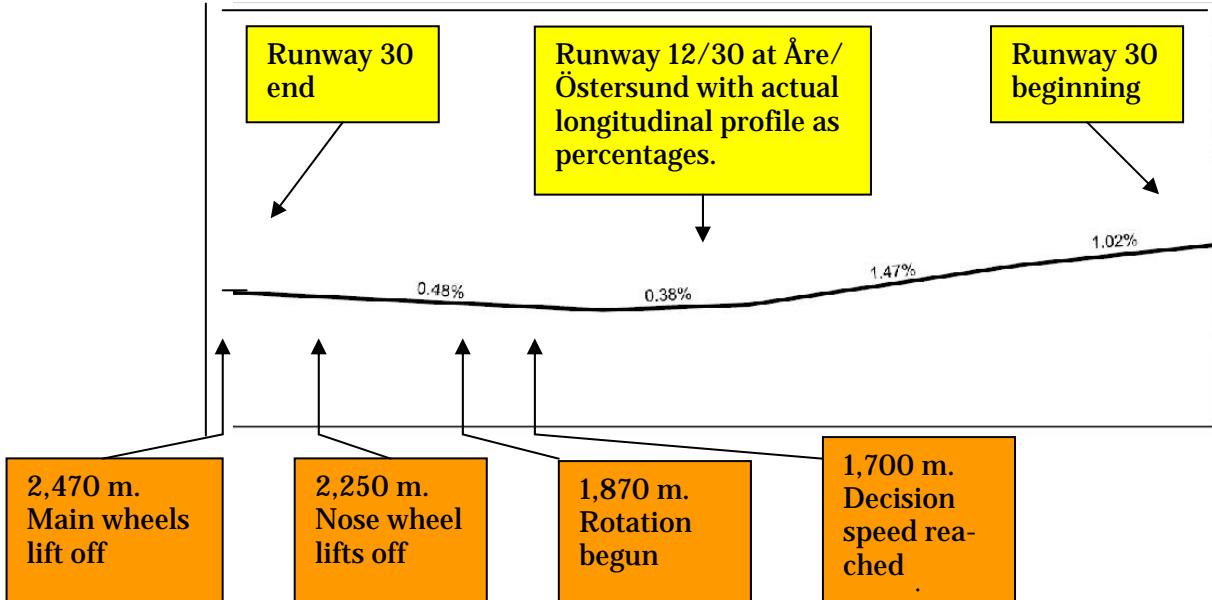
The aircraft rolled for about 47 seconds along the runway before the nose wheel lifted off. This took place at about 164 kt (CA), and after a further 3.5 seconds, approximately, the main wheels left the runway. During the subsequent second the aircraft collided with the two transverse light bars closest to the runway 12 threshold, at a height of about 45 cm above ground.

The rolling distance was calculated from the CA recording, time and most recent known wind information (120/8). Runway 30 has a length of 2 500 m. The calculations show that the aircraft reached decision speed  $V_1$  at about 1 700 m from the start of the runway, rotation began at about 1 870 m, the nose wheel lifted at about 2 250 m and the main wheels left the runway about 30 m from the end of the runway.
