**UK AIRPROX BOARD**

# **Analysis of Airprox in UK Airspace**

**Report Number 21  
July 2008 – December 2008**

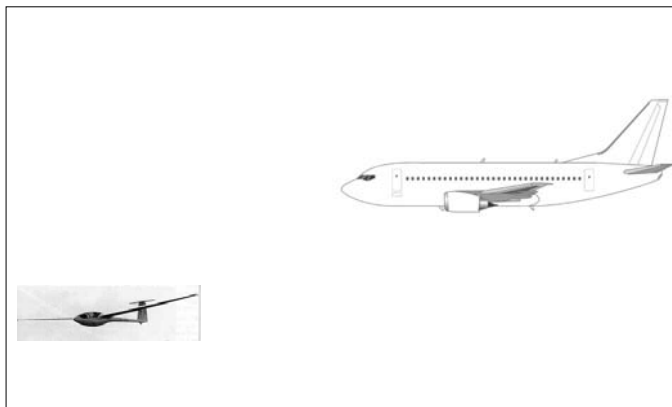
**THE B737 PILOT** reports that they were inbound to East Midlands in contact with APR, squawking as directed with Mode C and on a radar heading of 300° at 180kt to intercept the localiser for RW27 from the S when he saw a low-winged glider in his 12 o'clock, passing N to S between 300ft and 500ft beneath them. He did not take any avoiding action but assessed the risk as being high.

The relatively late visual acquisition of the glider by the B737 crew was thought by airline pilot Members to have most likely been due to their high workload as they were coming onto the final approach and preparing the ac for landing. In addition, it is well known in the aviation community, that modern, low profile, gliders are very difficult to acquire visually, particularly in good gliding conditions when there is a significant amount of white cloud present.

Cause: A conflict with an untraced glider.

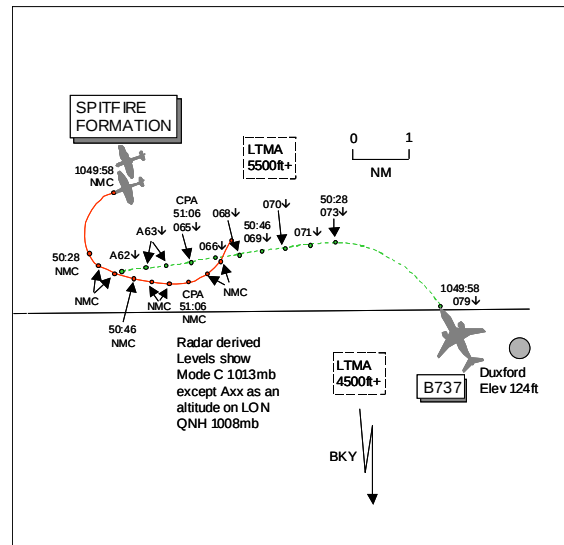
By 1050:46, the radar recording shows the B737 steady on the assigned heading, passing FL69 Mode C and now within area TMA 9. Once level at 6000ft QNH, the B737 would be 500ft above the base of TMA 9 (5500ft) and in accord with the MATS Part 1 guidance at Section 1, Chapter 6, Page 4, Paragraph 9, which states *"Except when aircraft are leaving controlled airspace by descent, controllers should not normally allocate a level to an aircraft which provides less than 500 feet vertical separation above the base of a control area or airway."*

Also at this time the radar recording shows the Spitfire formation in the B737's 12 o'clock position, range 2-3nm, in a L turn. In the absence of Mode C and any other information, Essex had no reason to believe that this unknown ac [actually a pair] was anything other than traffic operating below CAS. Subsequent sweeps of the radar show the unknown radar return appearing to stop its turn on an E'ly track and then pass to the S of the B737. At 1051:05, the B737 pilot calls Essex and he responds by issuing the flight a heading change onto 240°. This was read back but the pilot adds *"...we've just been passed very close by two Spitfires in formation same level"* to which the controller replies *"...they're obviously inside controlled airspace confirm that's level at six thousand feet"*, the pilot answering *"Affirm Sir er they were probably er five hundred metres away if not less"*.

Members noted that the Spitfire Formation Leader was operating on the RPS whilst flying below the LTMA. This was contrary to the procedures set out in the UK AIP [ENR 1-7-1] which states that airspace within and under TMAs do not form part of the Altimeter Setting Region. Moreover, when flying below TMAs and CTAs, pilots should use the QNH of an adjacent aerodrome when flying below the Transition Altitude. This is to ensure that pilots of such flights are able to operate safely, cognisant that their indicated altitudes flown are placing their ac below the promulgated CAS base level. It was also noted that although the Spitfire Leader had reported squawking Modes A and C in line with the guidance in the UK AIP [ENR 1-6-2-1], NMC was evident from the radar recording. Members reiterated the importance of squawking Modes A and C, when fitted, to ensure that ATC conflict alert systems and ACAS 'safety nets' are able to function fully.

Cause: Sighting report.

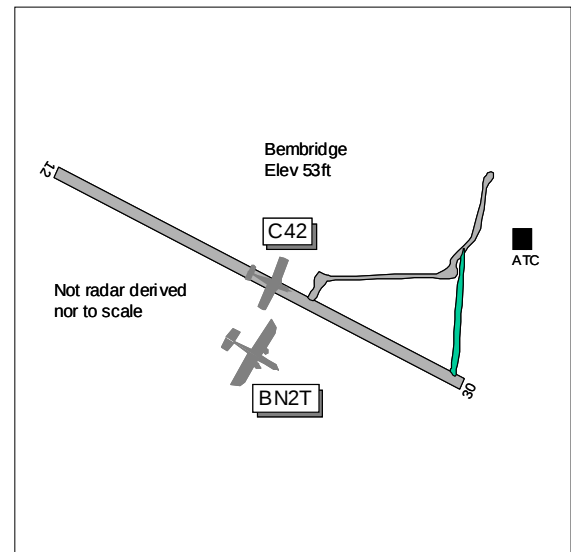
**AIRPROX REPORT NO 096/08**

**THE C42 IKARUS PILOT** reports flying a dual training sortie with a student PPL in the visual cct at Bembridge and in communication with Bembridge Radio on 123.25MHz; no transponder was fitted. The visibility was >20km flying 3000ft below cloud in VMC. The ac was coloured white with blue stripes and the strobe lights were switched on. He was positioned downwind for RW12 when another ac's pilot reported joining crosswind and visual with his ac. As he turned onto base he saw the other ac, a BN2T Islander, tight in behind his ac so he reported his position again stating his intentions to fly a tight cct with a touch and go. He believed that this would increase the separation rather than fly a normal size cct. He landed and proceeded with the touch and go half way down the RW. As he commenced his climb passing 100ft at 65kt he heard the BN2T's pilot declare he was going around, at the same time seeing a large shadow of an ac alongside his ac on the RW. Fearful of a collision he called on the 'Tower' frequency asking on which side of his ac was the BN2T passing. Hearing a reply 'on the right' he then saw the BN2T in a low climb filling his screen on the starboard quarter no more than 50ft away having obviously carried out a very late 'go-around'. He continued his climb holding the RW C/L as he did not know the intentions of the BN2T's pilot after the go-around. The incident was witnessed by a ground observer who described how close the BN2T was on initiating its go-around and, at that point, he realised that it was his duty to report it. He later spoke to the BN2T pilot who was unrepentant of the whole incident. He assessed the risk as high.

Cause: Sighting report.

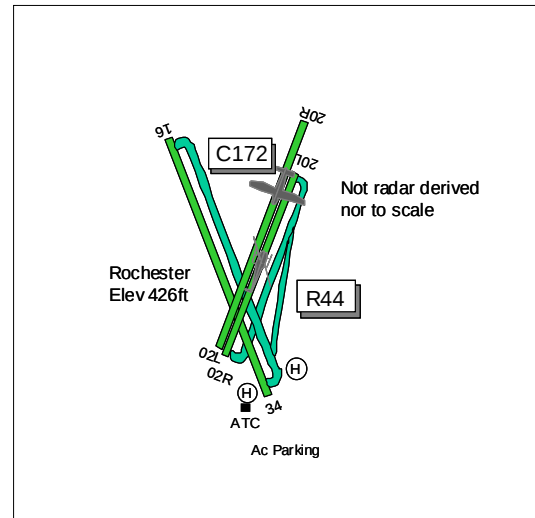
**THE C172 PILOT** reports flying a dual training sortie with a student and in receipt of an AFIS from Rochester Information on 122.25MHz; the transponder was switched off. The visibility was 10km in VMC and the ac was coloured white with strobes and anti-collision lights switched on. He was conducting a cct detail on RW20 and was on final approach having already reported 'final'. On short final he heard a request being made by an R44 student pilot to taxi (not using 'student' c/s but he had heard the pilot when inbound 1hr earlier when he had become temporarily unsure of his position and needed guidance) to which the Tower responded with 'hover taxi to 20'. The R44 pilot did not appear to understand this call and asked for it to be repeated which the Tower did, annunciating more slowly to 'hover taxi to 20'. By now there was another ac on finals behind his C172, a PA28 being flown by a solo student pilot who had also called final. At this point the R44 pilot commenced take-off on RW02 relief RW [RW02R] towards them, accelerating and then climbing to about 20ft passing close to their L. He had had the R44 in sight at all times but was concentrating on its manoeuvres rather than his student's landing for a touch and go. At the closest point they were in the flare and float at 3-4ft above the RW heading 200° at 65kt whilst the R44 passed 20ft above them and 10m clear to their L flying at about 50-60kt. During this phase they did experience some turbulence from the R44 but it was minimal. They continued with their touch and go and understood that the R44 at some point turned W across the path of the PA28 student on final. He called the Tower to state that they were on RW20 but made no further comment as he did not want to distract the R44 student. After completion of the sortie, he discussed the matter with the AFISO who said she would be contacting the R44 student's instructor and that she would be reporting the incident. He assessed the risk as medium.

Cause: The R44 student pilot took off on the wrong runway and flew into conflict with the C172.

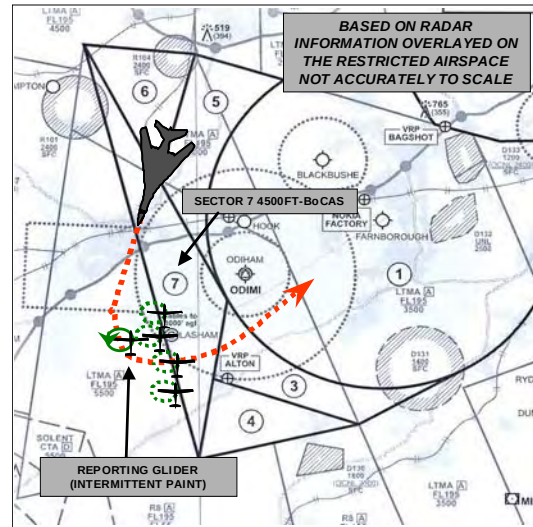
**AIRPROX REPORT NO 102/08**

**THE GROB ASTIR PILOT** reports flying a soaring flight in a white and red glider with no lights or SSR fitted. When passing through heading 270° while circling 1nm NW of Lasham at 50kt, he saw a B-1B 2-3 nm away holding for the Farnborough Air Show. The ac was to the NE of Lasham and when it was about 050° from his position, it banked left towards Lasham and tightened its turn. He descended from his initial height of about 1700ft QFE to about 1400ft QFE during his turn and flew along the centreline of Lasham RW09. During the turn the B-1B passed through the area where he and one other glider were orbiting in a thermal but the closing speed was too high for him to make a turn away. At the time he was turning left from 290° to approx 270° so he pushed the nose down and selected full airbrake to descend. The B-1B passed within 100m of him, both vertically and horizontally, and with its steep angle of bank his view of it was a side profile.

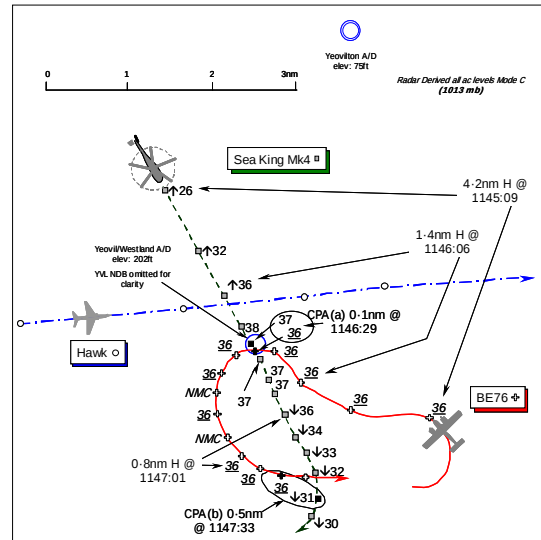
**AIRPROX REPORT NO 103/08**

**THE WESTLAND SEAKING HC MK4 PILOT**, a QHI, reports that he was outbound for an IFR NAVEX, clockwise around Yeovilton, whilst in receipt of a RIS from the Yeovilton APPROACH controller (VLN APR). His helicopter was crewed with two pilots and he was occupying the LH seat as pilot-in-command with his student in the RH seat. The assigned squawk was selected with Mode C.

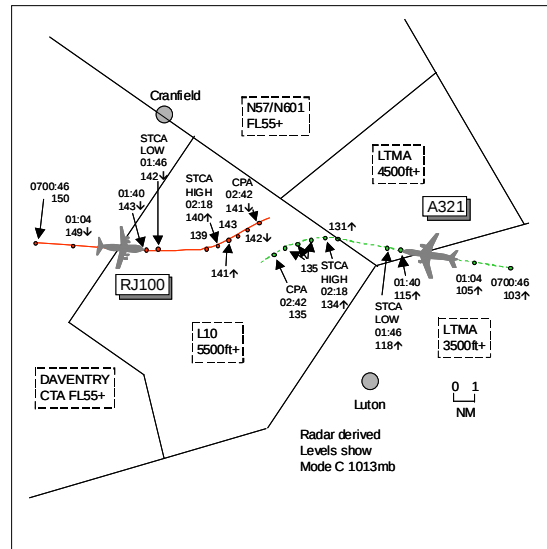
**THE A321 PILOT** reports outbound from Stansted IFR and in receipt of a RCS from London on 119.775MHz squawking 2235 with Mode C. Climbing towards BKY, their initial clearance was to turn L heading 280°. They were cleared to FL160 and on passing FL115 at 250kt they were told to expedite through FL120 and again shortly afterwards through FL130. A TCAS TA was received at about FL125 on traffic about 5nm away followed by an RA 'descend' passing FL135. Avoiding action was taken in accordance with TCAS demands until clear of conflict. Shortly before the RA the controller gave an 'avoiding action' L turn onto heading 220° which was executed. He was not sure of the exact geometry of the Airprox as one pilot was taking avoiding action whilst the other was making RT calls but he believed the other ac passed 500ft above at the CPA with a high risk of collision. He was concerned because when he advised ATC of their TCAS descent the controller had said 'negative climb climb' which, had they complied, could have been catastrophic.

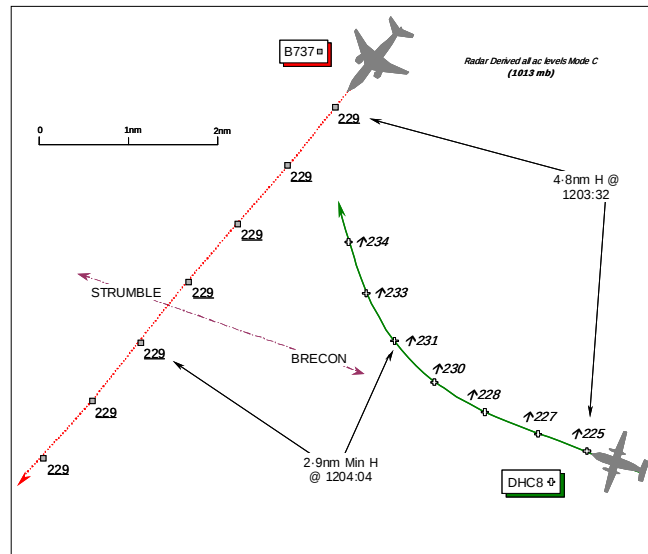
**THE LAC COMBINED SECTOR 8 & 35 TACTICAL CONTROLLER (S8/35 TAC)** reports that the DHC8 was outbound via BCN (BRECON) and STU (STRUMBLE). His PLANNER had co-ordinated a climb with S23 but no level restriction was mentioned so he annotated the paper fps accordingly. After the DHC8 turned westbound at BCN, STCA activated between it and a background track - the B737. Avoiding action was issued to the DHC8 crew to turn R onto a heading of 360°. The DHC8 crew reported having the other ac displayed to them on TCAS but no report of an RA was received. Once clear of the B737, the DHC8 was turned L onto a heading of 300° and the crew instructed to resume their own navigation toward STU.

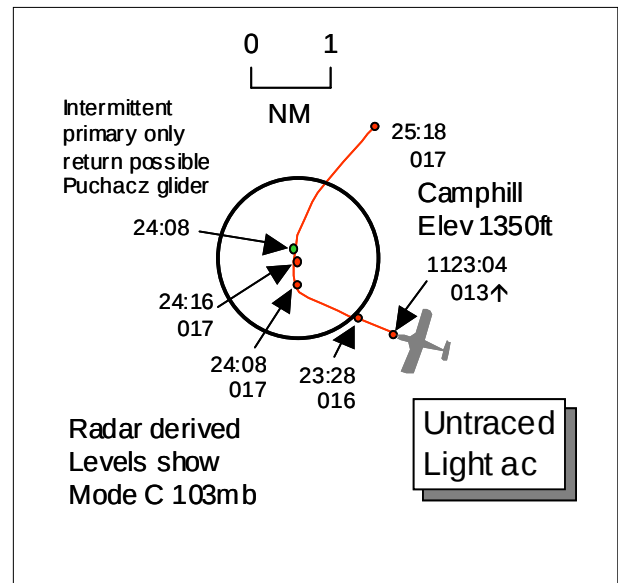
**AIRPROX REPORT NO 106/08**

**THE PUCHACZ GLIDER PILOT** reports flying a dual training sortie from Camphill and was in communication with the gliding club on 129.975MHz. The visibility was >30km flying 1300ft below cloud in VMC and the ac was coloured white. The wind was 280/15-20kt with several gliders soaring on the ridge on the Western boundary of the airfield as well as picking up thermals and drifting downwind; heights varied between 600ft to 1000ft. Launches were via winches placed halfway along the Western boundary. He was instructing and soaring at 700ft QFE over the Southern end of the Western boundary heading 330° and tracking 350° at 45kt. He first saw the other ac, a low wing single engine ac coloured cream/navy as it appeared from under his starboard wing about 200ft below and 100yd to his E. The ac was flying straight and level at about 100kt N'bound, just W of the C/L of the airfield. This course was held for about 3-4km and he then turned his attention back to his student's progress. As the other ac passed over the Northern end of the airfield it was seen to give a brief wiggle to indicate its pilot had seen other traffic and was reacting suddenly. He opined that had he been flying S'bound such that he could see the approaching ac he would have taken precautionary evasive action. He believed that there was a high risk of collision with his glider and with several others. Also, had the ground crew been unaware of its presence and initiated a launch, as they were ready to do at that moment, there was every likelihood of a collision with the launch cable.

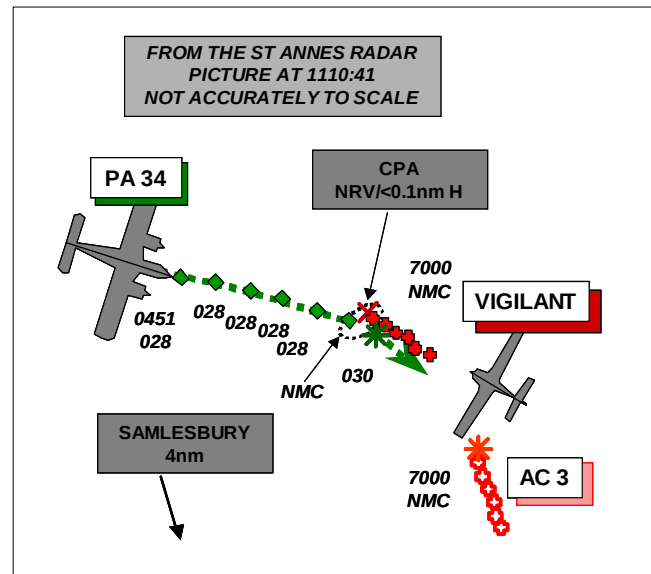
**AIRPROX REPORT NO 107/08**

**THE PA34 SENECA PILOT** reports flying solo with a passenger in a blue and white ac with strobes, nav lights and the anti-coll beacon switched on, on a private IFR flight from Ronaldsway to Gamston. He was in the cruise at 3000ft on RPS 1015mb, heading 107° at 162kt in receipt of a RIS from Blackpool and squawking as directed with Mode C when he was informed of traffic at 4nm in his 12 o'clock with no height displayed. He replied that he was good VMC on top and looking but he could not see the ac. Slightly later Blackpool said the traffic was then at 2nm still in the 12 o'clock with no height and there was a further ac to the south also with no height, probably Samlesbury based gliders. He continued to scan and caught sight of an ac about 500m away straight ahead so he immediately disengaged the autopilot and turned right and climbed. The other ac did not manoeuvre and passed below his port wing. He specifically noted that the other ac had no lights on [see Vigilant pilot's report below]. He reported the incident to Blackpool and after landing telephoned them to inform them that he would be filing an Airprox. He assessed the risk as being very high.

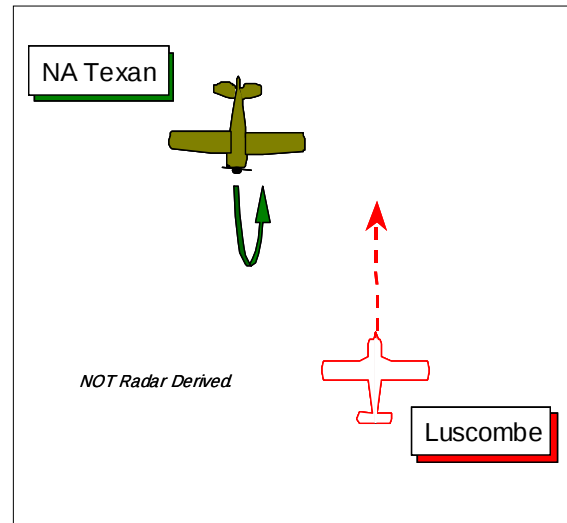
**AIRPROX REPORT NO 108/08**

**THE NORTH AMERICAN AT6D TEXAN PILOT** provided a very full account reporting that his ac has a vintage Dark Green USAAC colour scheme but the anti-collision beacon was on whilst participating in a flying display over Portsmouth Dockyard. Operating VFR in VMC, he was in communication with HMS ILLUSTRIOUS through FLYCO on 122.1MHz and the Flying Display Director (FDD) - the controlling & co-ordinating authority for the display. A squawk of A7000 was selected with Mode C 'on'.

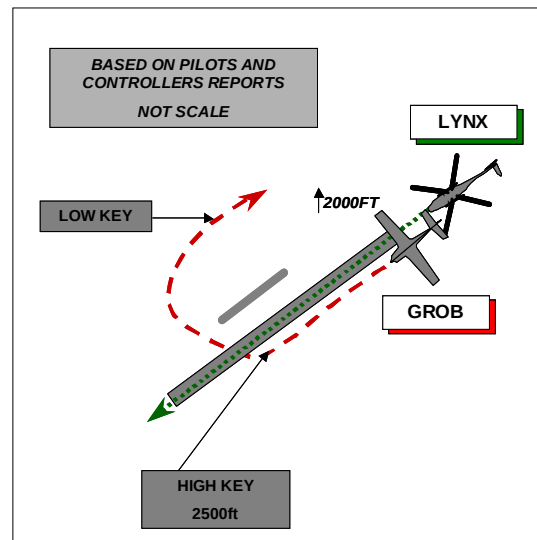
NR

Cause: The Grob Tutor pilot descended into conflict with the Lynx AH7.

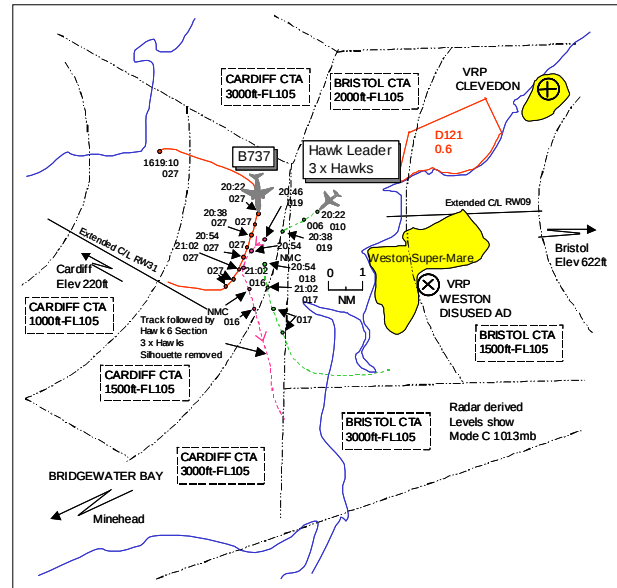
**AIRPROX REPORT NO 112/08**

Date/Time: 9 Aug 1621 (Saturday)  
Position: 5121N 00304W (13nm WSW Bristol Airport - elev 622ft)  
Airspace: FIR/CTA (Class: G/D)  
Reporting Ac Reported Ac  
Type: 9 x Hawks B737-800  
Operator: HQ AIR (Trg) CAT  
Alt/FL: 1000ft↑ 2500ft  
 (QNH 1007mb) (QNH)  
Weather VMC CLBC IMC CLOC  
Visibility: 5000m  
Reported Separation:  
 1000ft V/0.5nm H NR  
Recorded Separation:  
 Leader 900ft V/0.7nm H  
 Hawk 6 1100ft V/0.2nm H

Cause: Having been given an ambiguous position report and in the belief that the formation was in Bristol airspace, the Bristol APR instructed the Hawks to climb to the level occupied by the B737.

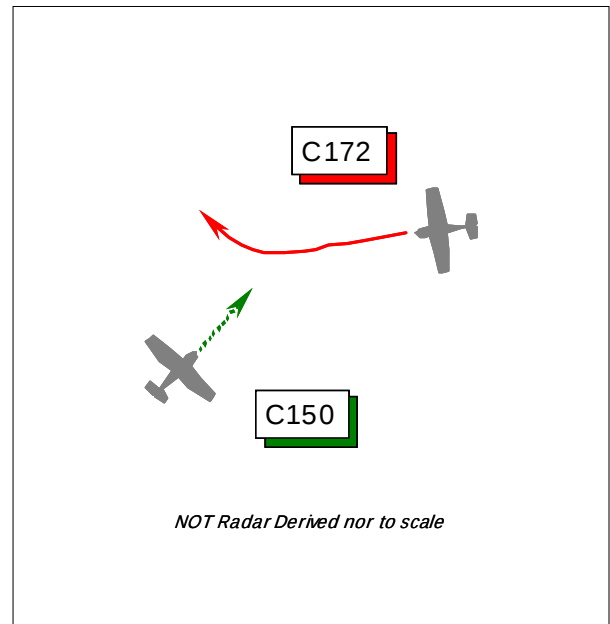
**AIRPROX REPORT NO 113/08**

Date/Time: 30 Jul 0944  
Position: 5242N 00207W (14nm WSW of Tatenhill)  
Airspace: London FIR (Class: G)  
Reporting Ac Reported Ac  
Type: Cessna 150 Cessna 172  
Operator: Civ Pte Civ Com  
Alt/FL: 1800ft 1700ft  
 QNH (1015mb) QNH  
Weather VMC CLBC VMC CLBC  
Visibility: 25km 15-20km  
Reported Separation:  
 300ft V/0.2nm H 800m H  
Recorded Separation:  
 Contacts merged in azimuth  
 (Birmingham ASR)

Cause: A conflict in Class G airspace resolved by the C172 pilot.

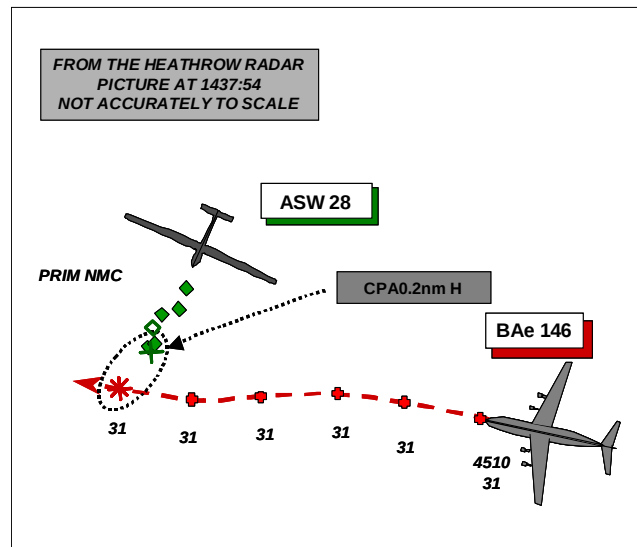
~50ft V (calculated) /0.2nm (370m) H

Cause: Non sighting by the BAe146 crew and a late sighting by the ASW28 pilot.

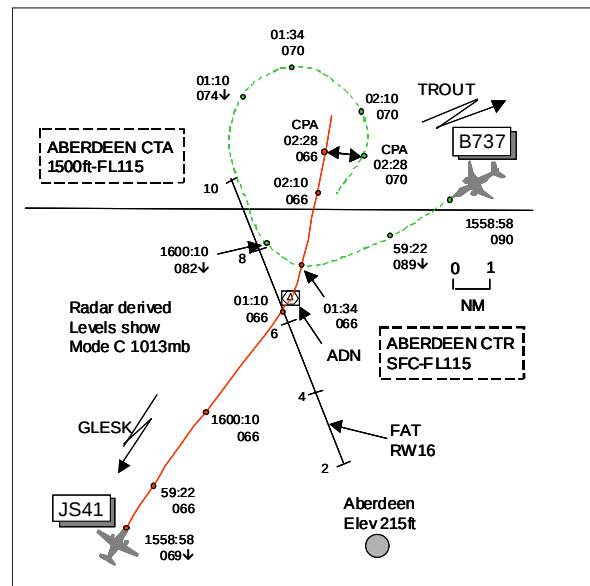
**AIRPROX REPORT NO 115/08**

Recorded Separation:  
400ft V/1.1nm H

Cause: Aberdeen INT DIR descended the B737 into conflict with the JS41 near the ADN hold.

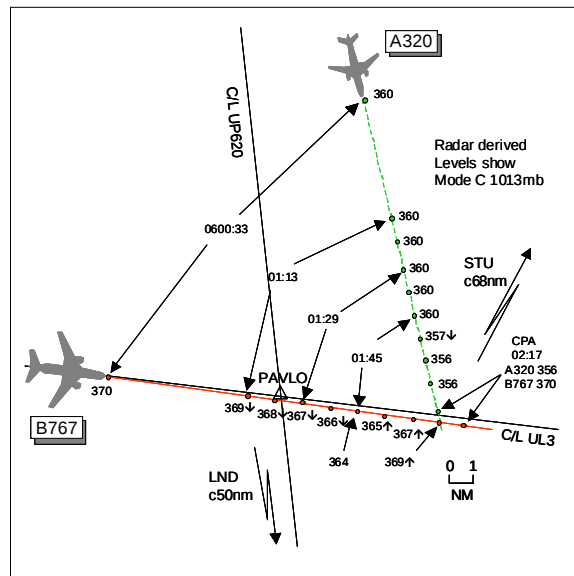
400ft V/4-4nm H

or 1400ft V/1-2nm H

Cause: The LAC S6/9/36 Tactical descended the B767 into conflict with the A320.

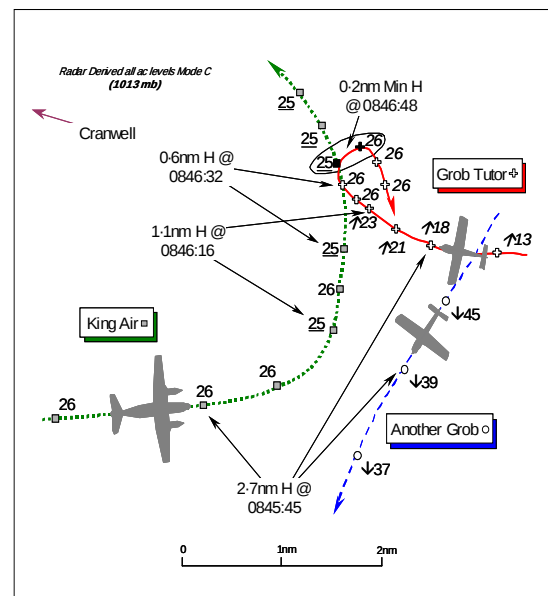
100ft V/0.2nm H

Cause: A conflict resolved by the King Air pilot.

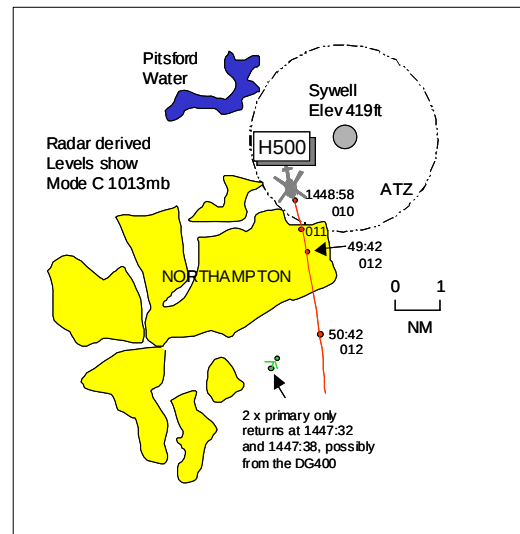
**AIRPROX REPORT NO 119/08**

Date/Time: 15 Aug 1450  
Position: 5215N 00049W (3nm SSW Sywell)  
Airspace: LFIR (Class: G)  
Reporting Ac Reported Ac  
Type: DG400 Glider H500  
Operator: Civ Pte Civ Pte  
Alt/FL: 1500ft 1500ft  
 (QNH) (QNH)  
Weather VMC CLBC VMC NR  
Visibility: 30km NR  
Reported Separation:  
 10ft V/NR H Not seen  
Recorded Separation:  
 NR

Cause: A non-sighting by the H500 pilot and a late sighting by the DG400 pilot.

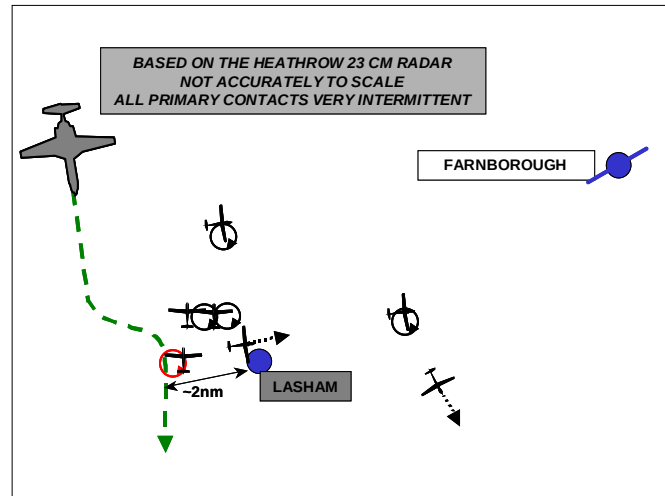
**AIRPROX REPORT NO 120/08**

Date/Time: 20 August 1311  
Position: 5111N 00103W (2nm W Lasham)  
Airspace: London FIR (Class: G)  
Reporting Ac Reported Ac  
Type: Citation CJ525 Untraced  
Operator: Civ Comm NK  
Alt/FL: 5000ft NK  
 (QNH 1012 mb)  
Weather IMC In Cloud NK  
Visibility: N/A NK  
Reported Separation:  
 Not seen NK  
Recorded Separation:  
 NR

Members observed that although the Citation had come very close horizontally to an intermittent, primary-only radar contact, presumed to be a glider, and the initial avoiding action given had been with respect to that contact, the Citation had been IMC in cloud at the time: therefore, it had most likely been separated vertically from the (presumed) glider. Since the Citation pilot observed the TCAS contact at about the same time as the Farnborough Controller had passed him avoiding action, he had most likely associated the two pieces of information as being in respect of the same confliction. However, when all the facts emerged, it was apparent that the two events had been unconnected. The Board thought that the contact that the Citation pilot had observed on his TCAS 1 had most likely been the other ac that was inbound to Farnborough ahead of him which was well separated both vertically and horizontally although, at the time, probably on the same relative bearing as the (presumed) glider. That being the case, the Board agreed that the incident had been a TCAS sighting report with no inherent risk.

The Unit investigation also made a number of recommendations including setting up two working groups: one between LTC and Farnborough and the other between Lasham and Farnborough. Each is tasked to review inter-Unit procedures which, in the case of Lasham and Farnborough, will include improving communications facilities. Another recommends that the airport authority at Farnborough install radar recording equipment in accordance with the ICAO standards and detailed in ATSD ATSN 127: 'Automatic Recording of Surveillance Data by ATS Units'. A final recommendation asks the Farnborough GM to review the requirement to display the Lasham gliding area on the Farnborough radar displays (as that installed at LTC).

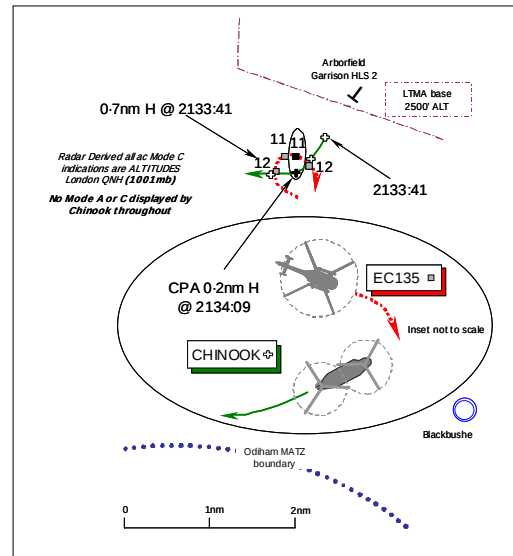
**AIRPROX REPORT NO 124/08**

Date/Time: 2 September 2134 NIGHT  
Position: 5122N 00054W (1nm SW of Arborfield Garrison HLS 2 - elev 160ft)  
Airspace: UKNLFS/FIR (Class: G)  
Reporting Ac Reported Ac  
Type: Chinook Mk2 EC135  
Operator: HQ JHC Civ Comm  
Alt/FL: 700ft 900-1000ft  
 QNH (1001mb) agl  
Weather VMC Haze VMC NR  
Visibility: 10km 10km+  
Reported Separation:  
 100ft V/250m H Nil V/300-500m H  
Recorded Separation:  
 0.2nm H

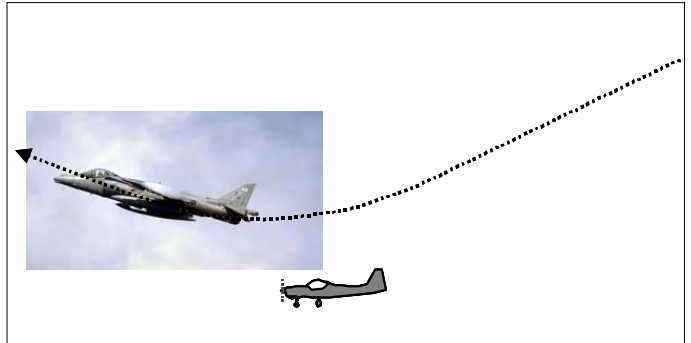
**AIRPROX REPORT NO 125/08**

Date/Time: 3 Sep 1040  
Position: 5256N 00022W  
 (6nm SE Cranwell)  
Airspace: Lincs AIAA (Class: G)  
Reporting Ac Reported Ac  
Type: Firefly T67M Harrier GR9  
Operator: HQ Air (Trg) HQ Air (Ops)  
Alt/FL: 6500ft ~6000ft  
 (RPS 989mb) (NR)  
Weather VMC CLAC VMC NR  
Visibility: UNL NR  
Reported Separation:  
 150ft V/200ft H Not Seen  
Recorded Separation:  
 NR V/<0.1nm H

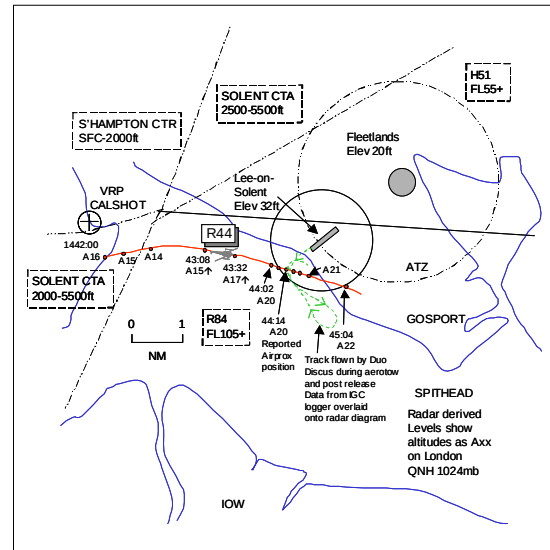
### AIRPROX REPORT NO 127/08

Date/Time: 14 Sep 1444 (Sunday)  
Position: 5048N 00113W (1nm SW Lee-on-Solent - elev 32ft)  
Airspace: FIR (Class: G)  
Reporting Ac Reporting Ac  
Type: Tug+Duo Discus R44  
Operator: Civ Pte Civ Trg  
Alt/FL: 1800ft↑ 2300ft  
(QFE) (RPS)  
Weather VMC CLBC VMC NR  
Visibility: >20km NR  
Reported Separation:  
20-30ft V/50m H 1-200ft V/10-20m H  
Recorded Separation:  
NR

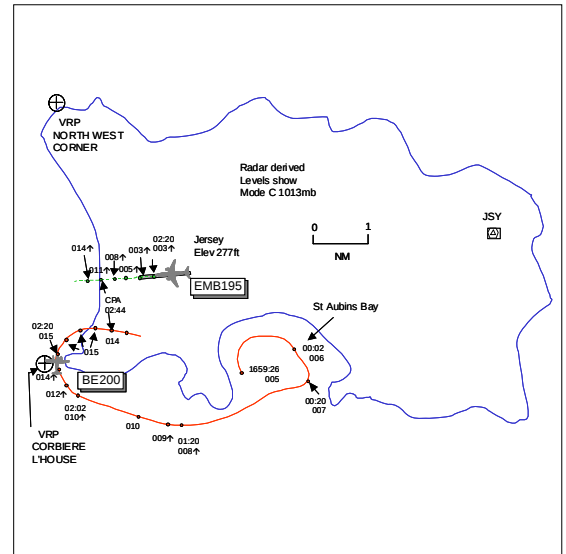
**AIRPROX REPORT NO 128/08**

Date/Time: 10 Sep 1703  
Position: 4912N 00213W (1.25nm WSW Jersey  
 - elev 277ft)  
Airspace: ATZ (Class: D)  
Reporting Ac Reported Ac  
Type: EMB195 BE200  
Operator: CAT HQ Air (Trg)  
Alt/FL: 600ft↑ 1500ft  
 (QNH 1011mb) (QNH)  
Weather VMC CLBC VMC CLBC  
Visibility: 45km >10km  
Reported Separation:  
 200ft V/0.5nm H 1000ft V/1nm H  
Recorded Separation:  
 300ft V/0.9nm H

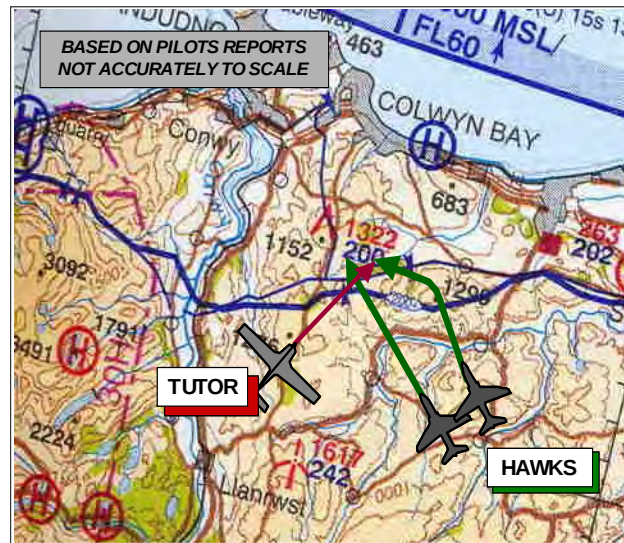
### AIRPROX REPORT NO 129/08

Date/Time: 19 September 1437  
Position: 5314N 00340W (4nm SSE of Conwy)  
Airspace: UKDLFS (Class: G)  
Reporting Ac Reported Ac  
Type: Hawk TMk1 Grob Tutor  
Operator: HQ AIR (Trg) HQ AIR (Trg)  
Alt/FL: 250ft agl 500ft agl  
(RPS 1023) (RPS N/R)  
Weather VMC CLBC VMC CAVOK  
Visibility: >10km 30nm  
Reported Separation:  
V 30ft/H 30-50m V 0/H 50m  
Recorded Separation:  
300ft V/<0.1nm H

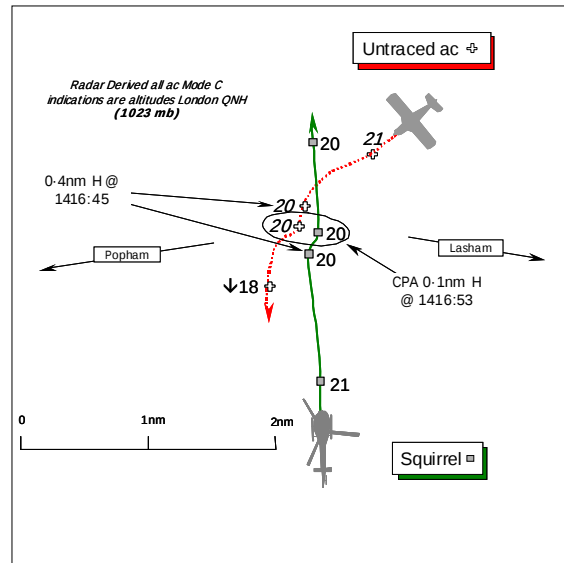
**AIRPROX REPORT NO 131/08**

Date/Time: 18 September 1416  
Position: 5112N 00109W (257° Odiham 8.1nm  
 - elev 405ft)  
Airspace: London FIR (Class: G)  
Reporting Ac Reported Ac  
Type: Squirrel HT2 Untraced  
Operator: HQ AAC N/K  
Alt/FL: 1500ft N/K  
 QFE (1008mb)  
Weather VMC Haze NK  
Visibility: 10km N/K  
Reported Separation:  
 Nil V/250ft H N/K  
Recorded Separation:  
 Nil V/200yd H

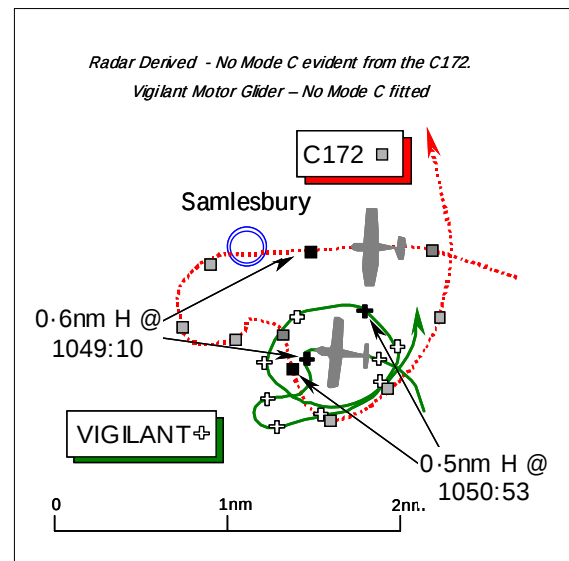
### AIRPROX REPORT NO 133/08

Cause: Whilst manoeuvring in the vicinity of a promulgated gliding site, the C172 pilot flew into conflict with the Vigilant.

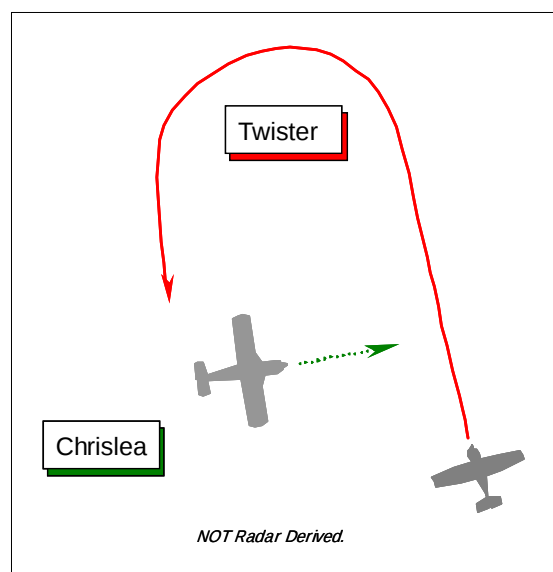
Cause: An effective non-sighting by the Chrislea Super Ace pilot and a late sighting by the Twister pilot.

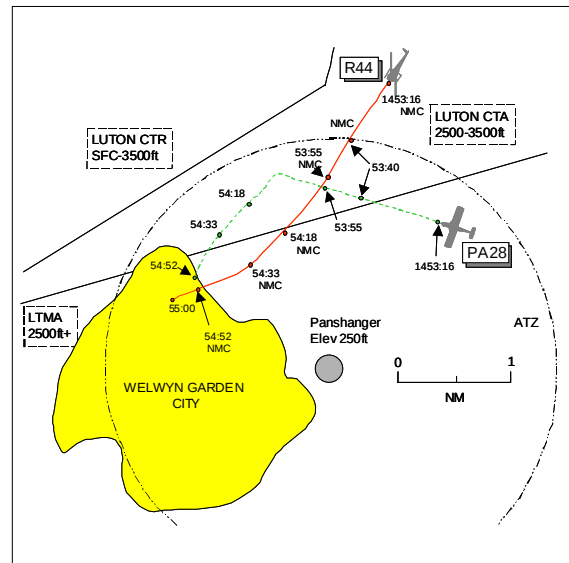
Cause: The R44 pilot entered the Panshanger ATZ without fulfilling the requirements of Rule 45 of the Rules of the Air and flew into conflict with the PA28 which he did not see.

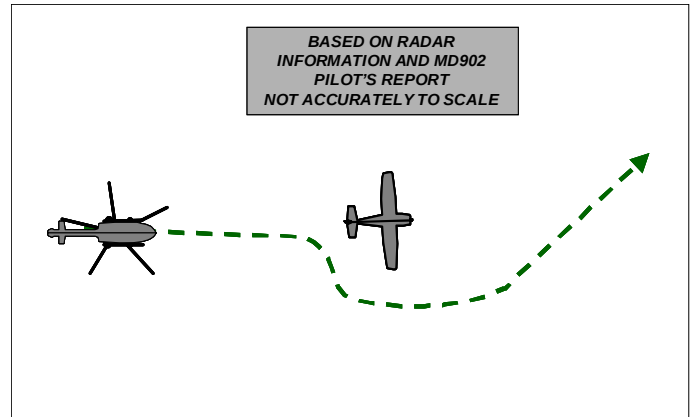
Cause: A conflict in Class G airspace resolved by the MD902 pilot.

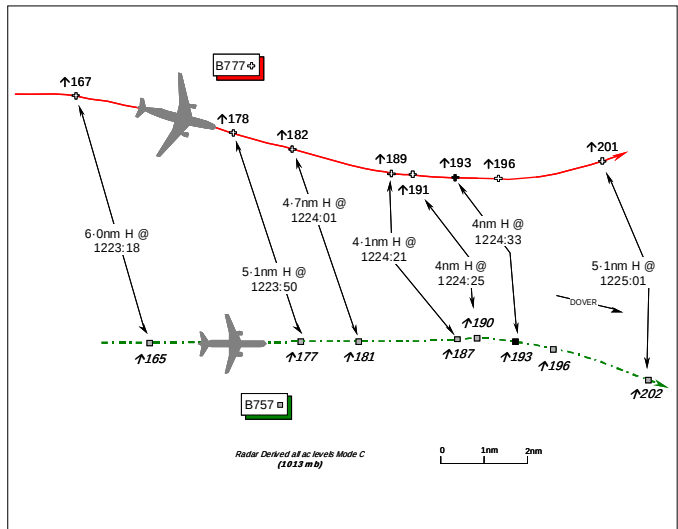
Cause: The B777 crew deviated from their assigned heading and turned into conflict with the B757.

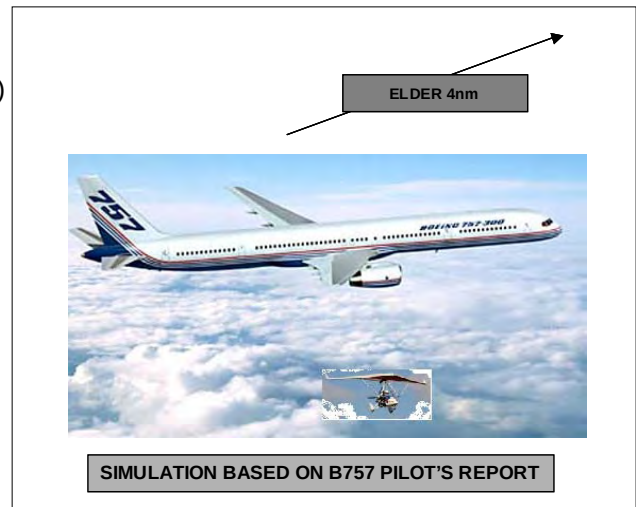
Cause: Conflict in Class C Airspace with an untraced Microlight

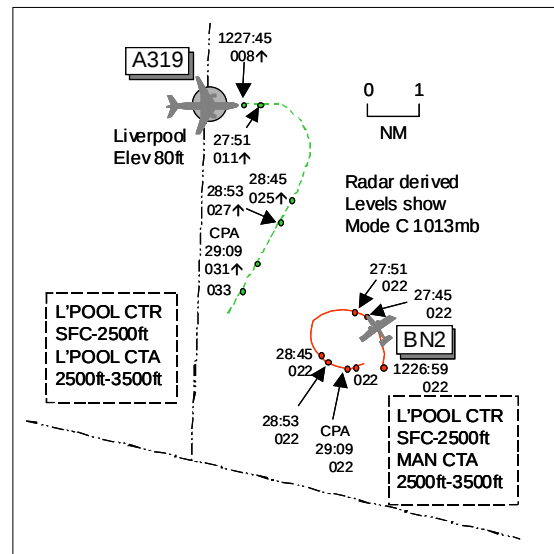
Cause: Without the benefit of TI, the proximity of the BN2 caused concern to the A319 crew.

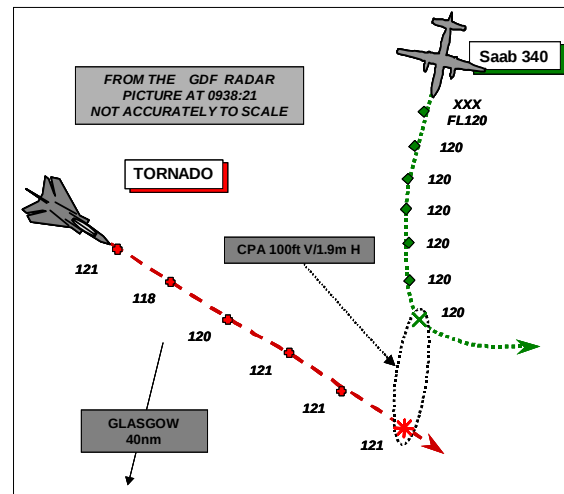
**AIRPROX REPORT NO 143/08**

Cause: A conflict in Class F airspace resolved by the ScACC Westcoast Controller.

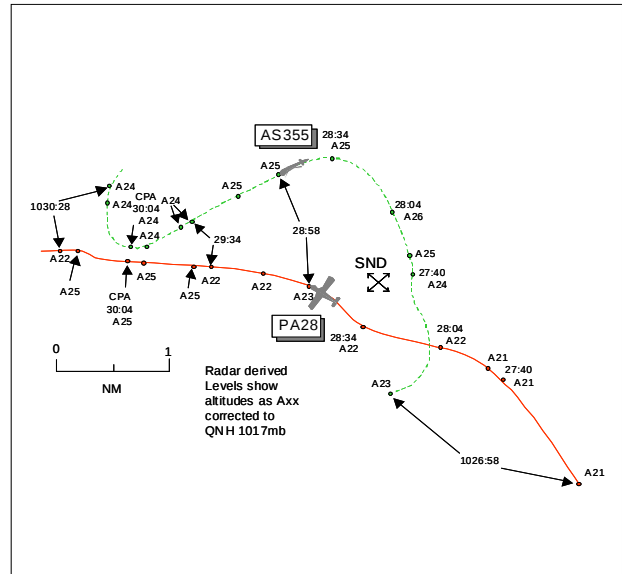
**AIRPROX REPORT NO 144/08**

Cause: The PA28 pilot did not inform Southend ATC of his change in flight conditions or altitude and flew into conflict with the AS355.

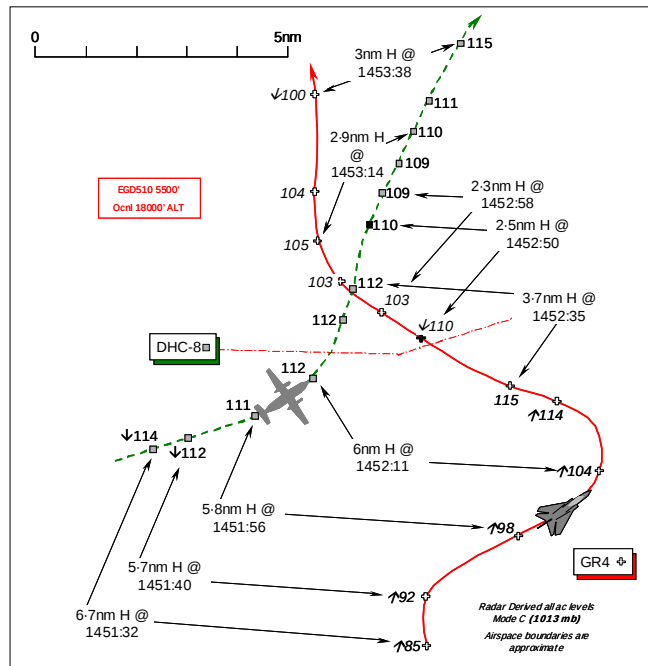
Cause: Sighting report (TCAS).

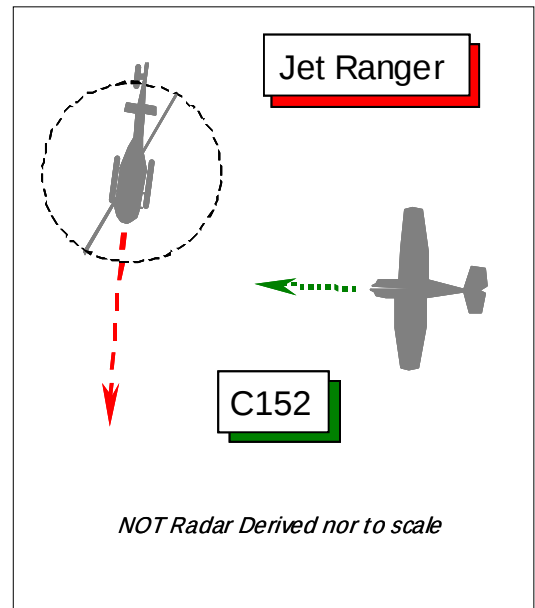
**AIRPROX REPORT NO 146/08**

Cause: The B206 JetRanger pilot flew close enough to the C152 to cause its pilot concern.

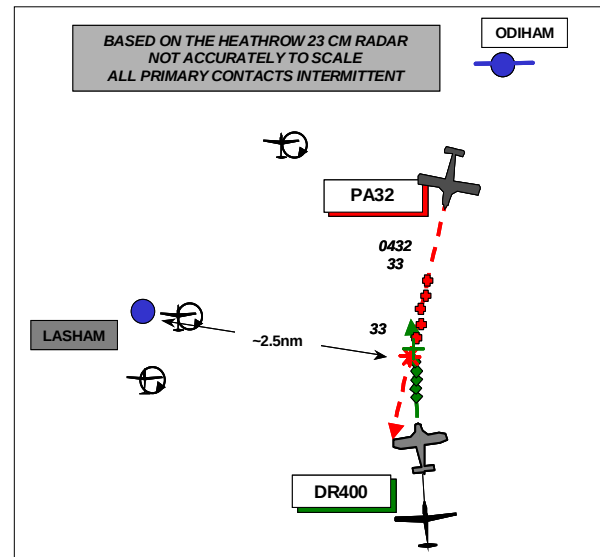
### AIRPROX REPORT NO 147/08

Cause: The PA32 pilot flew close enough to the Robin DR400 to cause its pilot concern.

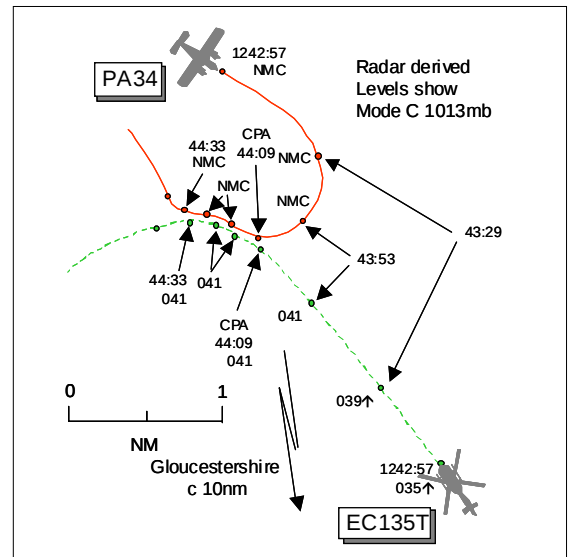
**AIRPROX REPORT NO 155/08**

Cause: A non-sighting by the PA34 pilot and an effective non-sighting by the EC135T pilot.

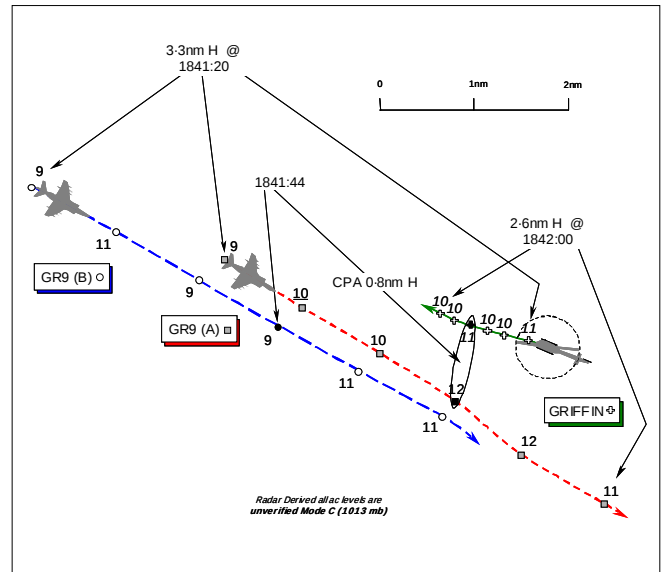
**AIRPROX REPORT NO 156/08**

Cause: The Harrier GR9 formation entered the LFA9 DUA and flew into conflict with the Griffin.

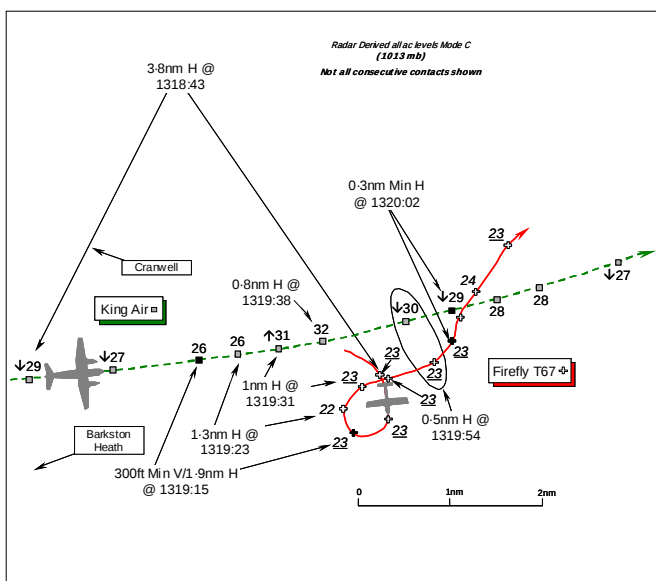
300ft Min V @ 1.9nm H

0.3nm Min H @ 600ft V

Cause: Conflict in the vicinity of the Cranwell radar pattern resolved by the B200 King Air crew following TCAS.

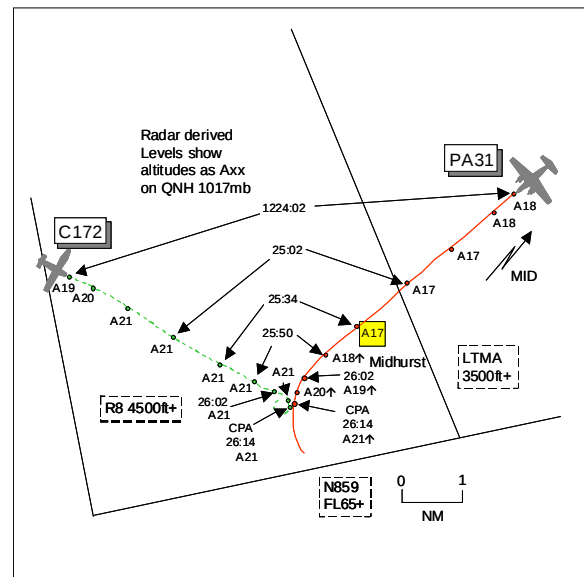
**AIRPROX REPORT NO 159/08**

Cause: A non-sighting by the PA31 pilot and a very late sighting by the C172 pilot.

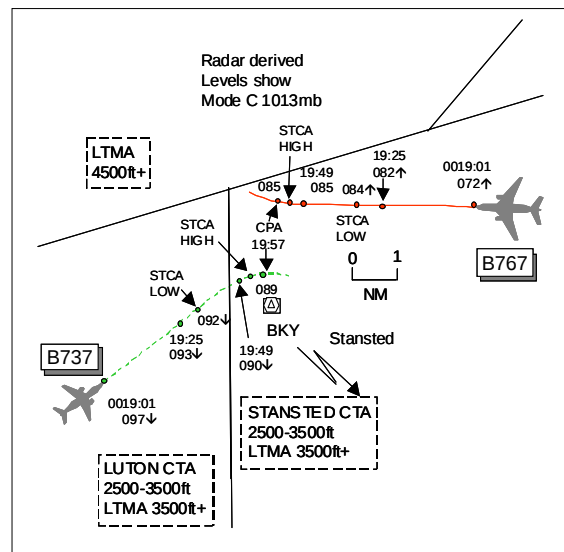
Cause: The B767 crew did not set SAS and climbed above their cleared level.

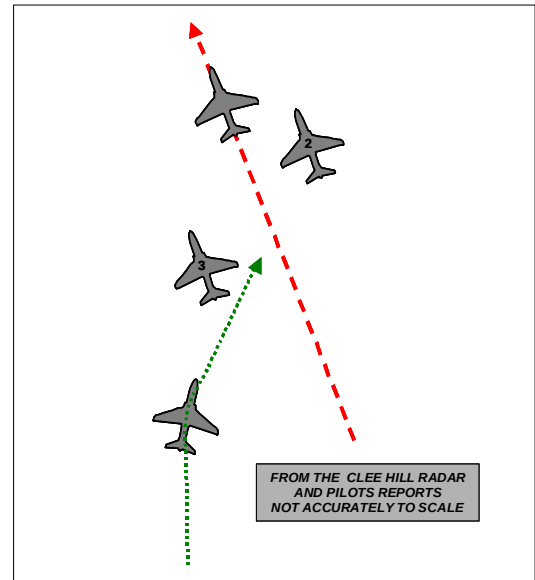
**AIRPROX REPORT NO 161/08**

Cause: An effective non-sighting by the singleton crew and late sightings by the Hawk formation crews.

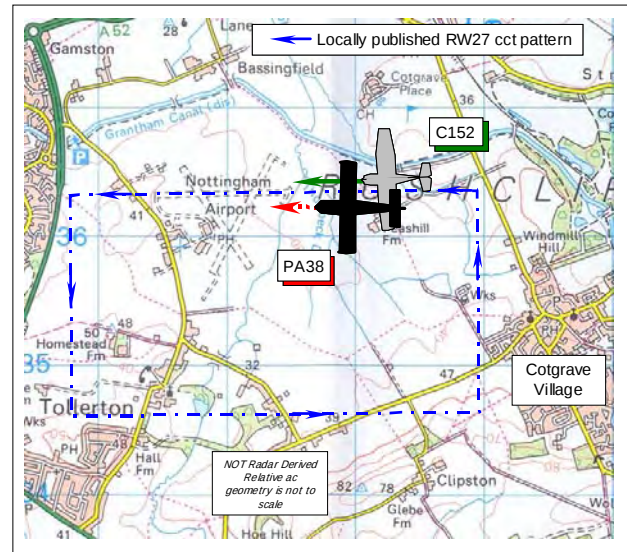
**AIRPROX REPORT NO 162/08**

Cause: The PA38 student pilot flew into conflict with the C152 on final approach which she did not see.
