AIRCRAFT ACCIDENT REPORT 5/2000

Air Accidents Investigation Branch

**Report on the accident to
Boeing 767-322ER, N653UA
at London Heathrow Airport
on 9 January 1998**

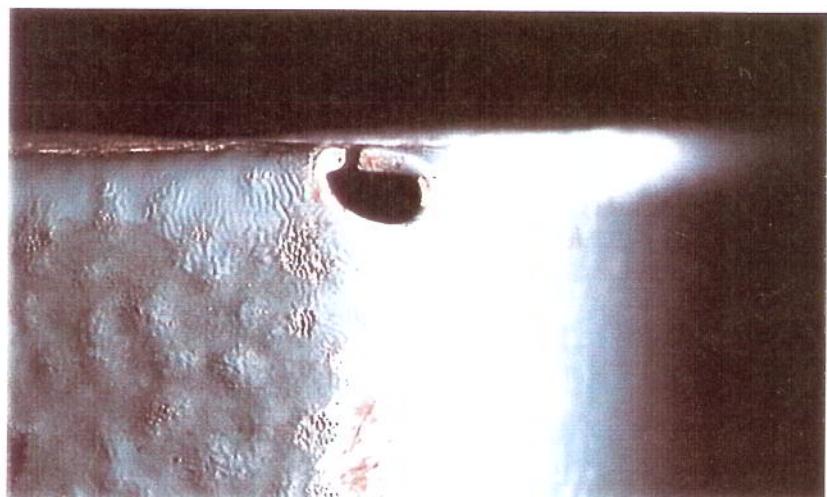
c

For comparison, below, a view of a top corner from the front of the chiller where three folds intersect. No exposed sharp edges were apparent.

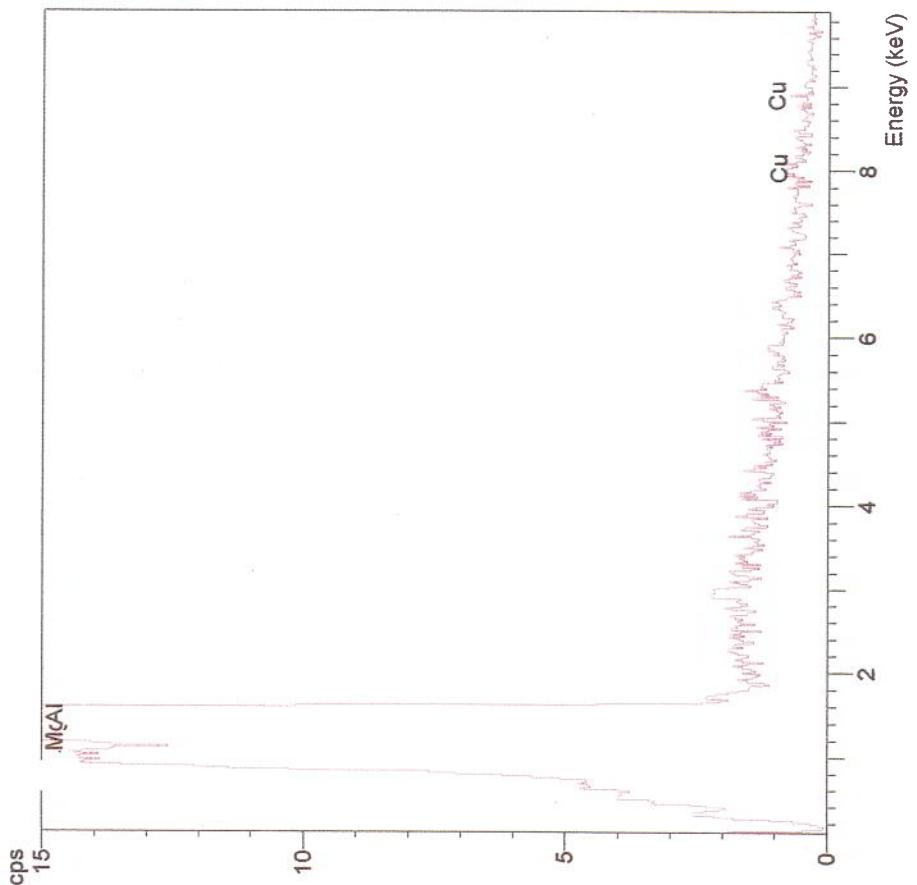
Box covering refrigeration unit
Typical EDX spectrum of aluminium alloy
from which box is made

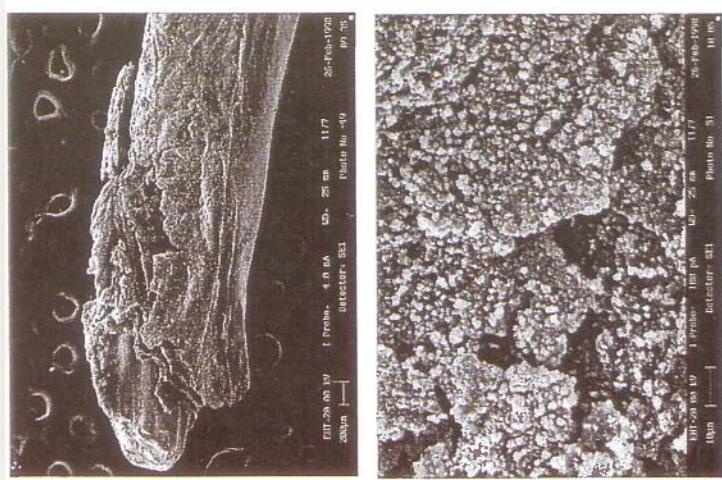
Wires from harness which suffered electrical failure

LHS: micrographs and EDX spectrum of aluminium and copper
'dust' on insulation of wire 11/7
Upper micrograph - location; Lower micrograph - detail

RHS: Element maps of aluminium nodules on wire 11/8

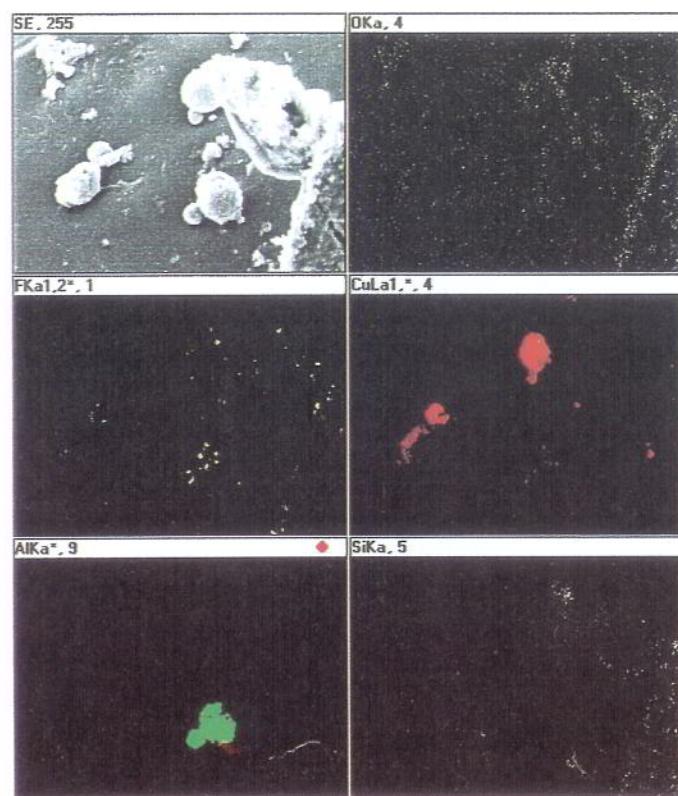
Element maps of aluminium and copper spheres on wire 11/9

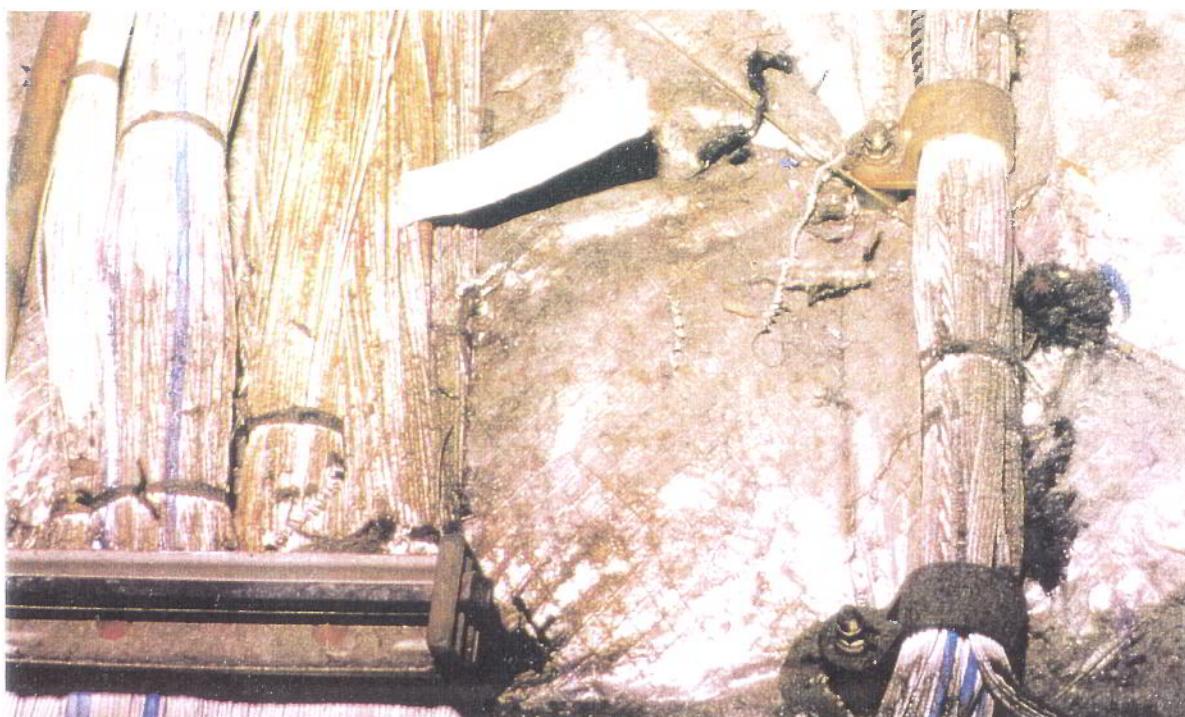
TYPICAL EXAMPLES OF CONDUCTIVE DEBRIS

Contamination of wiring looms by drilling swarf, found in a retired B747, above, and an A300, below.
