Air Accidents Investigation Branch

**Report on the accident to
Airbus A340-311, G-VSKY
at London Heathrow Airport
on 5 November 1997**

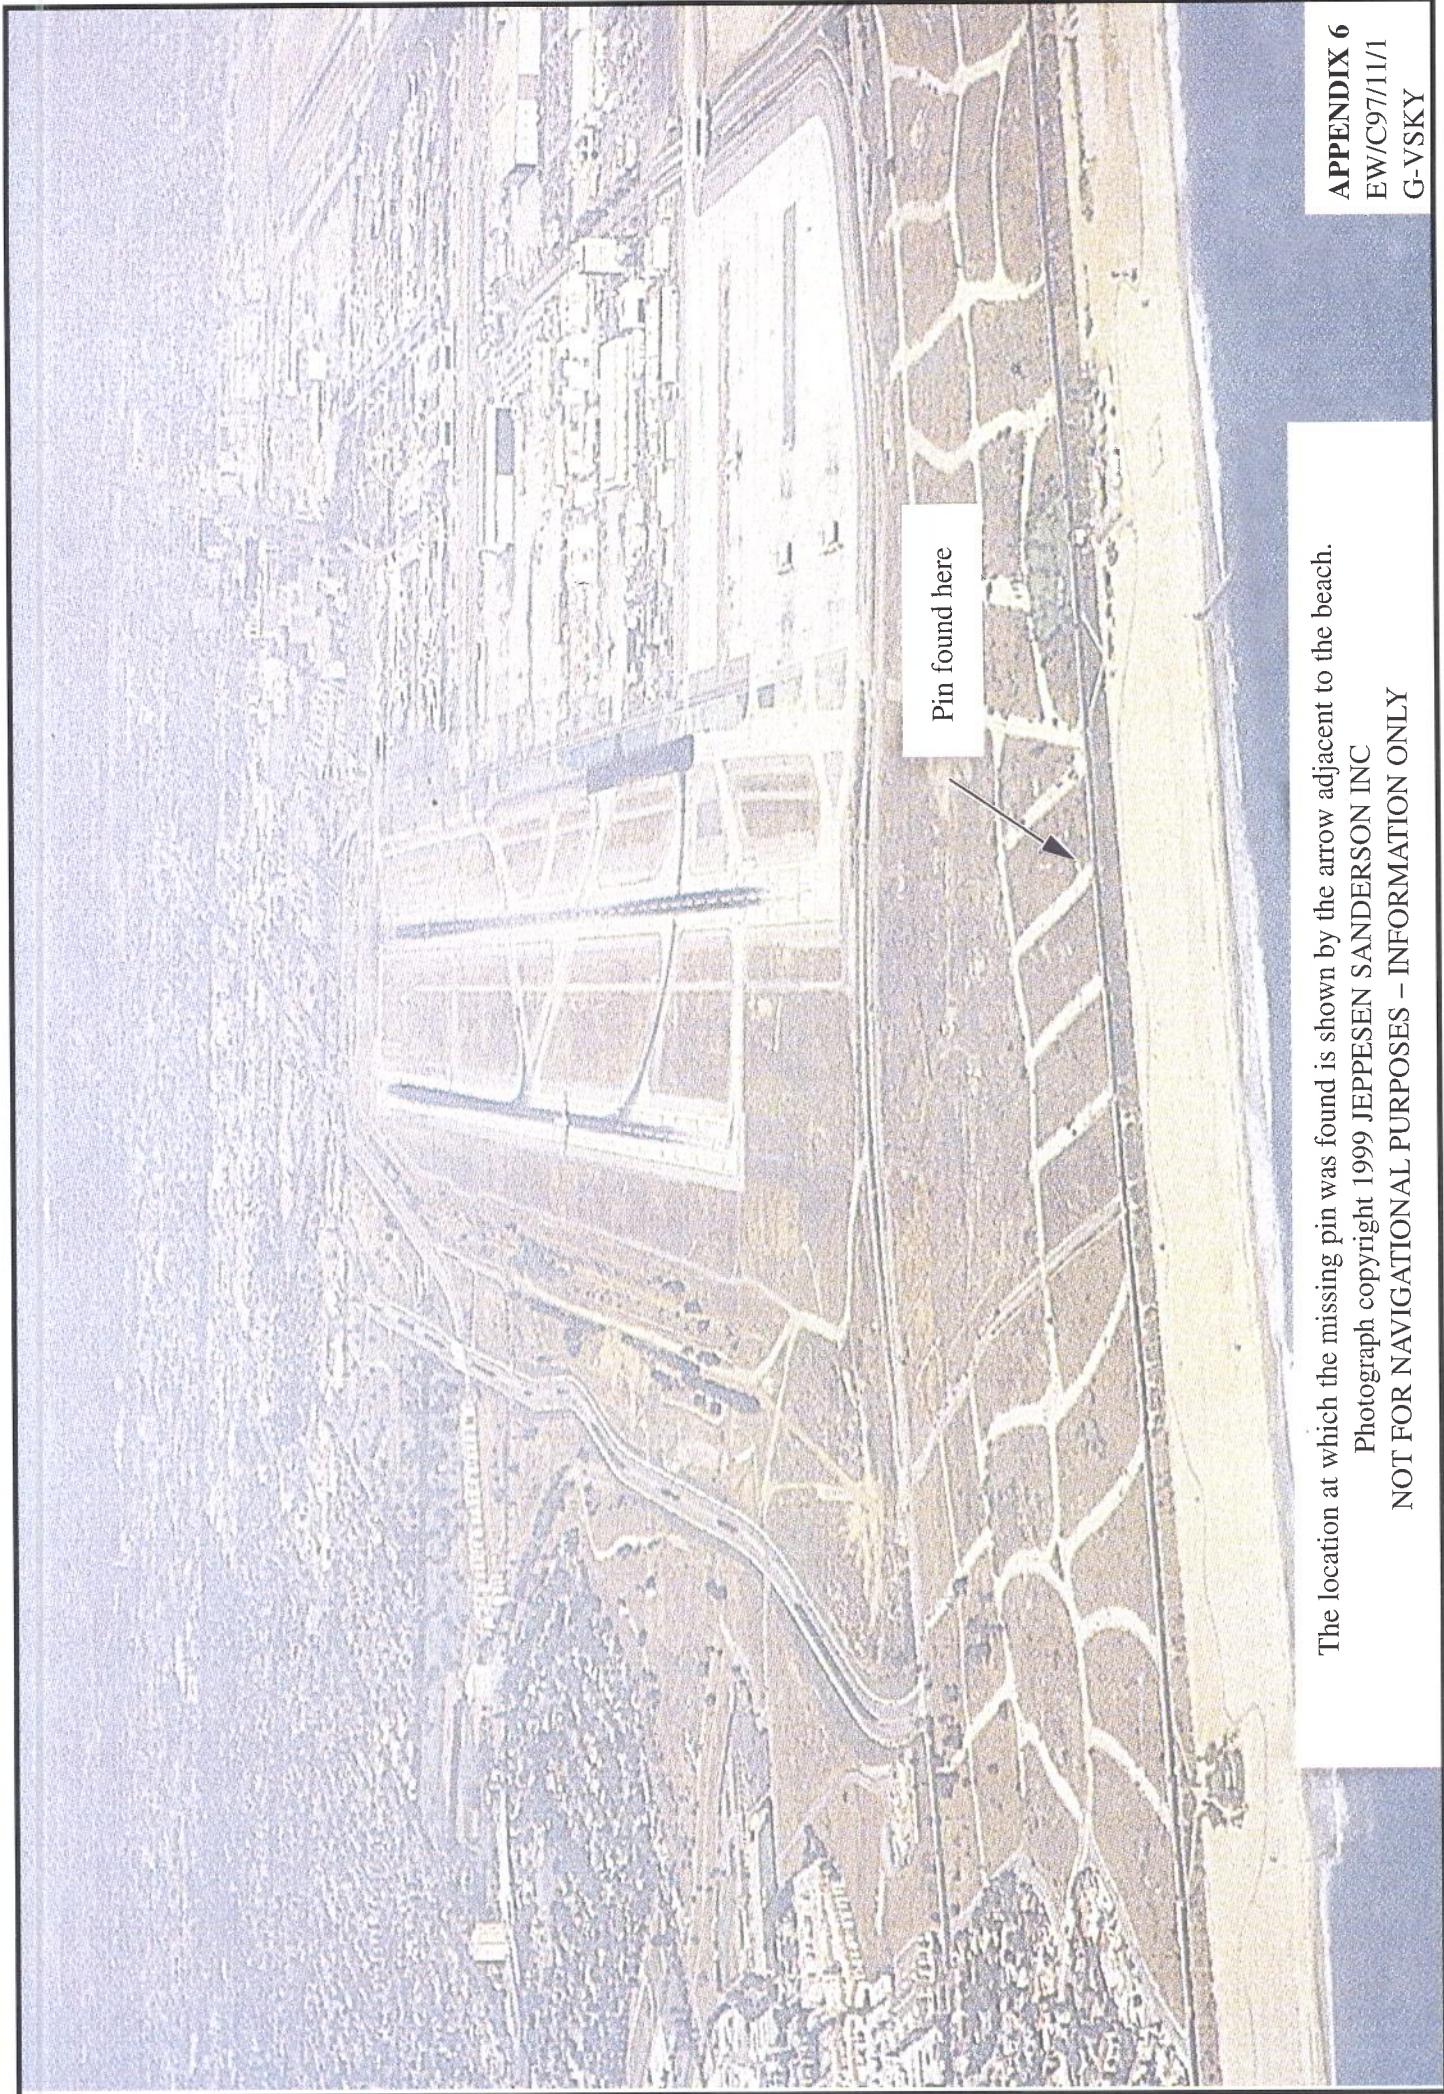
Pin found here

The location at which the missing pin was found is shown by the arrow adjacent to the beach.

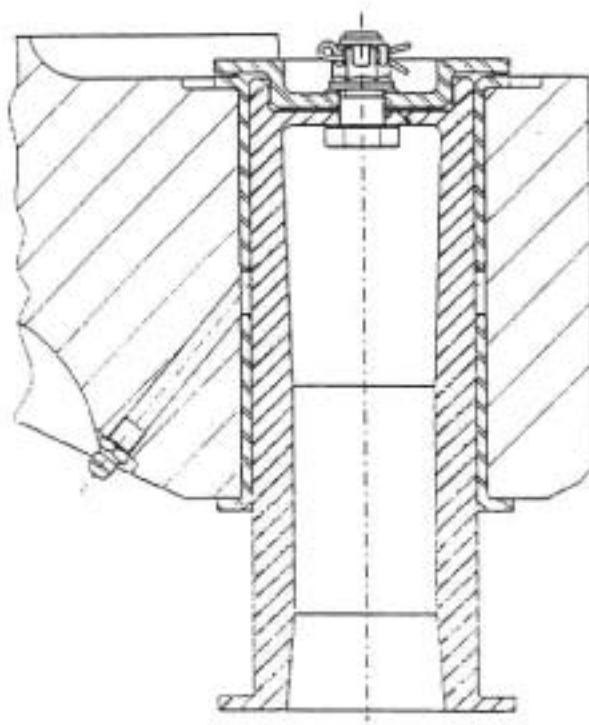
EIS (ENTRY INTO SERVICE) AND IGW
(INCREASED GROSS WEIGHT) TORQUE PINS

PISTON HOUSING AND TORQUE PIN ASSEMBLY FITTED TO G-VSKY

IGW pin assembly drawn. EIS standard as fitted to G-VSKY was similar except for a reduced wall thickness within the pin, and the use of smaller 1/4 inch diameter fasteners.

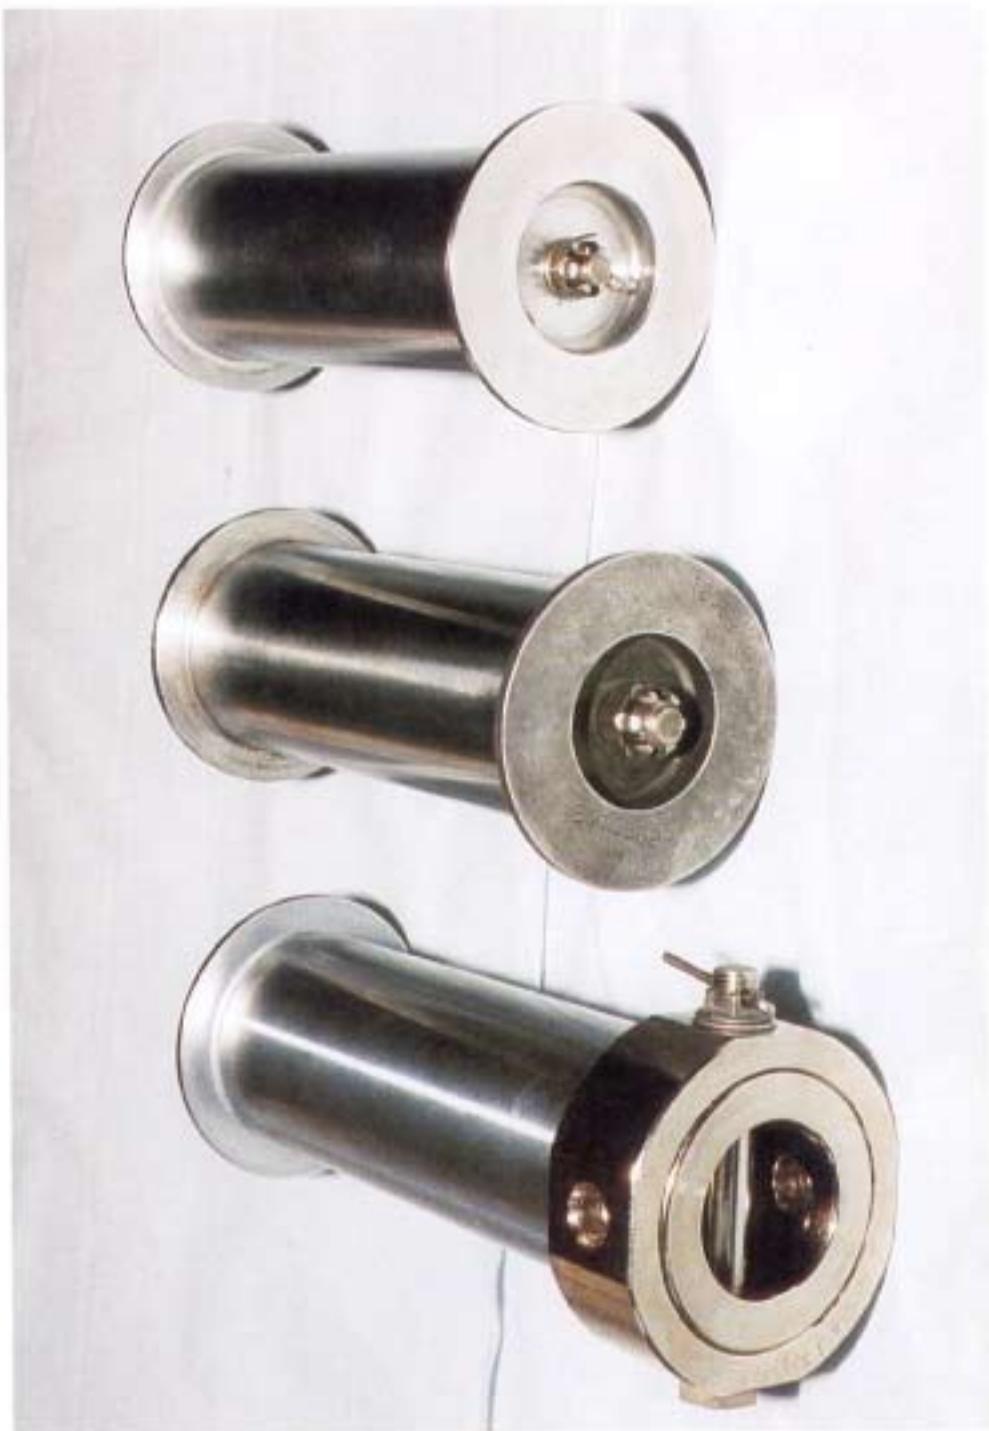
TORQUE PIN ASSEMBLIES
Left The redesigned pin, collar and retaining parts
Centre The increased Gross Weight Standard
Right The Entry Into Service Standard

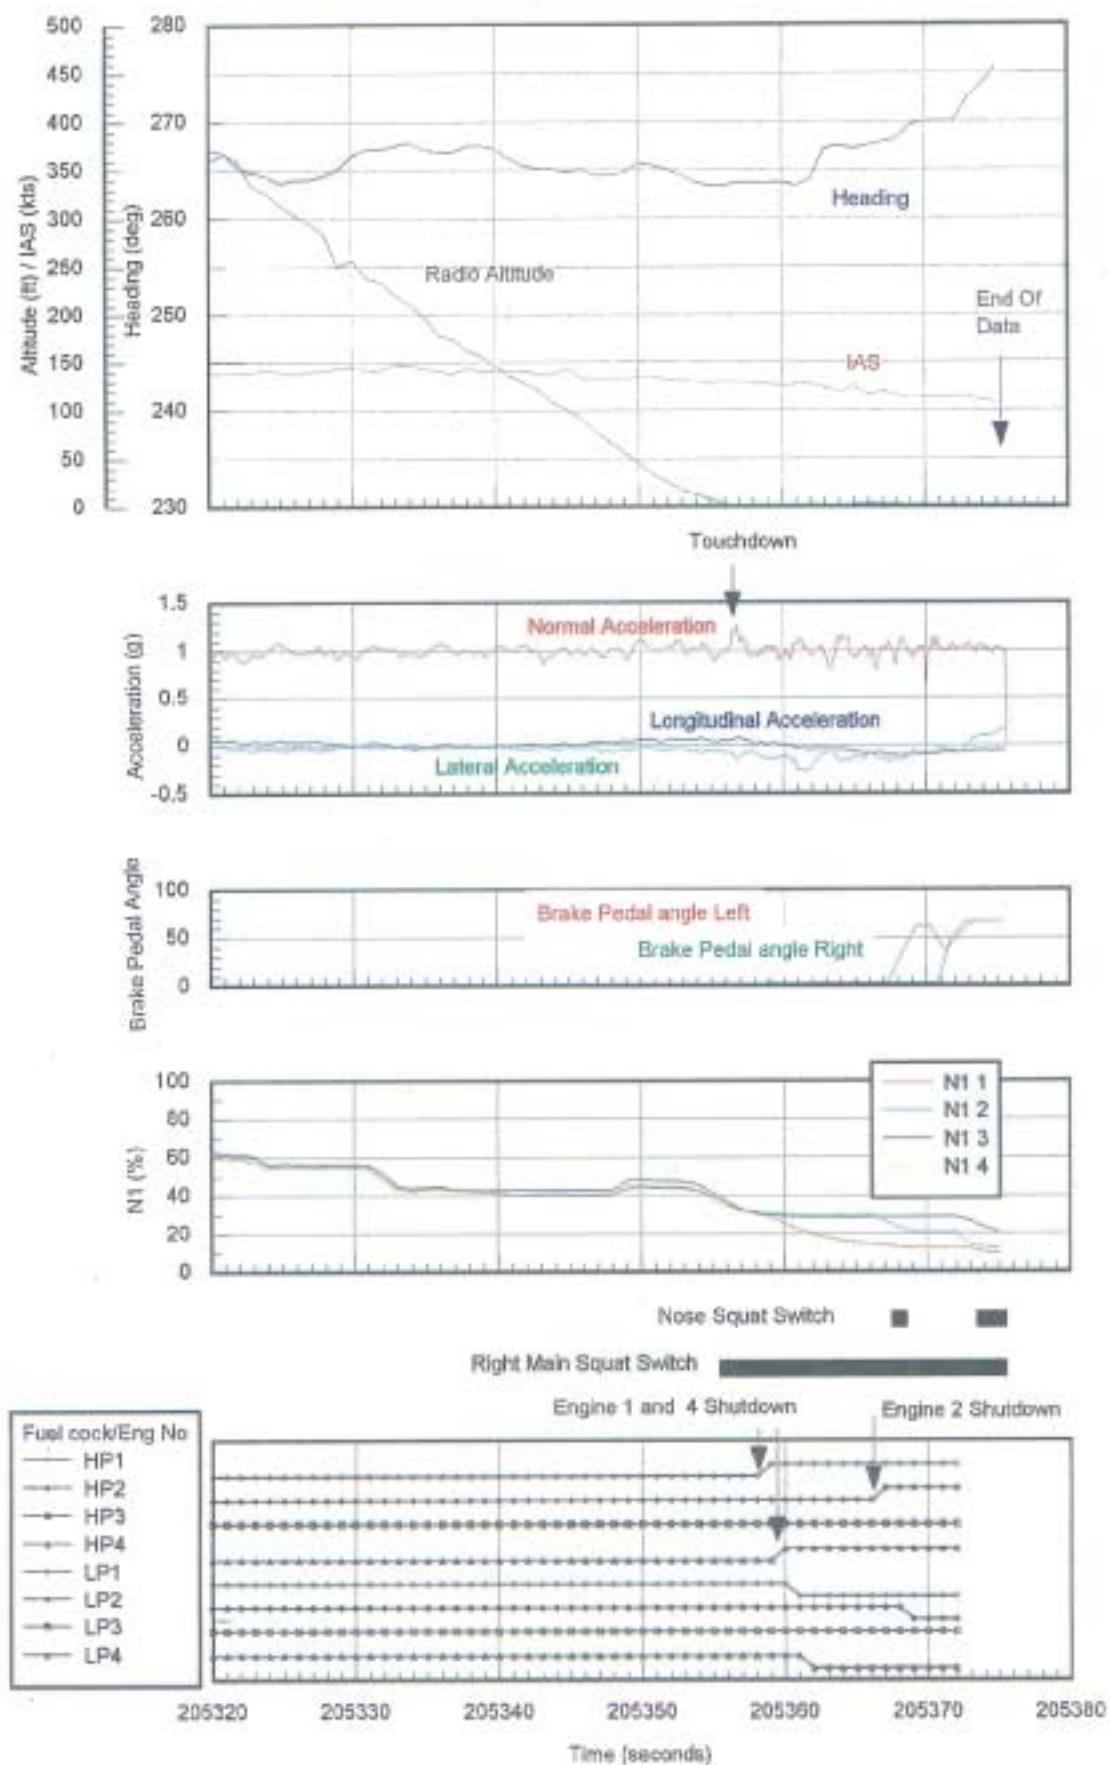
APPENDIX 15
FIGURE 3
EW/C97/11/1
G-VSKY

Figures 3 and 4 at Appendix 15 show the final approach and touchdown, which was at an IAS of 129 kt and with a normal acceleration of 1.262g. The pitch attitude at touchdown was 7.4° and the roll attitude was 4.9°. The pitch attitude gradually decreased until the nosewheel made contact with the runway 17 seconds later. The aircraft was initially on a heading of 264°M and maintained this heading until 6 seconds after touchdown, when the aircraft began to turn gradually to the right. The aircraft remained slightly rolled to the right; however 9 seconds after touchdown the roll attitude increased to 9.8° to the right at a roll rate of 3° per second. At this point the pitch attitude was around 0° and the No 4 engine pod contacted the runway at an IAS of 124 kt.
