CONTENTS

SPECIAL BULLETINS

ACCIDENT

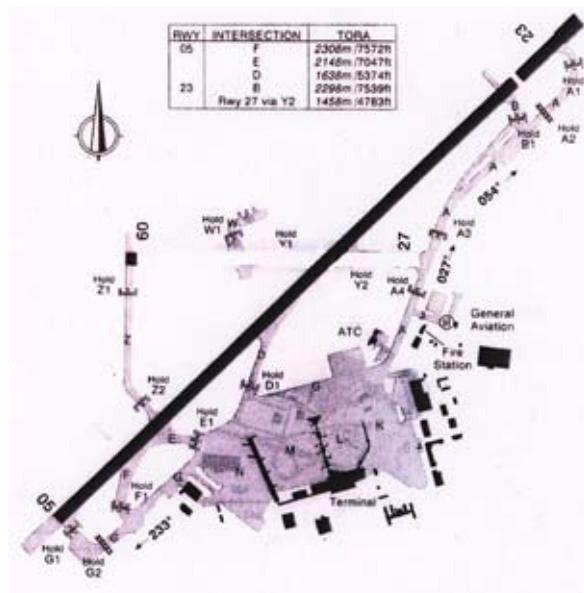
With Visual mode selected for Runway 05/23, only the runway surface area is monitored as shown in Figure 2. When LVP mode for Runway 05/23 is selected the additional areas of the holding points to the runway edge as well as the runway(s) surface is monitored as shown in Figure 3. When both Runways 05/23 and 09/27 are in use, the Cross Runway operations mode should be selected. With Runway 05/23 and Cross Runway mode selected, an additional defined area covers the 09/27 runway surface between the Y1 and Y2 holding points as well as the Runway 05/23 surface area. This area is shown in Figure 4.

The visual controller and ATCO colleagues were not aware that when only Runway 05/23 or 09/27 was in use with Visual mode selected, the areas between the holding points and the runway edge were not defined

Visual mode

areas. The actual defined area in the Visual mode is shown at Figure 2 but their perception of the defined area is illustrated at Figure 3.

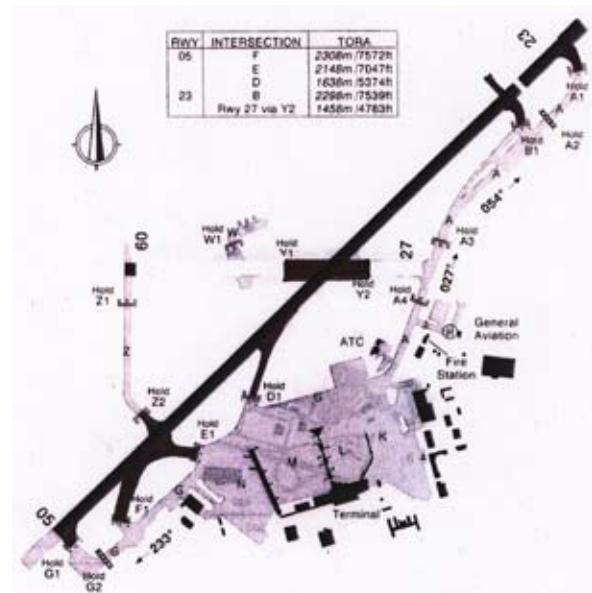
Figure 3

covered by the Cross Runway operations mode, which would have created an alert when the DHC-6 crossed Y1 is shown at Figure 3.

LVP mode

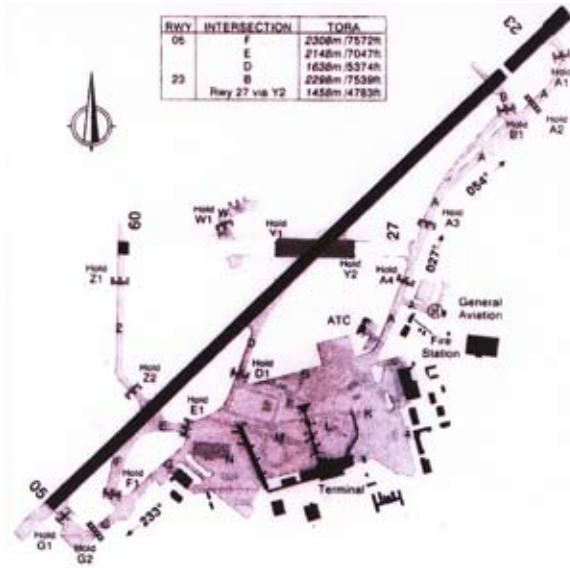
Figure 4

Cross Runway operations

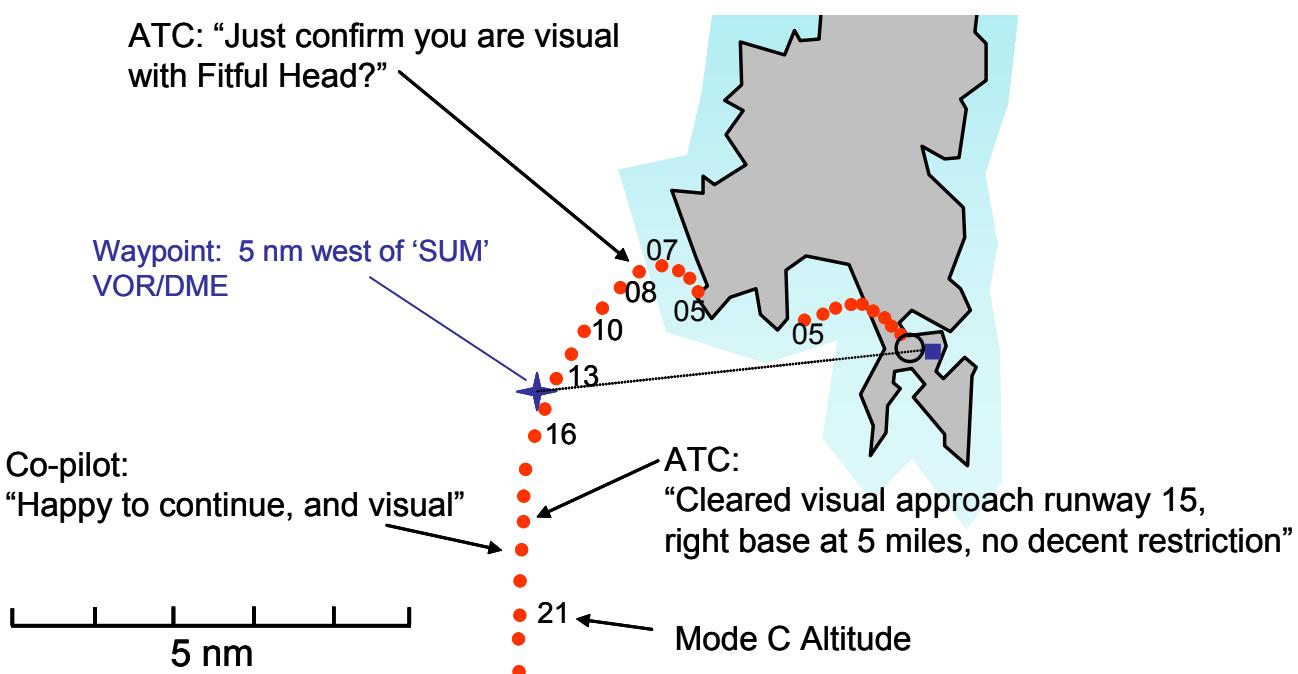
Figure 2 shows the aircraft's radar track and significant R/T exchanges. When the co-pilot contacted the Sumburgh Approach controller he was told that the aircraft would be radar vectored for the Localiser/DME procedure for Runway 09. The co-pilot acknowledged this, but requested a visual approach to Runway 15, if it was possible. The commander then transmitted "...WE'VE SET UP OUR NAV BOX TO PUT US ON A

DESCENT RESTRICTION". As the controller began this transmission the SSR Mode C altitude indicated that the aircraft began descending below 2,100 ft, with an initial descent rate of between 1,500 ft/min and 2,000 ft/min.

As it approached the FMS waypoint, the aircraft commenced a gentle turn to the right. It passed about 0.2 nm to the east of the waypoint, whilst descending at about 1,500 ft/min through a Mode C altitude of 1,300 ft. The aircraft continued in a very gentle right turn towards the high ground of Fitful Head. The average descent rate reduced as the aircraft descended below 1,000 ft, to about 1,000 ft/min. When the aircraft was about 0.6 nm from the coastline as shown on the radar display, and at a Mode C altitude of 700 ft, the Approach controller asked "... JUST CONFIRM YOU ARE VISUAL WITH FITFUL HEAD?" The co-pilot replied with the single word "AFFIRM" and the subsequent radar returns showed the aircraft's turn rate to the right increased significantly until the aircraft had turned to track approximately

Radar plot and significant R/T exchanges

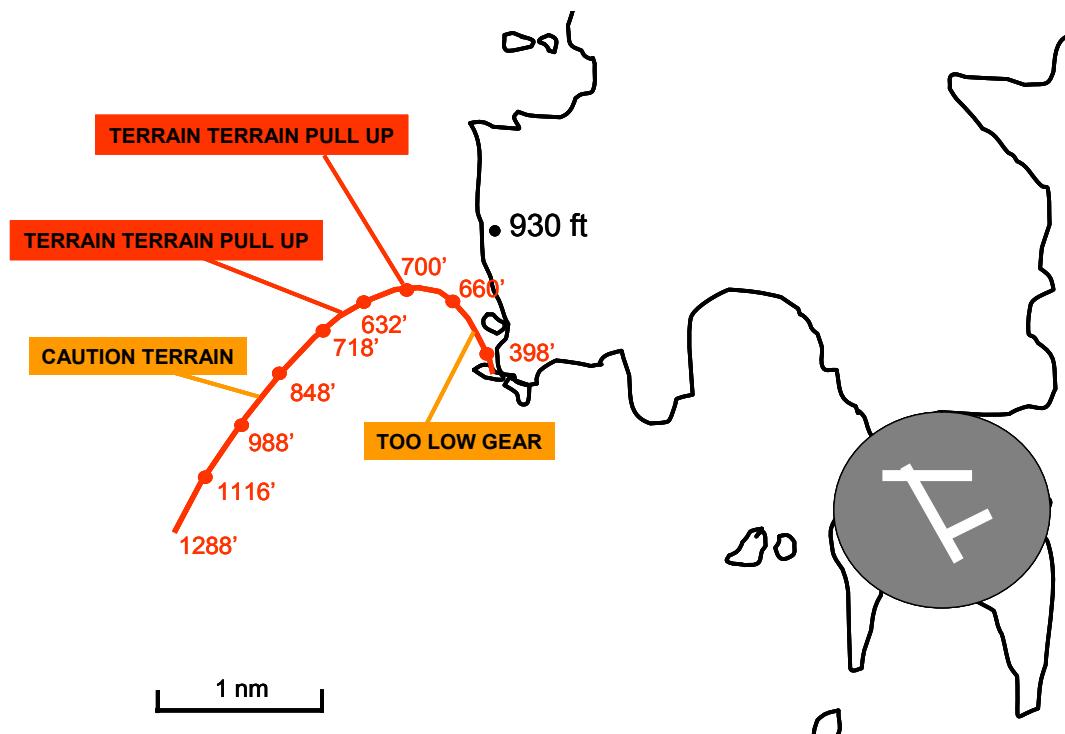
Figure 3
EGPWS record

The position of warnings and cautions generated by the EGPWS are depicted at Figure 3; values in red are radio altitudes. Figure 4 shows the aircraft's vertical profile for the same period. Flight data for each significant event, commencing with the start of the recorded data, is given in Table 1. Two recorded parameters were common to each event, these were: landing gear up and landing flaps not selected.

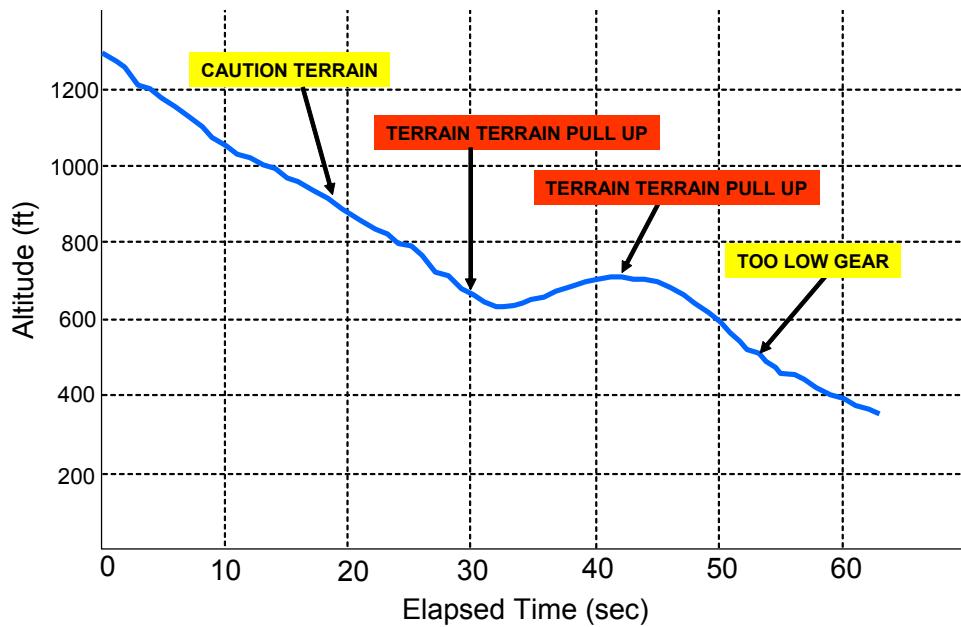
**Figure 4**

Aircraft vertical profile

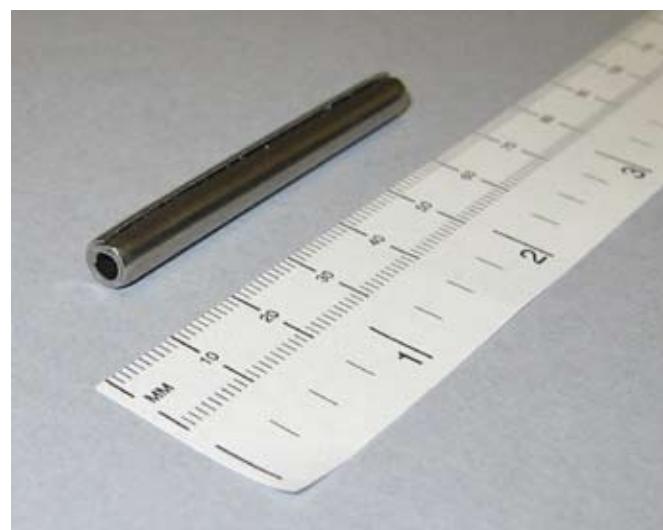
Figure 3
Detail of a scroll pin

The lower end of the pivot shaft fitted into a hole in the fork unit. The tolerances on the pivot shaft and the hole in the fork were such that for within-tolerance components there could be, at one extreme, a gap of 0.0016", and at the other extreme 0.0002" interference. Loctite adhesive was used to bond the two components. A 6 mm diameter scroll pin¹ was inserted into a hole through both the fork and the lower portion of the pivot shaft to locate the components positively and to take the relatively small load from tightening the shimmy damper nut, see Figure 3.

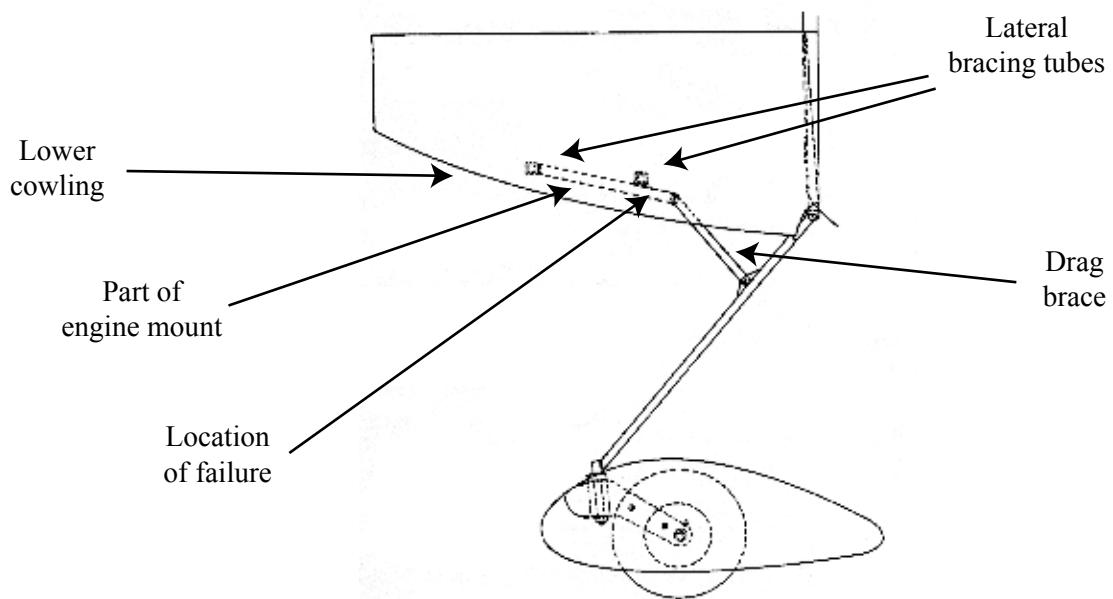
**Figure 1**

The longitudinal engine mount tube had failed at the location of the weld attaching it to the rear lateral

Nose landing gear and engine mount assembly
