A U S T R A L I A N   T R A N S P O R T   S A F E T Y   B U R E A U

AIR SAFETY INVESTIGATION

200100348

# **Cessna C310R, VH-HCP 3 km E Newman Aerodrome**

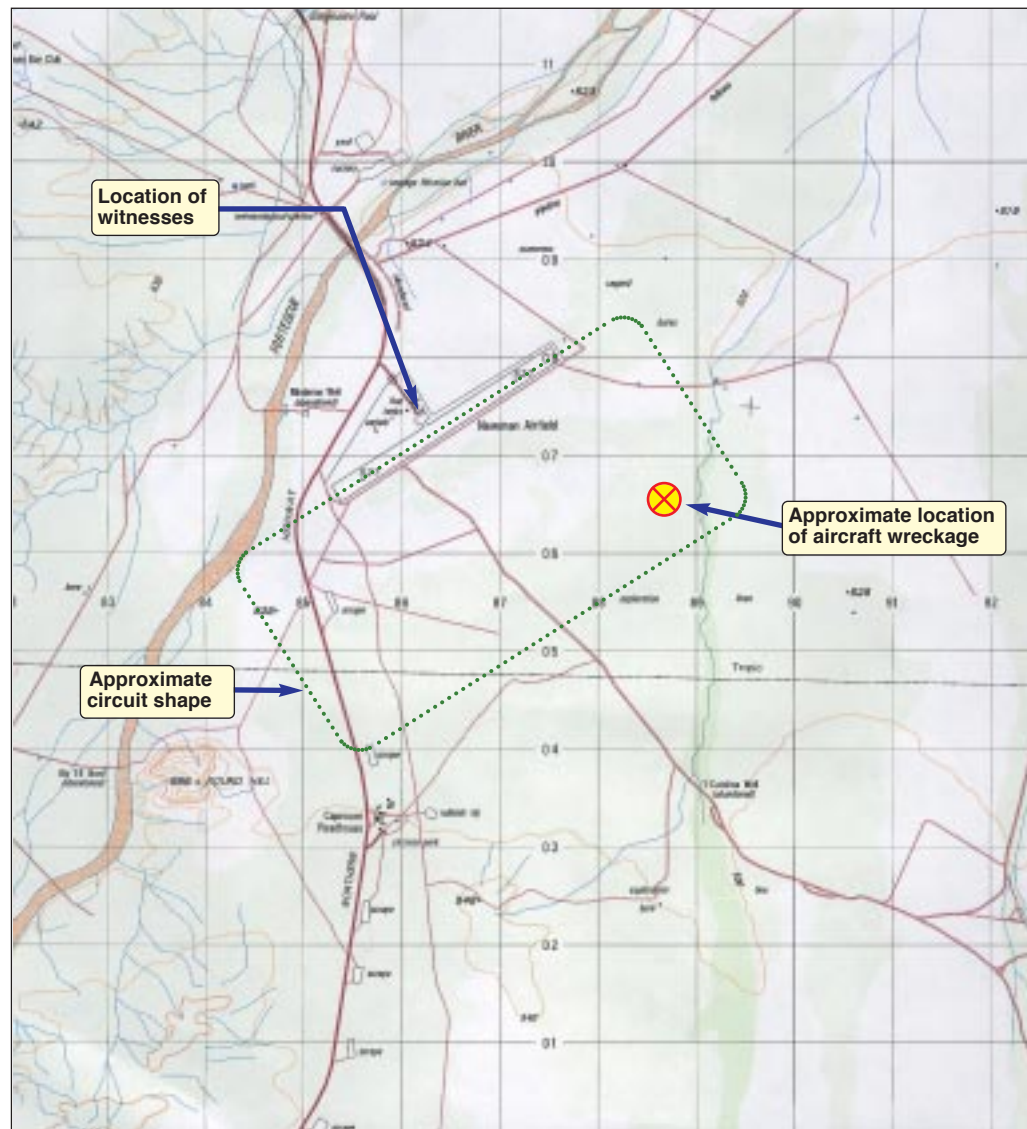
**FIGURE 1:**  
**Newman aerodrome and accident site**

Fig. 1 shows a map of Newman aerodrome, including the location of the accident site, and the location of the witnesses. Fig. 2 shows the location of Newman aerodrome relative to the township and the approximate track from Kiwirrkurra.

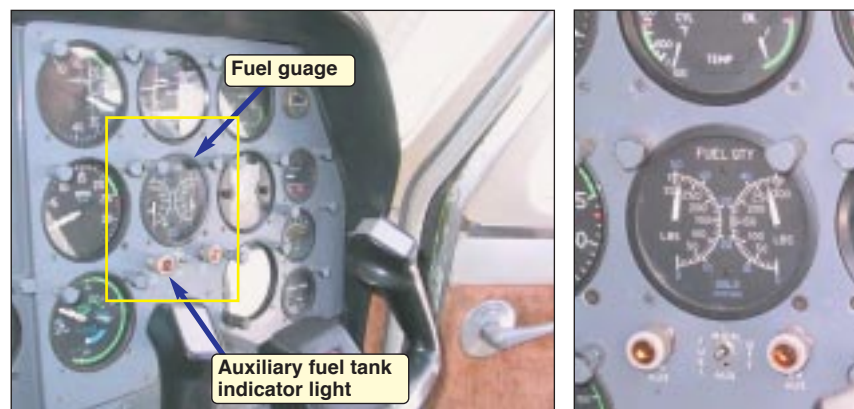
**FIGURE 3:**  
**Typical C310 fuel gauge and position on right side of instrument panel**

Each fuel tank was equipped with a capacitance-type fuel quantity sensing system that provided information to the cockpit-mounted fuel gauges (see fig. 3), installed on the right side of the instrument panel. Each gauge continuously indicated the fuel quantity of the tank from which the engine was drawing fuel. A spring-loaded toggle switch enabled the pilot to monitor the quantity of fuel contained in the non-selected tank. The main fuel tanks were not equipped with a low fuel quantity warning system.

The fuel gauge was calibrated in pounds (lbs). The maximum indication was 310 lbs, and the graduations reduced at intervals of 10 lbs over an indicating arc of about 180 degrees (see fig. 3).

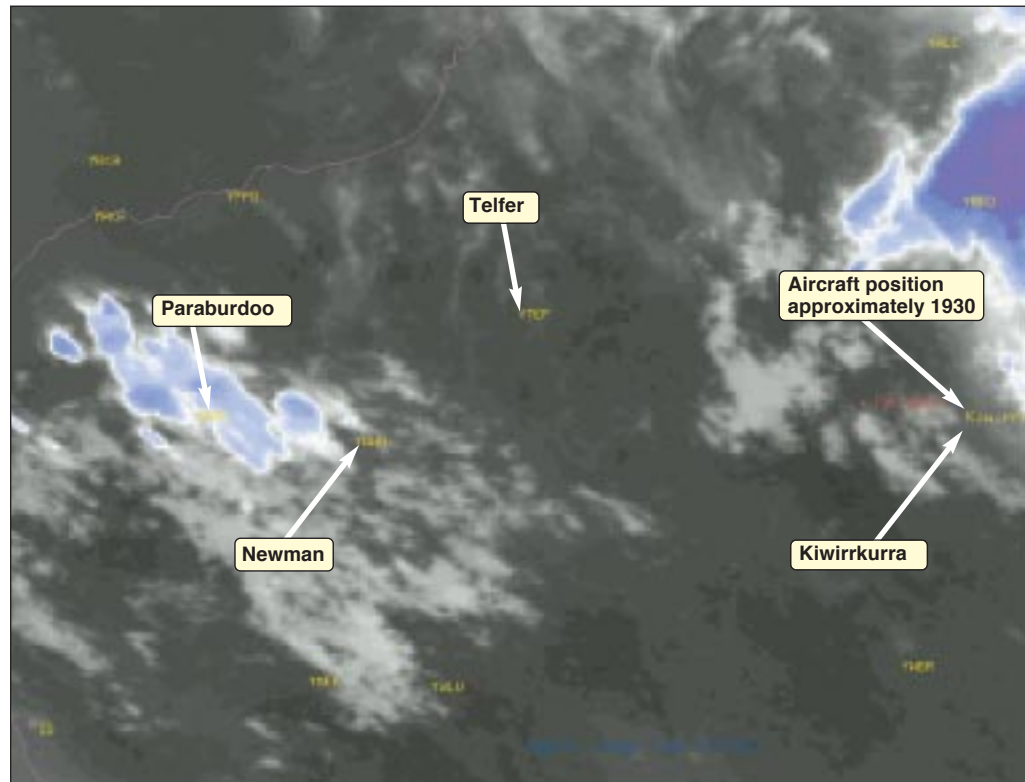
**FIGURE 4:**  
**Satellite image taken approximately 1930**

Archived data from ground-based lightning sensors<sup>14</sup> recorded thunderstorm activity in the region on the night of the accident, which included activity proximal to the track from Kiwirrkurra to Newman. Although the hourly satellite imagery did not reveal evidence of significant thunderstorm activity along the aircraft's track during the flight, a number of lightning strikes were recorded by the lightning sensors. Some of these strikes were within 30 NM of the aircraft's probable position (see fig. 5 to 7) and could be correlated with areas of cloud depicted on the satellite imagery. It was possible that there was thunderstorm activity along the track Kiwirrkurra to Newman during the occurrence flight, and it was likely that some lightning activity was not detected by the ground-based lightning sensors.
