ATSB TRANSPORT SAFETY INVESTIGATION REPORT
Aviation Occurrence Investigation 200404590
Final

Bell 206B, VH-CSH Dunedoo, NSW

22 November 2004

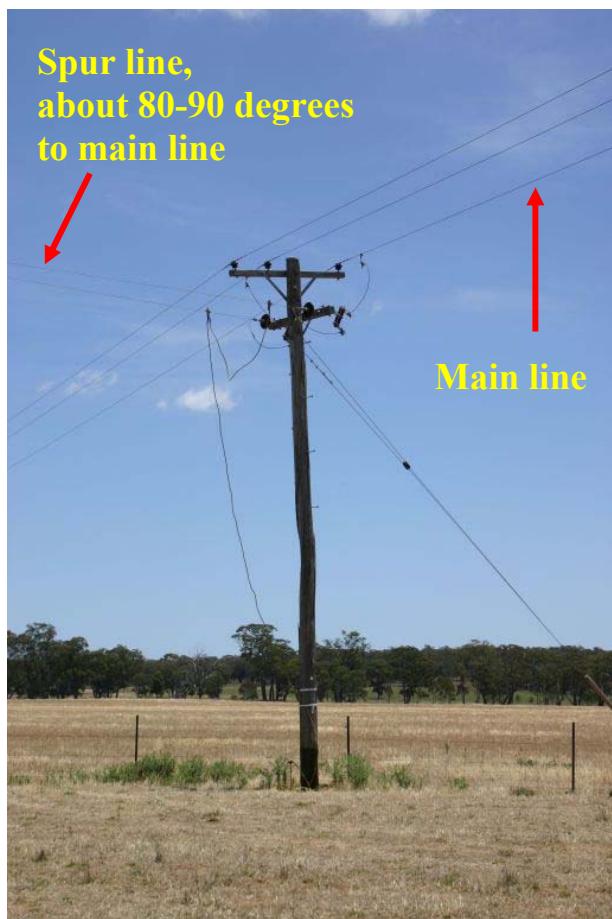
Figure 5: Junction of spur and main powerlines

A spur line consisting of two three-strand high-tensile steel wires⁵ extended about 80-90 degrees from a main powerline (see Figures 5 and 6). The wires had a calculated minimum breaking load of 22.2 kN and spanned about 300 m. The relative position of the powerlines, support poles and the helicopter's direction of flight, are depicted at Figure 4. The front-seat RLPB ranger reported that, when the property owner was returned to the homestead, all the occupants of the helicopter were aware of the existence of powerlines in the vicinity.

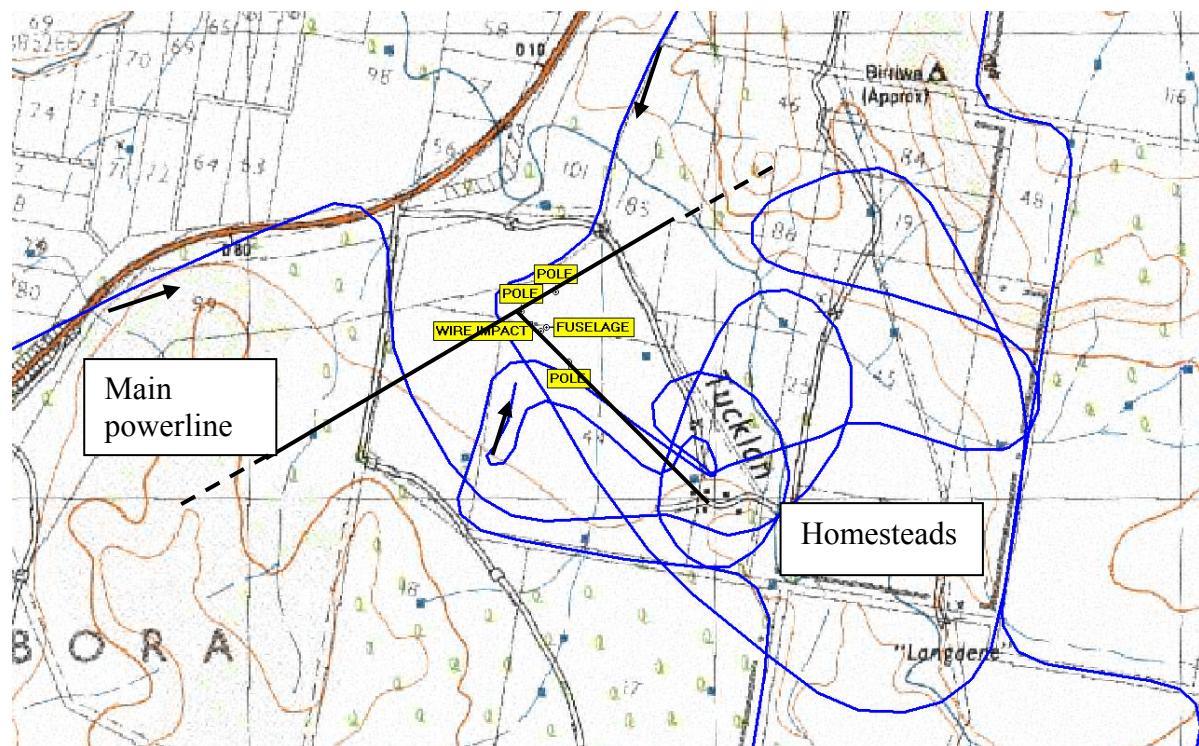
Figure 7: Recovered GPS track data

Track data recovered from a hand-held Global Positioning System unit, which had been mounted in the helicopter, revealed that the reconnaissance of the property included flight along a number of powerlines, including the spur line involved in the accident (see Figure 7).

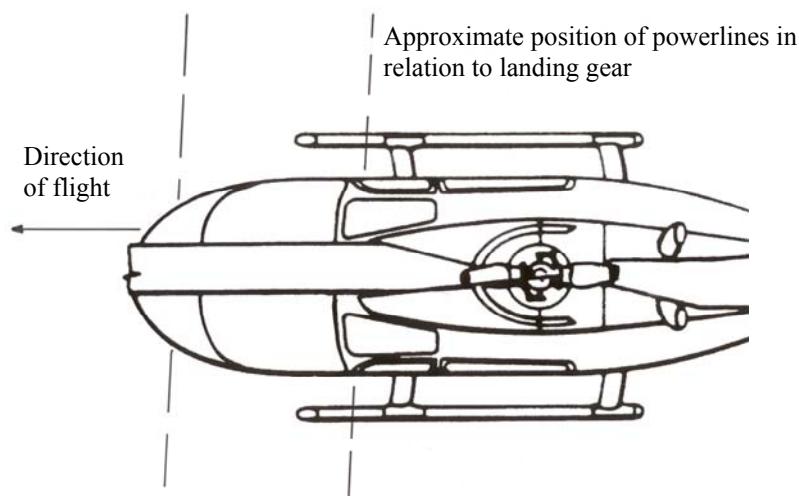
Figure 8: Approximate positioning of power lines in relation to the helicopter at impact

Examination of the powerlines and the helicopter skid landing gear revealed that the helicopter had struck both wires, while crossing at about 85-90 degrees relative to the powerline (see Figure 8), at a point between the skid landing gear and the fuselage floor. Impact markings on the helicopter's skid landing gear front crosstube and the forward, upper surface of both landing gear skids, indicated that the helicopter had contacted the powerlines more heavily on the right side than the left (see Figure 9). There was also evidence of electrical arcing on the surface of both wires and on the right side of the helicopter's skid landing gear.

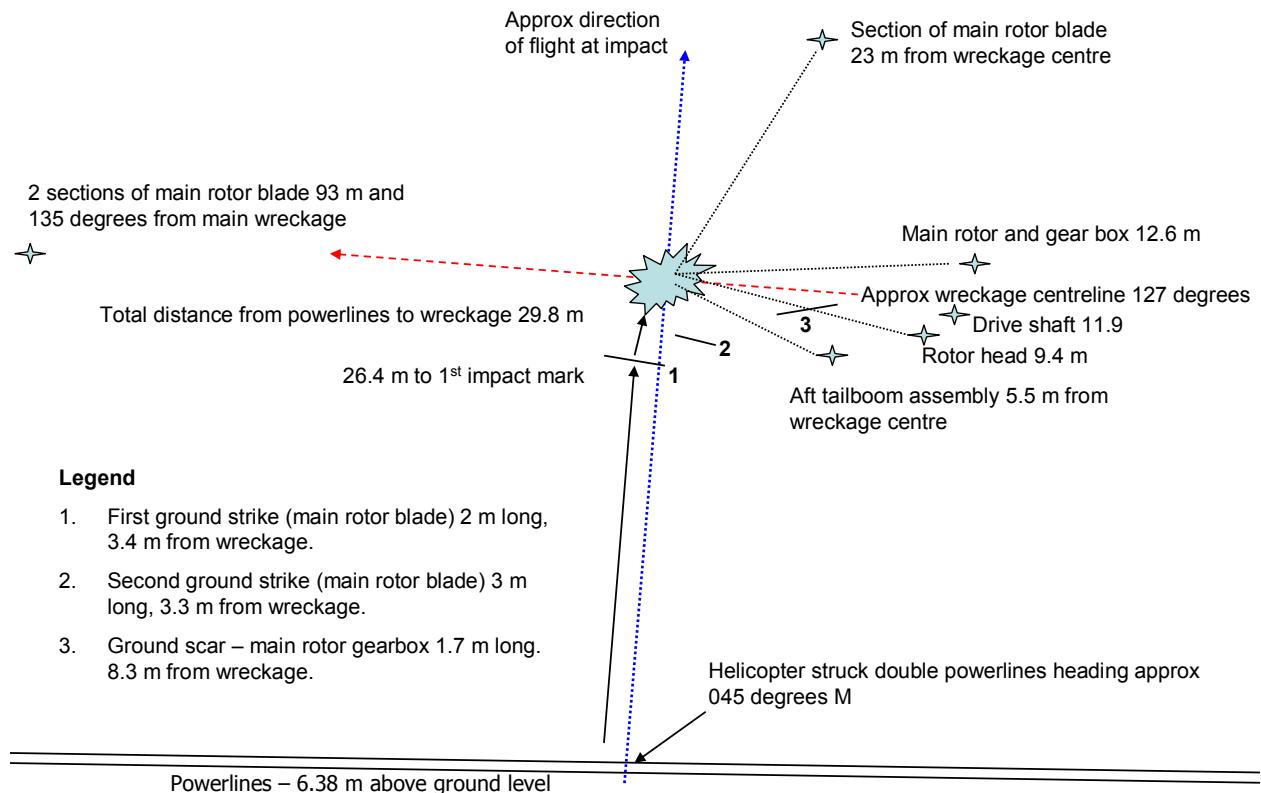
Figure 11: Diagram of accident site

The first ground impact mark was a 2 metre long main rotor blade strike, 26.4 m from a point directly beneath the first powerline impact point and 3.4 m from the main wreckage (see Figure 11). Subsequent ground impact marks were from the main rotor blades and the fuselage. The fuselage had impacted the ground heavily on its right side and right nose area in a slightly nose-down attitude, and rolled onto its left side before coming to rest. The impact had significantly distorted the right side and front of the fuselage structure and resulted in the rupturing of the fuselage-mounted fuel cell bladder (see Figures 12 to 15).

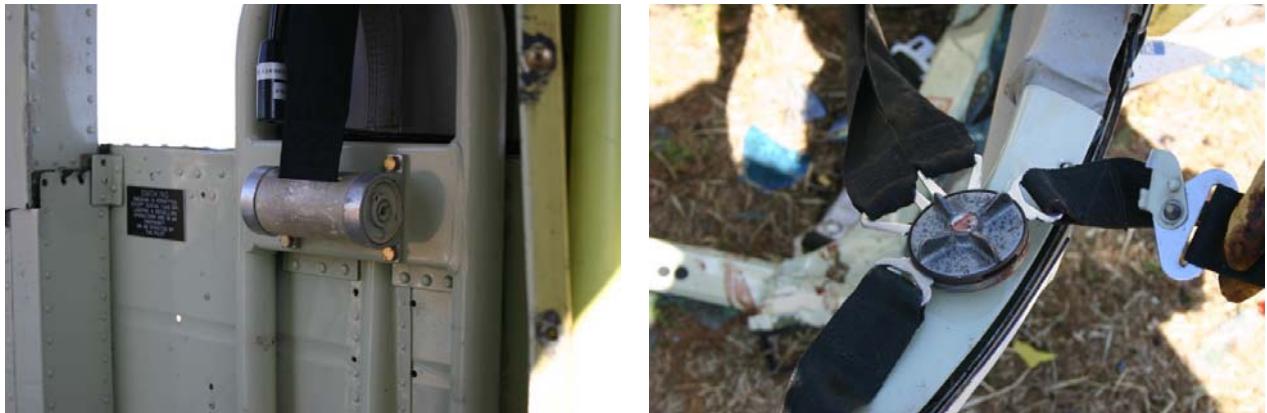
Figure 16: Front crew seat inertia reel assembly and harness buckle correctly secured

Each of the two front crew seats was fitted with a four-point harness seat belt, consisting of two shoulder straps and two lap belts that were fastened into a four-point buckle assembly by the seat occupant. The two shoulder straps were joined together into a single strap behind the shoulders of the occupant, which in turn was mounted in an inertia-reel assembly (see Figure 16).

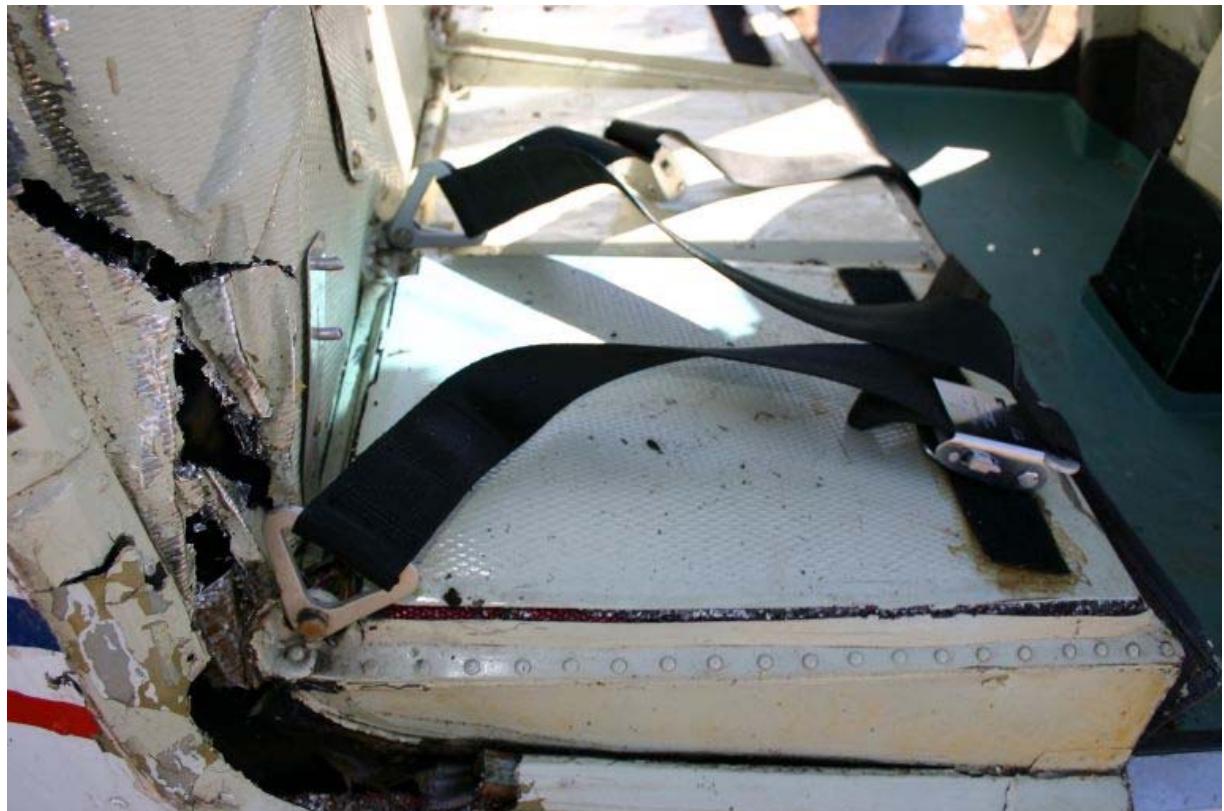
Figure 17: Right rear cabin seat belt

The three seats in the rear cabin of the helicopter were fitted with two-point lap belts that were attached to the airframe at three attachment points on the lower rear bulkhead. The belts had a tongue on one part of the belt that inserted into a lift-to-release buckle on the other part (see Figure 17).
