AVIATION SAFETY INVESTIGATION REPORT  
200204328

## Hamilton Island Aerodrome

Piper PA-32-300, VH-MAR  
26 September 2002

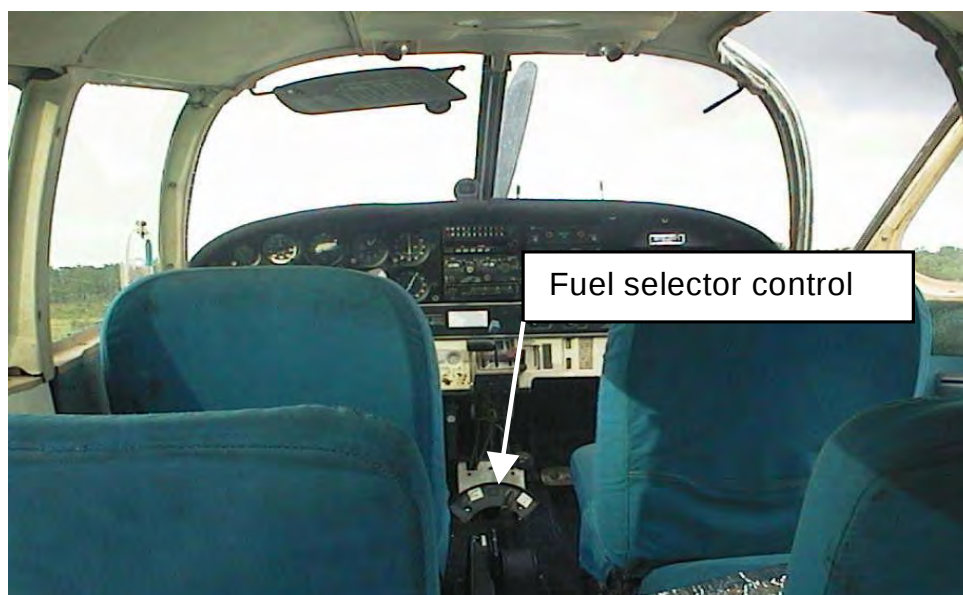
**Figure 4:** Occurrence aircraft cockpit photograph

Fuel lines connected each tank to an underfloor fuel selector valve. The fuel selector control was located on the floor beneath the centre of the aircraft's instrument panel. It had five positions, corresponding to: an OFF selection; followed by left tip; left main; right main; and right tip tanks when moving the selector from left to right. Those fuel selector control positions are indicated at Figure 3. The in-cockpit location of the fuel selector control is indicated in the occurrence aircraft cockpit photograph at Figure 4.
