ATSB TRANSPORT SAFETY INVESTIGATION REPORT

Aviation Occurrence Report – 200502137

**Evacuation
Hobart Airport
17 May 2005**

**VH-VQI
Boeing 717-200**

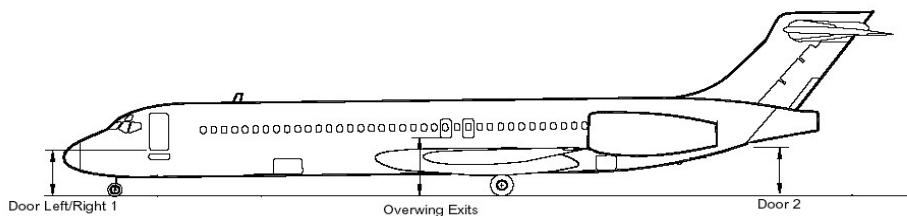
Figure 1: Aircraft door positions

The flight crew reported that they signed on for duty at 0500 and arrived at the aircraft at about 0530 to conduct pre-flight checks and the pre-flight inspection. At the same time, the cabin crew conducted a briefing and assigned crew positioning. The cabin manager (CM) was assigned the main entry Door Left 1 (L1) as per company procedures, and the other three crew were assigned to the Door Right 1 (R1), Door 2 (D2), and to the overwing assist positions.

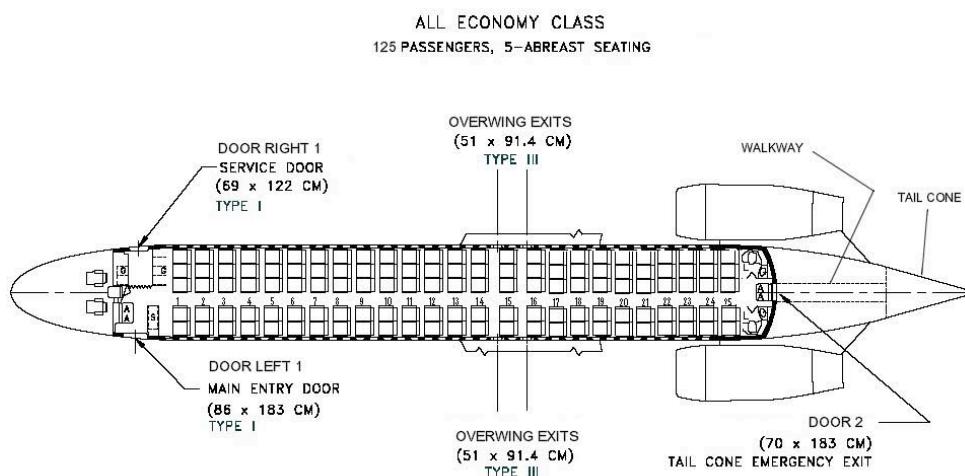
Figure 3: Aircraft seating and exit layout

The aircraft had a single-class configuration consisting of 25 rows with five seats per row, capable of holding 125 passengers (Figure 3).

The cabin had three floor level exit doors and four overwing exits (Figure 3). The main entry door (L1) was located behind the cockpit on the left side of the aircraft, and the service door (R1) was located directly opposite on the right side. Both of the forward doors were type 1⁴ exits and each door contained an emergency escape slide designed to automatically inflate when the doors were opened in the armed mode. The L1 and R1 doors were 2.24 m and 2.23 m above the tarmac, respectively.
