AVIATION SAFETY INVESTIGATION REPORT

BO/200105769

## Raytheon Beech 200C, VH-FMN

Mount Gambier, SA  
10 December 2001

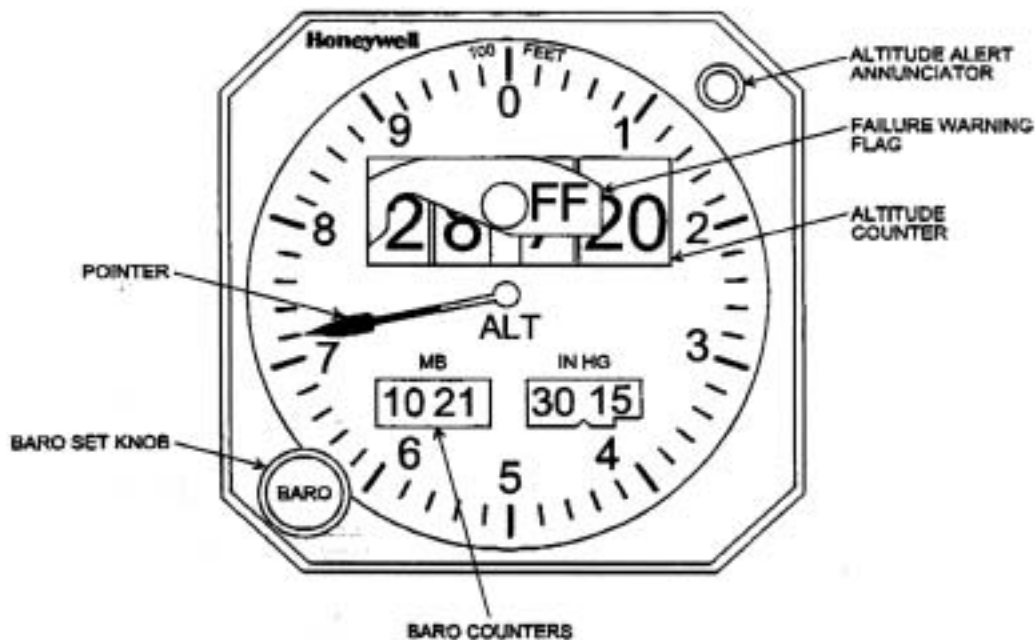
The altimeter and pitot-static system was last inspected on 19 January 2001, with no anomalies noted. The BA-141 altimeter is depicted at fig. 2.

**FIGURE 2:**  
**Sperry BA-141 encoding altimeter**

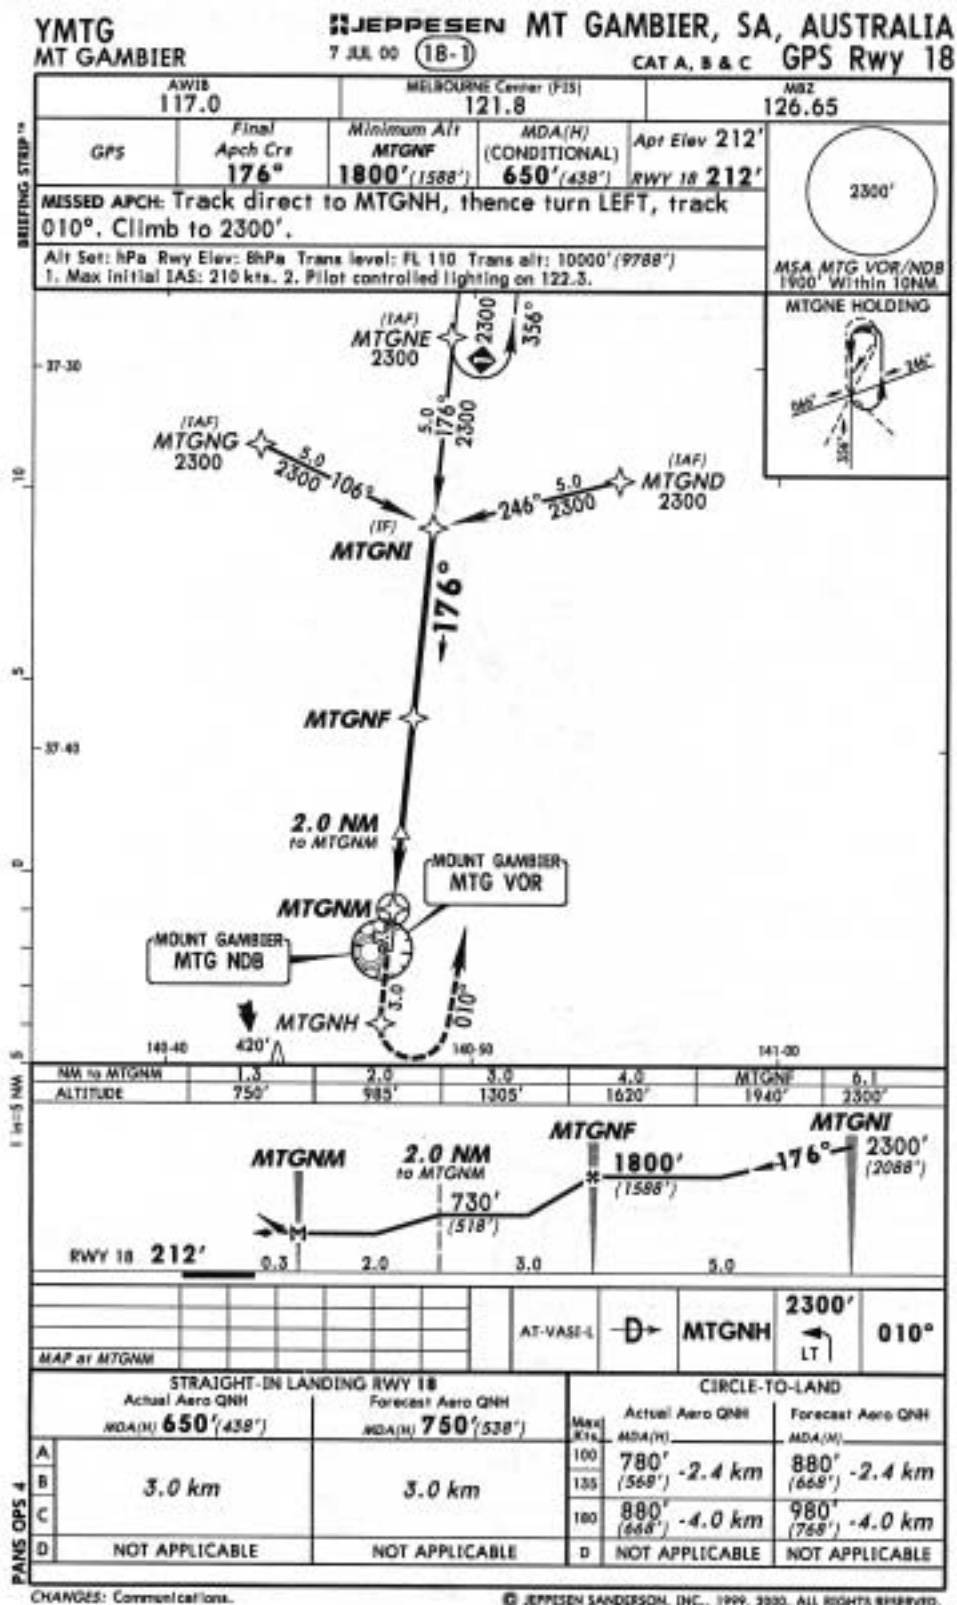
The pilot was reported to have used Jeppesen Sanderson, Inc. (Jeppesen) instrument approach charts. The Jeppesen Mount Gambier GPS RWY 18 Approach, current at the time of the occurrence, is depicted at fig.7. CASA had approved the use of GPS as a non-precision approach navigation aid, in Australian domestic airspace, under the Instrument Flight Rules. The operator reported that FMN was not certified to conduct GPS non-precision approaches, and company pilots were not trained to, and therefore not permitted to, conduct GPS non-precision approaches.

FIGURE 7:  
Jeppesen Mount Gambier GPS RWY 18 Approach

Witnesses located under the GPS RWY 18 Approach path, and to the south of the GPS waypoint MTGNF (5.3 NM north of the threshold RWY 18), reported that they heard the occurrence aircraft some distance to the west of them, and that it did not overfly their location. Witnesses located to the south and west of MTGNF, reported that the occurrence aircraft overflew their location.

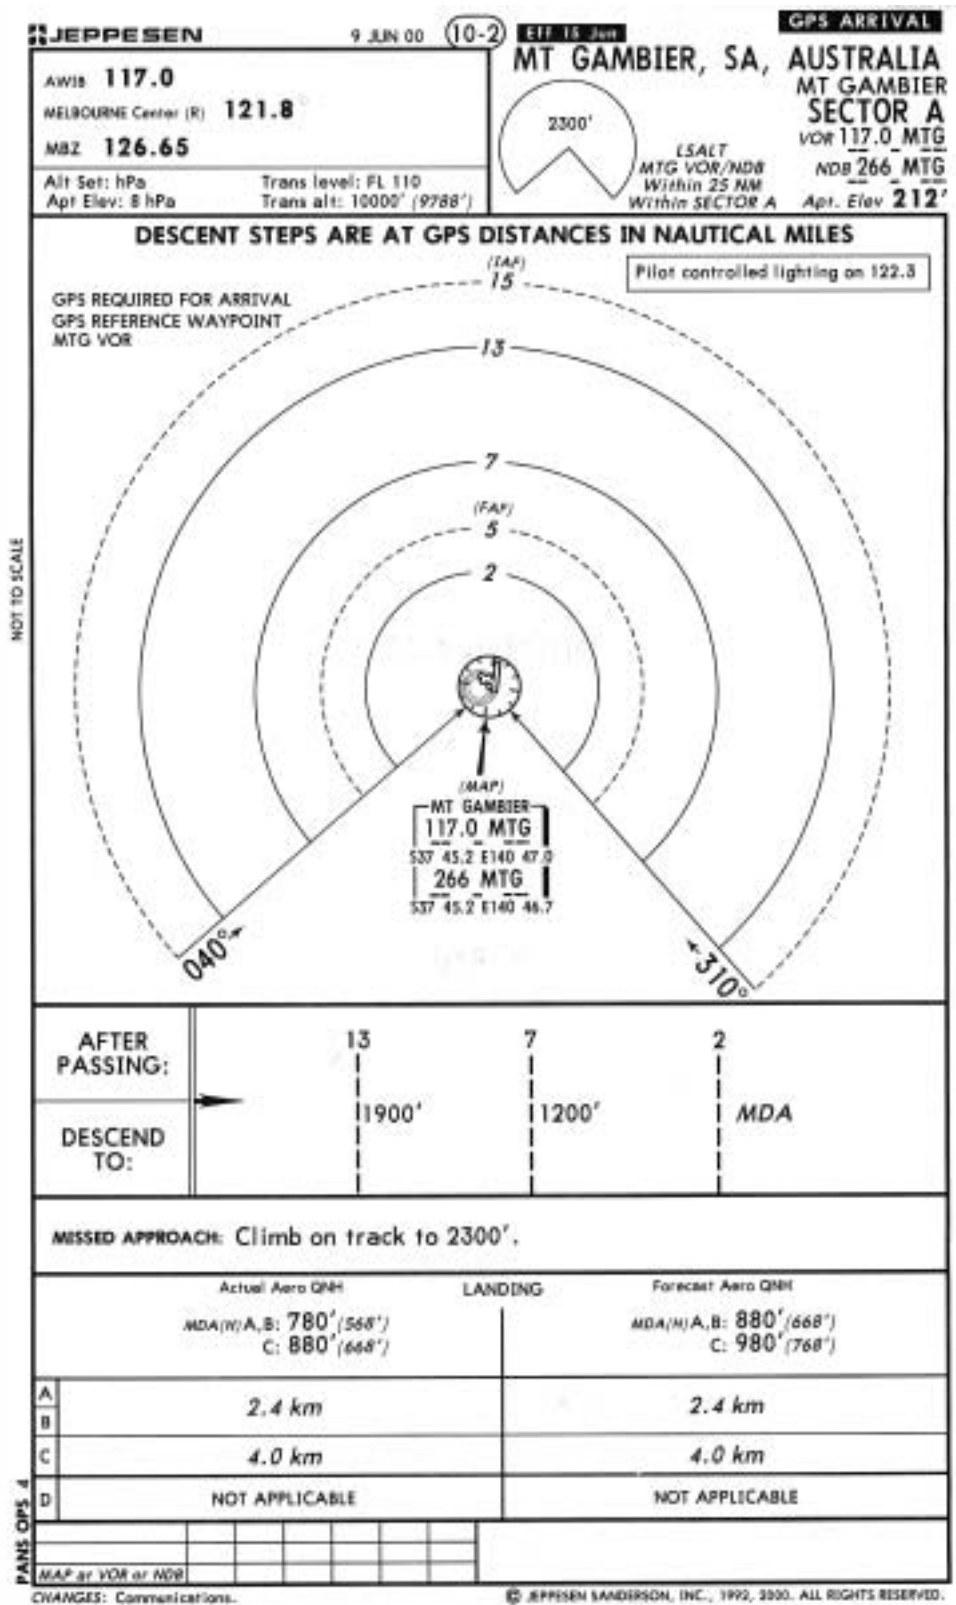
The minimum altitudes specified for the Mount Gambier GPS Arrival procedure, as shown at fig. 8, were 1,900 ft above mean sea level (AMSL) from 13 NM to 7 NM and 1,200 ft from 7 NM to 2 NM. The minimum descent altitude (MDA) for the procedure, at less than 2 NM, was 780 ft<sup>9</sup>. At MDA, the procedure specified a flight visibility requirement of 2.4 km. The missed approach point was the VOR. Descent below MDA is discussed at paragraph 1.16.4.2. The initial approach fix was at 15 NM and the final approach fix was at 5 NM, with reference to the Mount Gambier VOR.

<sup>9</sup> FMN was a Category B aircraft. The MDA for the approach was 780 ft, which was 100 ft lower than the 880 ft depicted on the chart. That was permitted in accordance with the provisions of the Aeronautical Information Publication because an actual aerodrome QNH was available to the pilot.

FIGURE 8:  
Jeppesen Mount Gambier GPS Arrival procedure

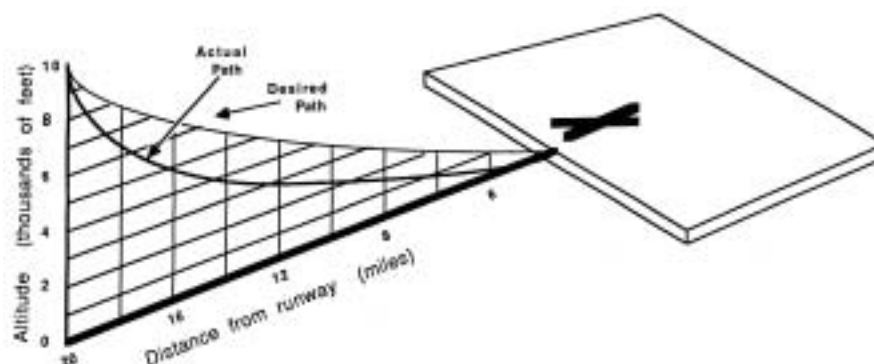
The latter stages of the occurrence flight were flown over dark, unlit terrain towards lights, in conditions of low cloud, rain showers and the lack of a defined horizon. Flying a visual approach in those conditions has been associated with less reliable pilot control of approach path angle due to the lack of visual cues. On occasions, pilots have experienced difficulty judging rates of descent and closure rates, resulting in them overestimating approach path angle and flying a shallow approach, sometimes resulting in ground impact short of the lit area. The same conditions can also produce high approaches, however low approaches have been shown to be more likely. In those instances of low approaches, a comparison of the approach path flown by pilots during a night visual approach, with the desired altitudes, is depicted at fig. 11.

**FIGURE 11:**  
Comparison of the approach path flown by pilots during a night visual approach with the desired altitudes<sup>14</sup>

- supplement outside visual reference to the runway with airport approach slope indicators or glide path information from navigation instruments
- use distance measuring equipment to fly a 3 degree approach angle
- overfly an unfamiliar aerodrome before commencing the approach to landing
