ATSB TRANSPORT SAFETY REPORT
Aviation Occurrence Investigation – AO-2010-089
Preliminary

**In-flight uncontained engine failure
overhead Batam Island, Indonesia
4 November 2010
VH-OQA
Airbus A380-842**

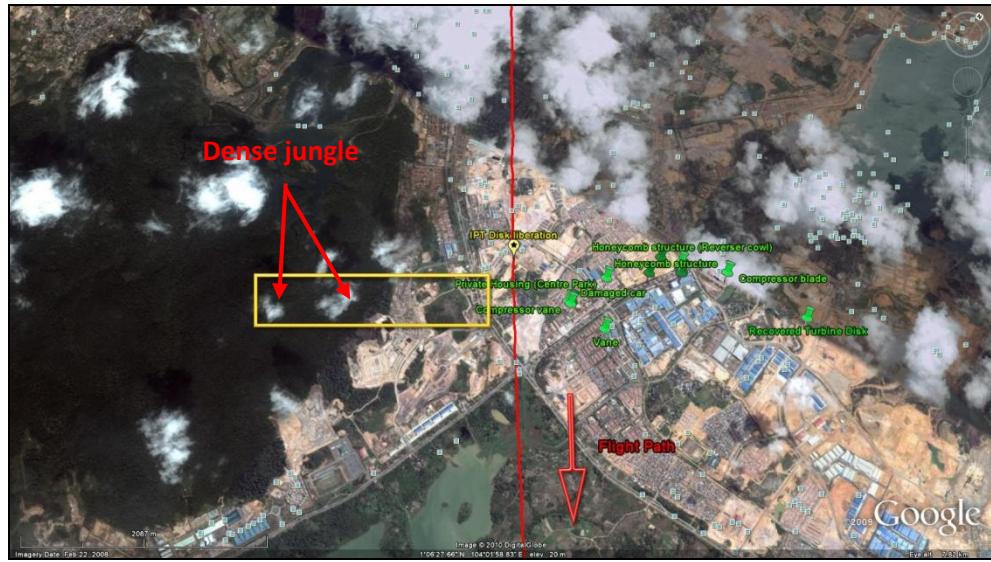
Figure 12: Estimated location of the missing disc segments (search area in yellow, including the area of dense jungle)

Trajectory analysis was undertaken to localise the search area based on a number of aircraft and engine parameters immediately prior to the failure, and on the location of the recovered segment of the IP turbine disc. On that basis, it was estimated that the missing disc segments should be located to the right of the aircraft's flight path, most likely in an area of steep, dense jungle (Figure 12).

Although the search was hampered by the local terrain, some small engine components, such as turbine blades and blade attachment points were recovered by local residents and provided to the investigation. However, no other significant turbine disc parts were recovered.

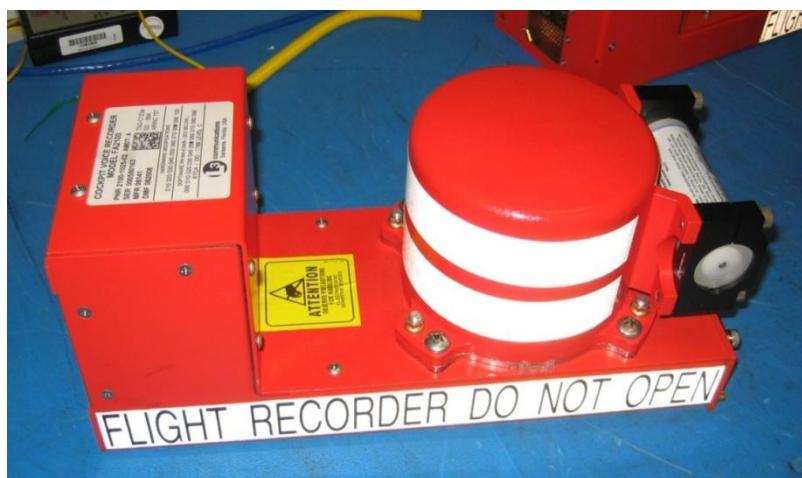
Figure 18: Cockpit Voice Recorder

The CVR contained over 2 hours of cockpit audio but, due to the continued running of the No 1 engine in Singapore, the audio at the time of the disc failure was overwritten. The available audio commenced during the landing approach and continued during the subsequent ground operations.

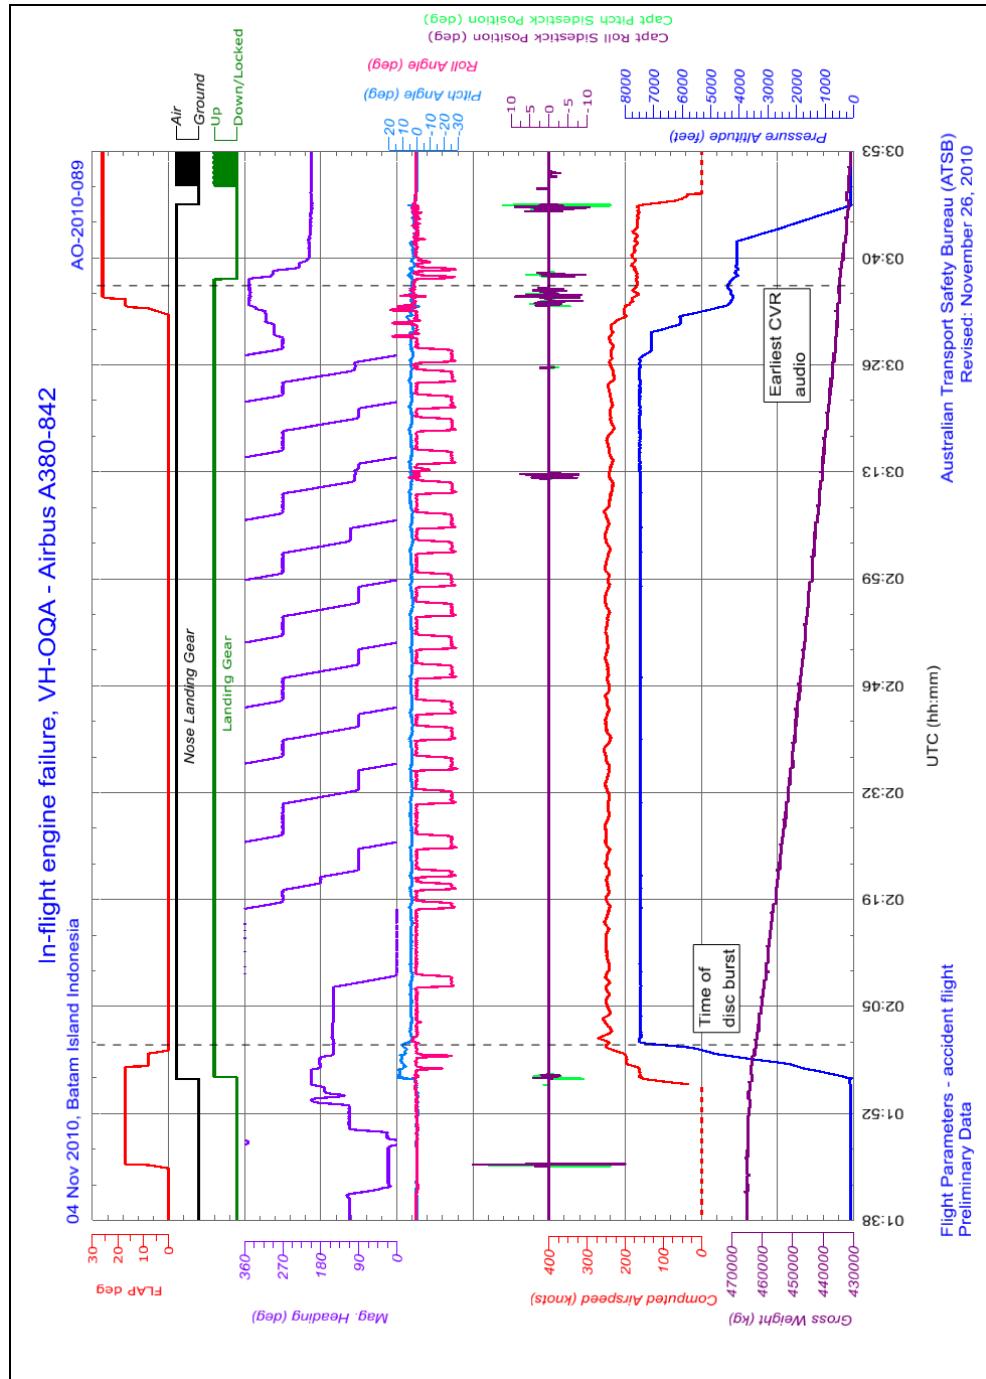
Figure A-1: Graphical representation of selected parameters for entire accident flight

Valuable information was drawn from the data regarding the engine failure (Appendix A).
