DUTCH
SAFETY BOARD

Runway Incursion

Runway Incursion Runway 24 Amsterdam Airport Schiphol

The Hague, January 2013 (project number 2010094)

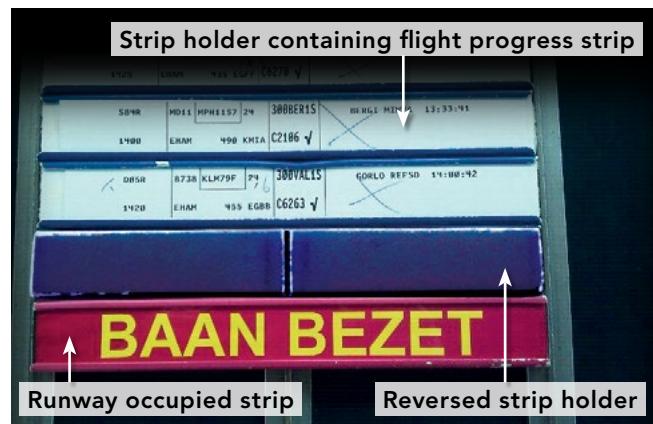
Figure 4: Strip holders

The relevant image of the runway then starts flashing on the panel and a sound is emitted by a 'ticker' (a regular ticking sound). The runway controller also reversed the strip holder with the next aircraft due to take off so that the text on the flight strip was no longer visible in the strip holder concerned to indicate that this aircraft was not permitted to take off. The strip holder contains a paper 'flight progress strip' showing the relevant flight data, such as aircraft type and flight number (see figure 4). The 'runway occupied' strip holder was added a few years ago. In addition to activating the flashing lights on the runway allocation panel, coupled with the regular sound of the 'ticker' and reversing the strip holder (the bottom of which is yellow) showing the next aircraft due to take off or land, the runway controller may insert the red 'runway occupied' strip holder (see figure 4). Incidentally, not all runway controllers do this, and in this particular case the 'runway occupied' strip holder was not used either. The Air Traffic Control Operations Manual [*Voorschriften Dienst Verkeersleiding*, hereinafter also referred to as the 'VDV'], does not incorporate any procedures for reversing the strip holder showing the next aircraft due to take off or land, nor for using the 'runway occupied' strip holder. The system used in the tower at Amsterdam Airport Schiphol does not contain a feature to indicate that several aircraft or vehicles are travelling on the runway at the same time. The air traffic controllers are aware of this particular feature of the system.

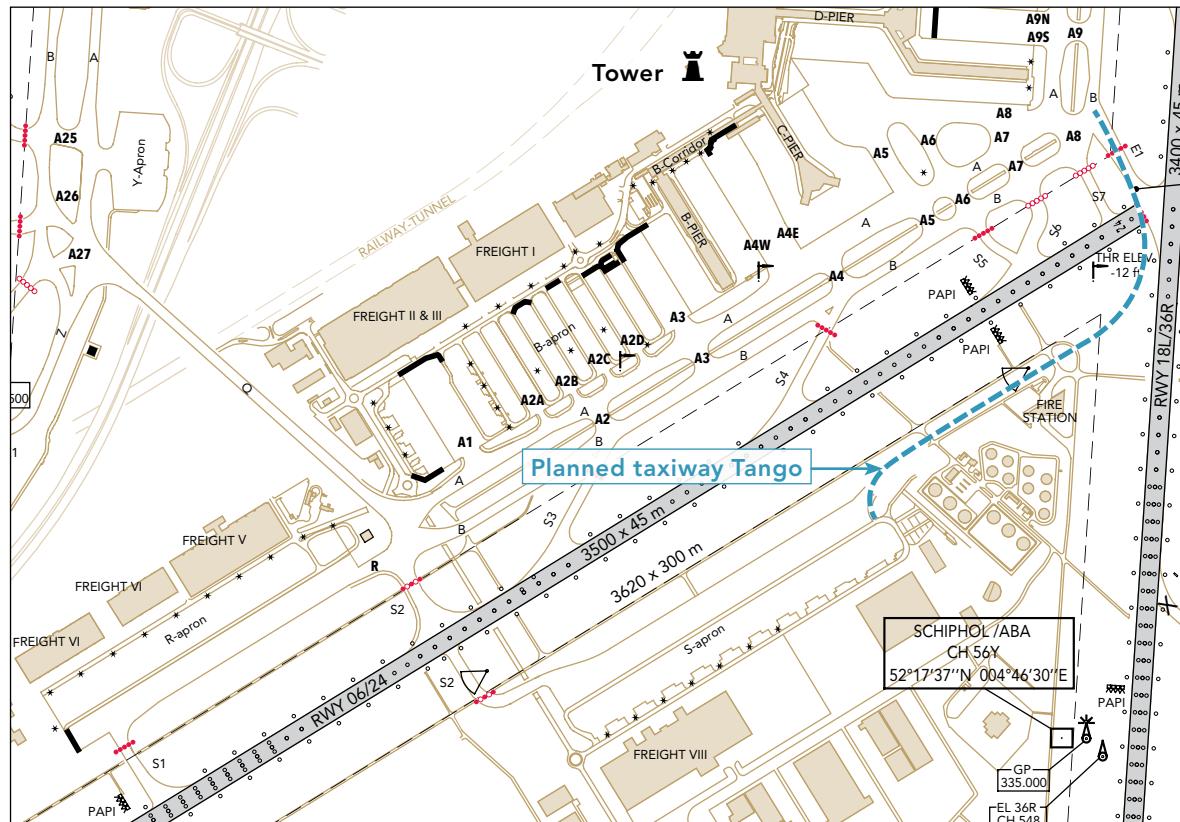
Figure 5: New Taxiway Tango scheduled for construction

After the Delta incident, there was a need for traffic to travel to and from Apron Sierra without having to cross an intersection or to keep this to a minimum. It had been decided to construct an additional taxiway called Tango to enable aircraft to cross Runway 06/24. In absolute terms, even though Taxiway Tango has been completed aircraft must still cross Runway 06/24, but they now cross the beginning of the runway. A key aspect of this intersection location is that the speeds of aircraft taking off are much lower at this location than at the current S2 intersection. The initial project planning schedule was based on completion in 2008/2009. However, Schiphol Group's Management Board passed a resolution to temporarily shelve all respective investments. According to Schiphol this was due to the sharp decline in the cargo market, which meant that considerably fewer aircraft needed to cross the runway. At that time completion was rescheduled to 2015. Air Traffic Control the Netherlands states that it has repeatedly stressed the importance of completing Taxiway Tango.

Schiphol Group's Management Board has indicated that construction of Taxiway Tango will begin in 2014 and that the taxiway is scheduled to be completed and put into operation on 1 March 2015.
