**COMISIÓN DE  
INVESTIGACIÓN  
DE ACCIDENTES  
E INCIDENTES DE  
AVIACIÓN CIVIL**

## **Report EXT A-001/2012 Afghanistan**

Accident involving an MD-83  
aircraft, registration EC-JJS,  
operated by Swiftair, S.A., at the  
Kandahar Airport (Afghanistan),  
on 24 January 2012

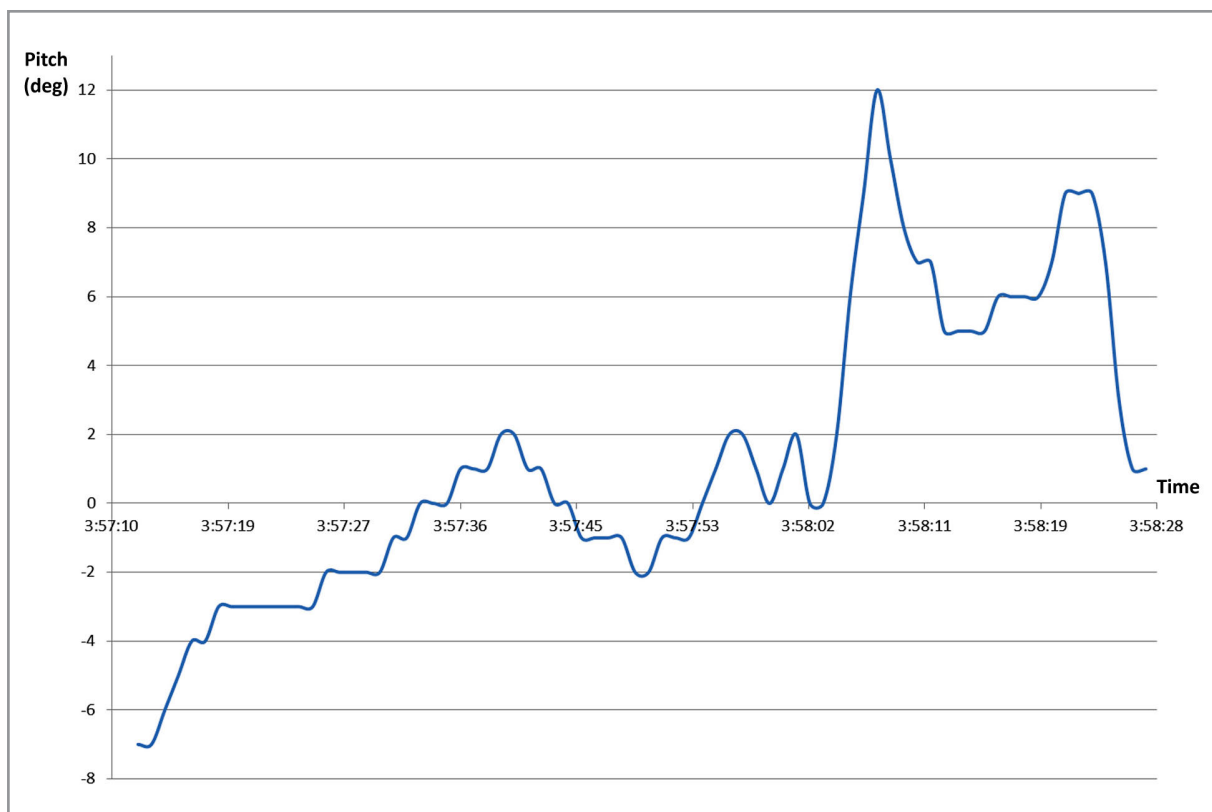
Figure 10. Pitch angle in the last 1,000 ft of RA

means of a sharp roll to the right that reached a value of  $20^\circ$  combined with an input to the right pedal that deflected the rudder up to  $15^\circ$  in the second before impact.
