# Appendix 1

Fragmentation and other damage features of the fan of No.1 engine from G-OBME

BMA BOEING 737 - 400 G - OBME

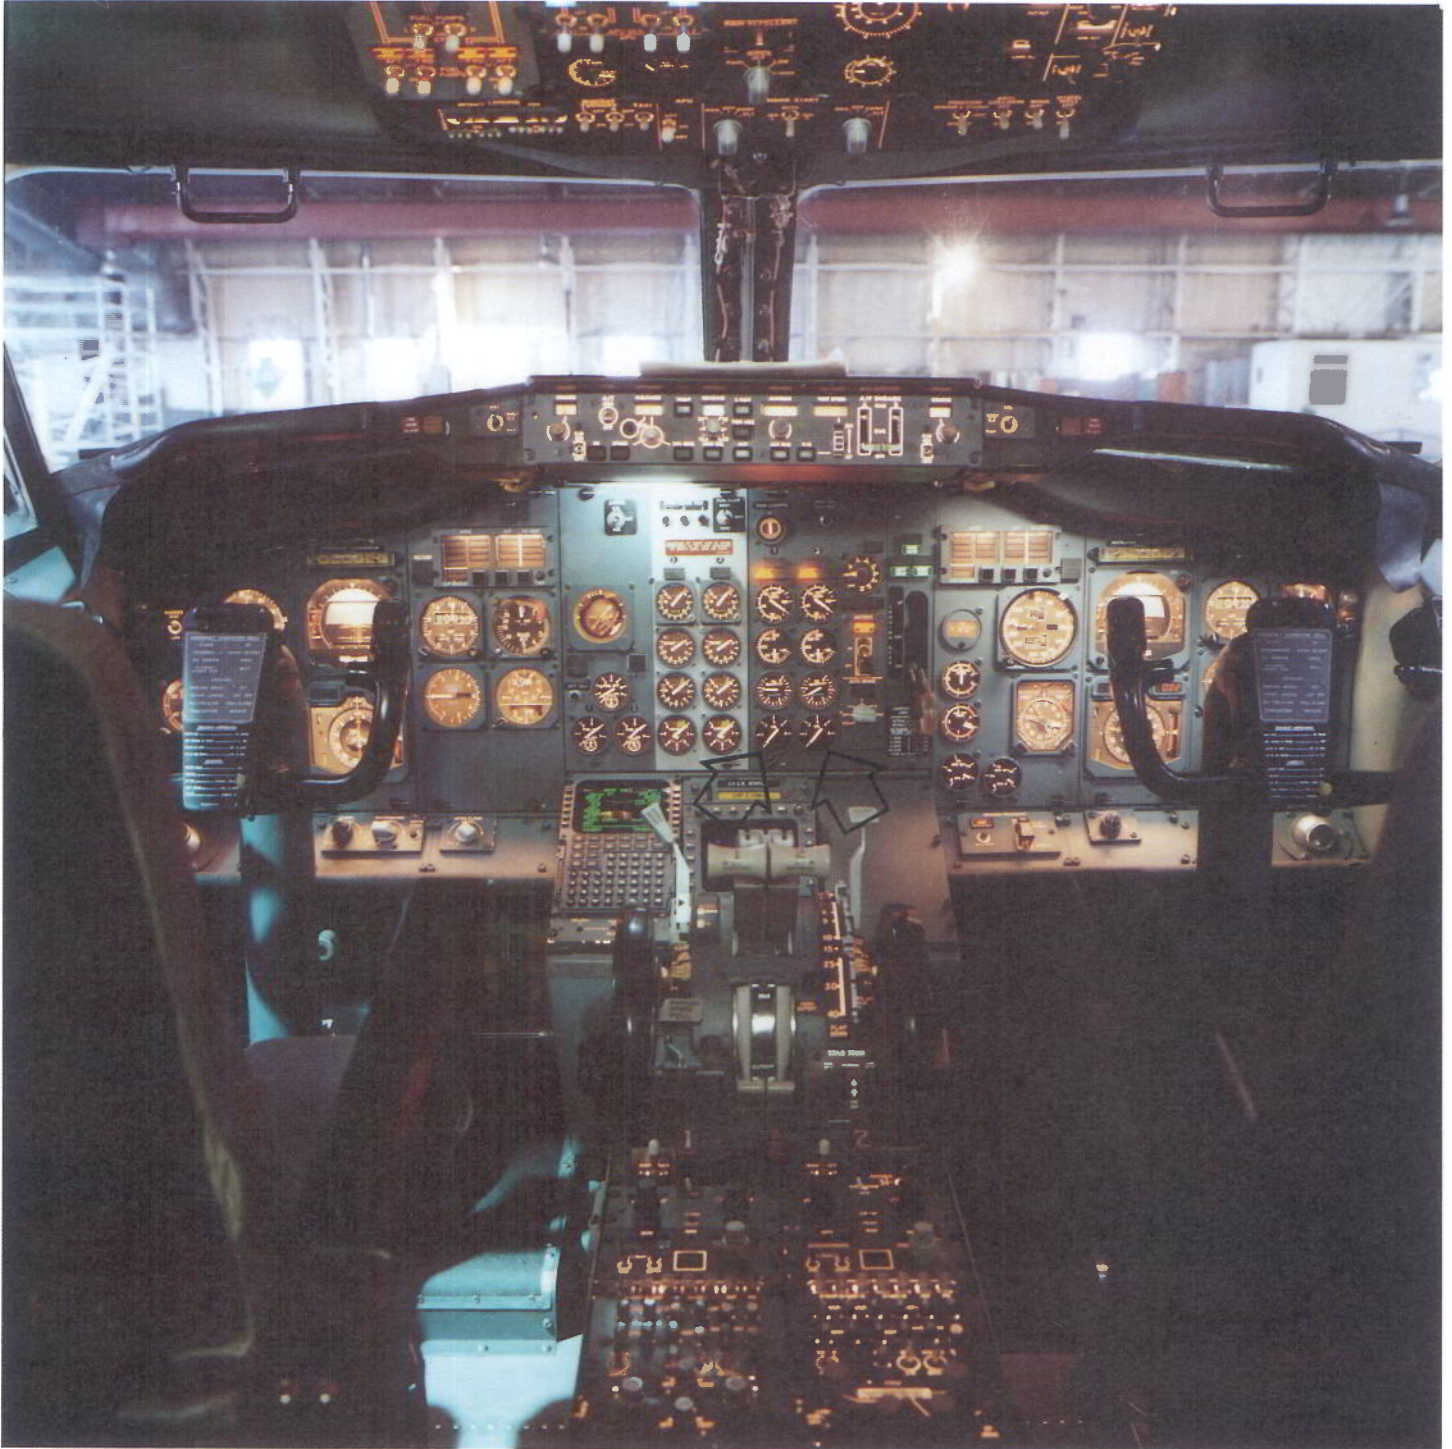
FIG 1: SHOWING HYBRID ELECTROMECHANICAL POINTER/LED COUNTER INSTRUMENTS USED FOR DISPLAY OF ENGINE PARAMETERS WITH VIBRATION INDICATORS ARROWED

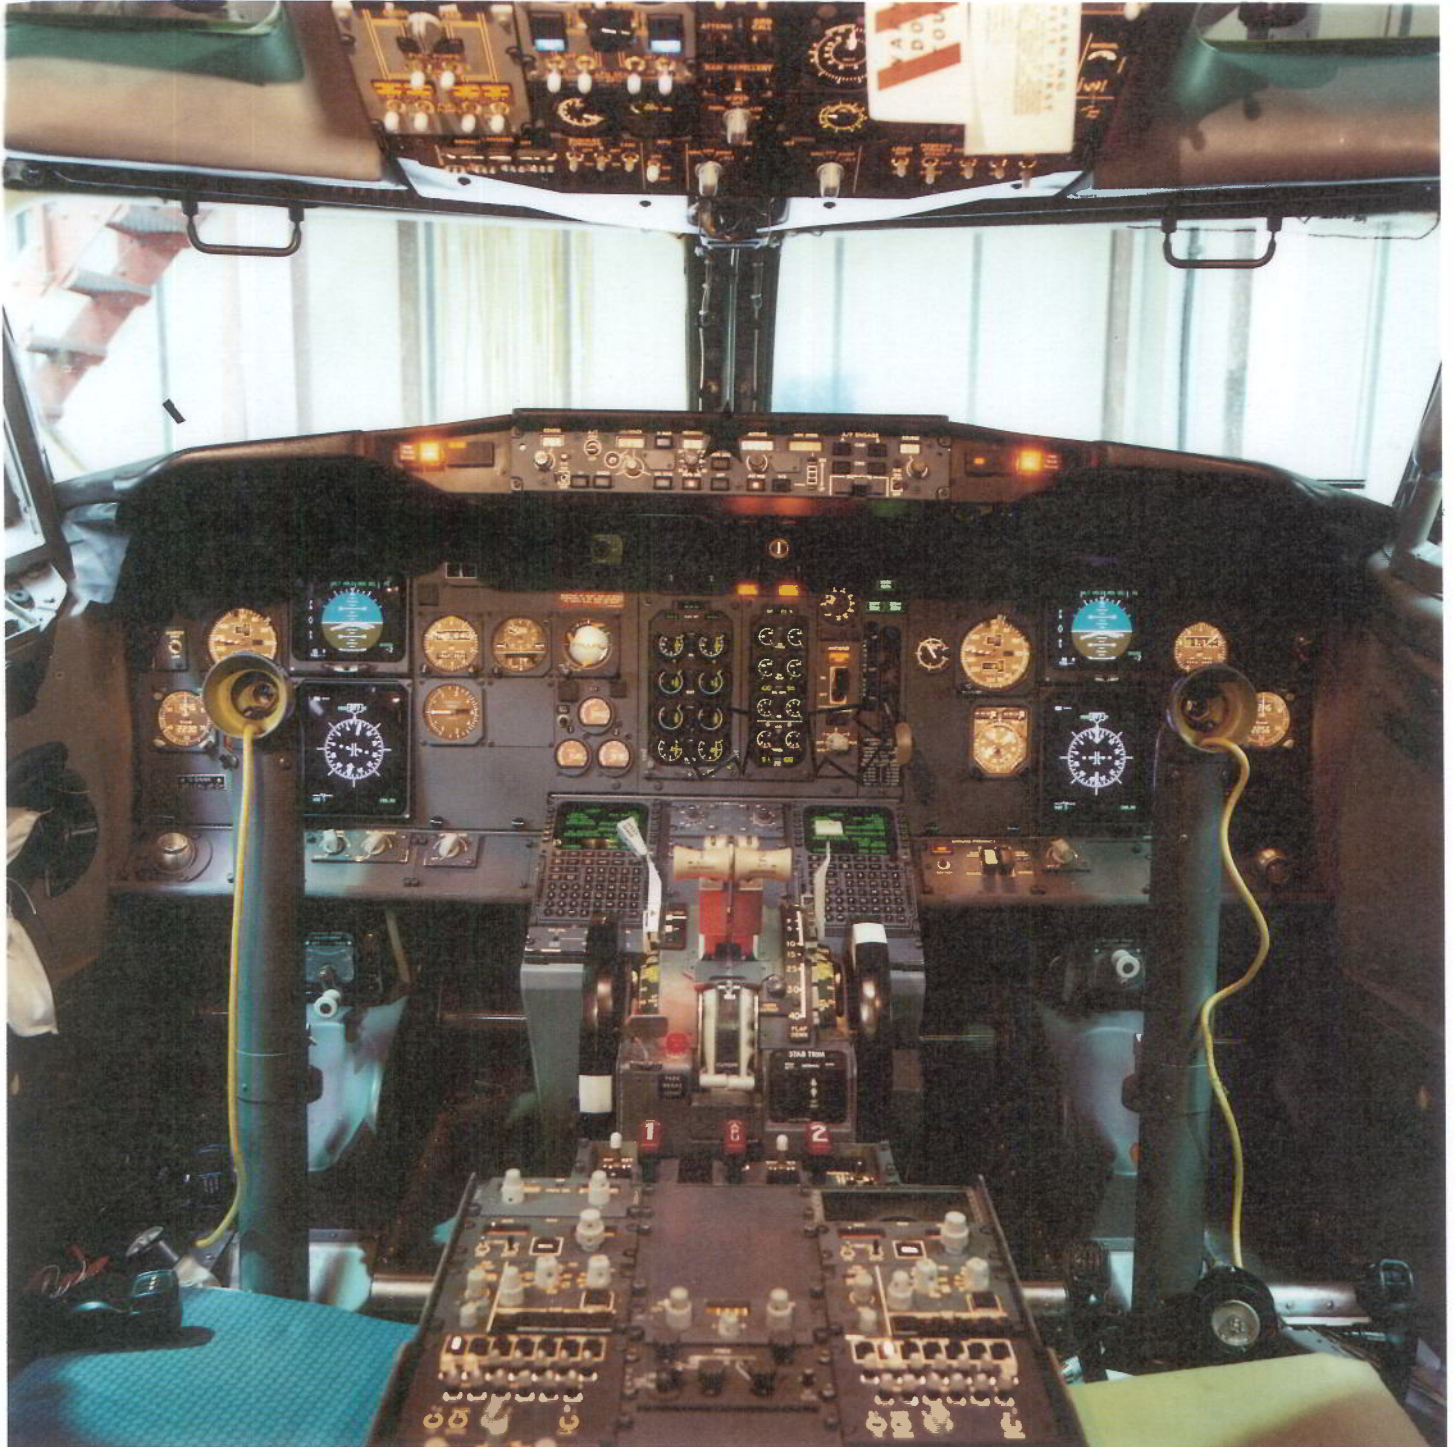
FIG. 2: SHOWING SOLID-STATE ELECTRONIC ENGINE INSTRUMENT SYSTEM (EIS),  
AS FITTED TO G-OBME, WITH VIBRATION INDICATORS ARROWED

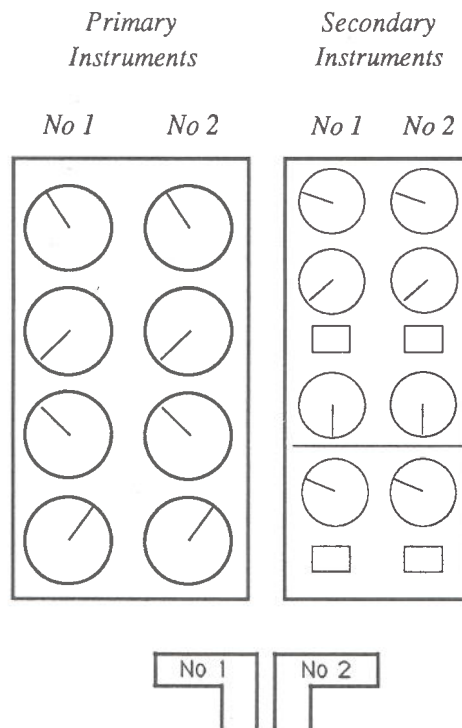
If the instruments are all to be located on the front panel, two possibilities are apparent. The first is to mount the secondary instruments to one side of the primary instruments as in Figure 2.

Figure 2 achieves the goal of keeping the instruments paired together, and thus maximises the chances of disparate readings being detected, but does so at the price of splitting up the instruments associated with a given engine, and of losing the advantage of having all instruments cognitively aligned with their corresponding throttle levers.

The layout of the EIS in the Boeing 737 Series 300/400 conforms to Figure 2, which has been widely used without apparent difficulty in many two-engined, two-pilot aircraft. The illumination of the display, however, might aggravate the problem of perceived misalignment of the instruments with their respective throttles. On the hybrid instruments (LED counters with electro-mechanical pointers) fitted to other aircraft of this type, the faces of the instruments needed to be lit from in front to show the pointers, dials and scale marks. Such lighting does not, of course, illuminate only the legends and pointers on the instruments but also the general structure and limits of the display, so that the instruments could be argued to be viewed within a structured visual frame. In the EIS display, all symbology is edge-lit and set against a heavily contrasting background which, in an aircraft at night will be, to all intents and purposes, black. This may have the effect of enhancing the extent to which the instruments are seen as a single display rather than as two separate displays, and may degrade the extent to which deviant readings in, say columns 1 and 3 of the matrix could readily be associated with the No 1 engine.

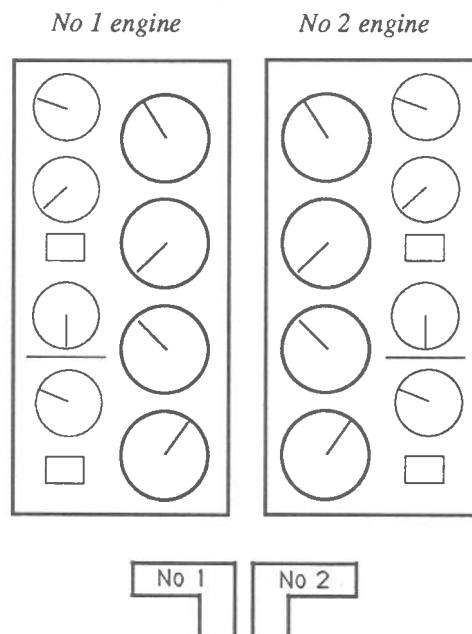
The second is to split the secondary instruments and mount them outboard of their respective primary instruments, as in Figure 3.

The advantage of the layout in Figure 3 is that the instruments for a given engine are all mounted together and are, if not spatially, at least cognitively, aligned with their associated power levers. This is achieved at the price of splitting the secondary instruments apart, with the associated possibility of disparate secondary readings going undetected.

Thus, Figure 3 could fairly be judged to maximise the probability that a given failure will be correctly identified by the crew as belonging to a given engine, at the possible cost of less efficient error detection on the secondary instruments, whereas Figure 2 may be judged as maximising the probability that disparate readings will be detected at the cost of degrading the probability that this detected failure will be associated by the crew with the correct engine.

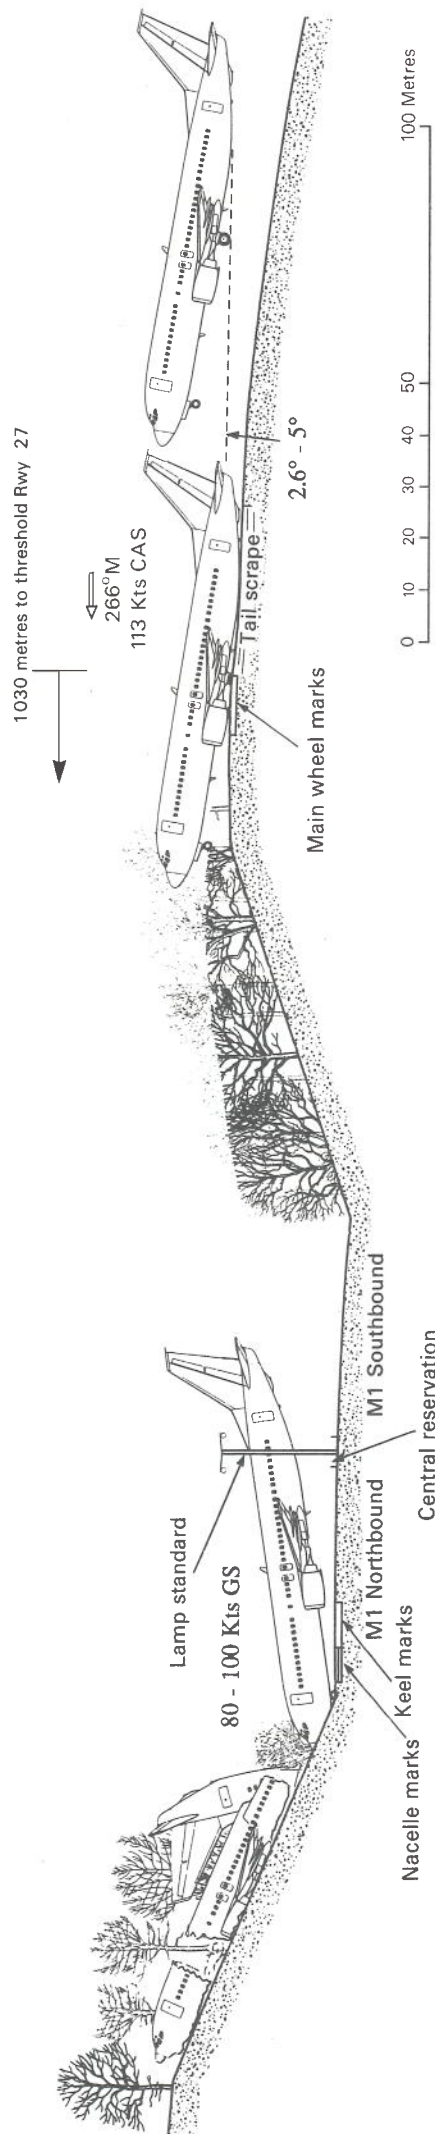
Appendix 3 figure 6 - Impact sequence

Examination of the fuselage showed that two major structural failures had occurred in the impact, one slightly forward of the wing leading-edge and one aft of the wing trailing-edge. These had respectively resulted in the fuselage nose section becoming detached from the centre section and the tail section buckling over, and to the right of, the centre section. The forward fuselage had therefore sustained a high degree of disruption in the passenger cabin, with floor structure, seats and furnishings becoming detached; similar damage had occurred around the aft fuselage failure. The floor structure and seating were much less disrupted in the centre (*ie* over-wing) section of the cabin and in the inverted tail section.

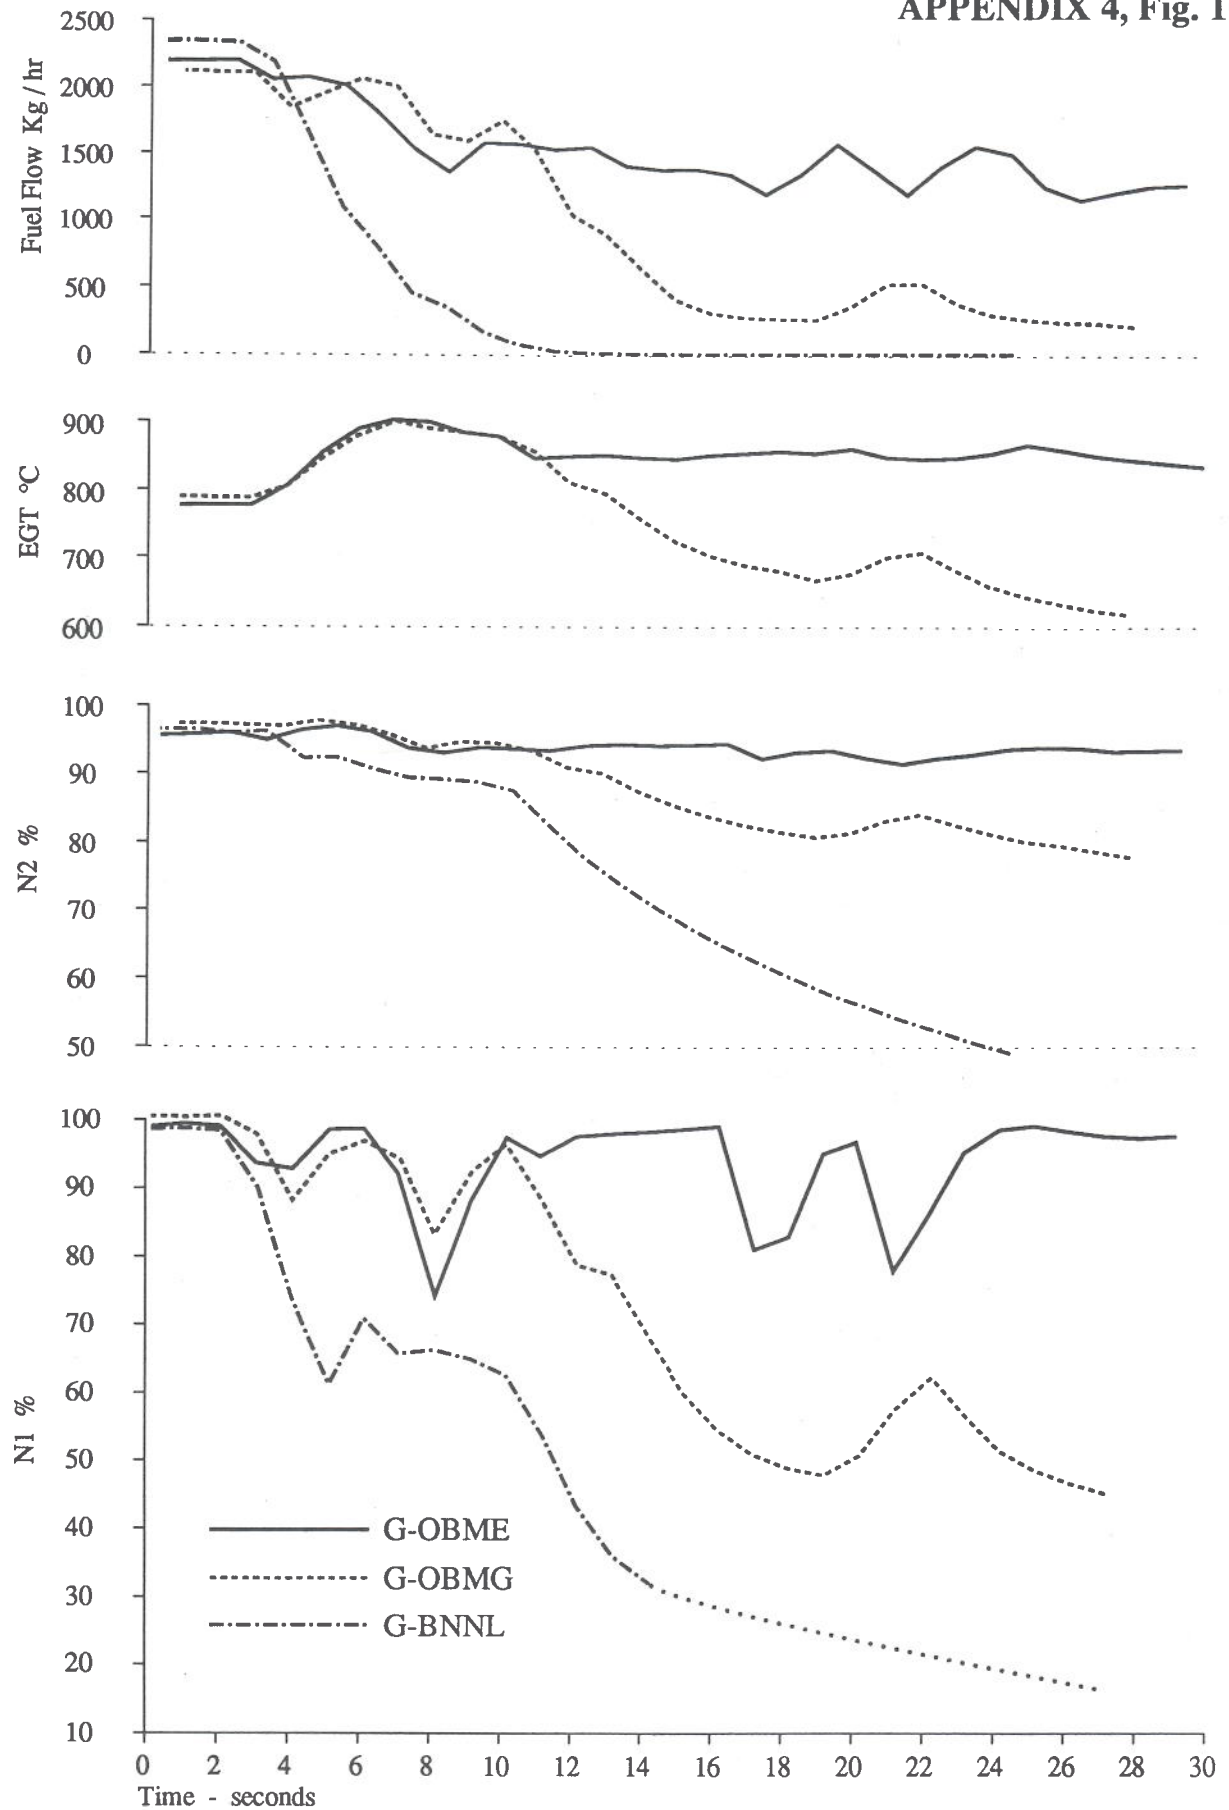
Comparison of engine parameter response following fan blade outer panel separation on three aircraft (G-OBME, G-OBMG, G-BNNL)

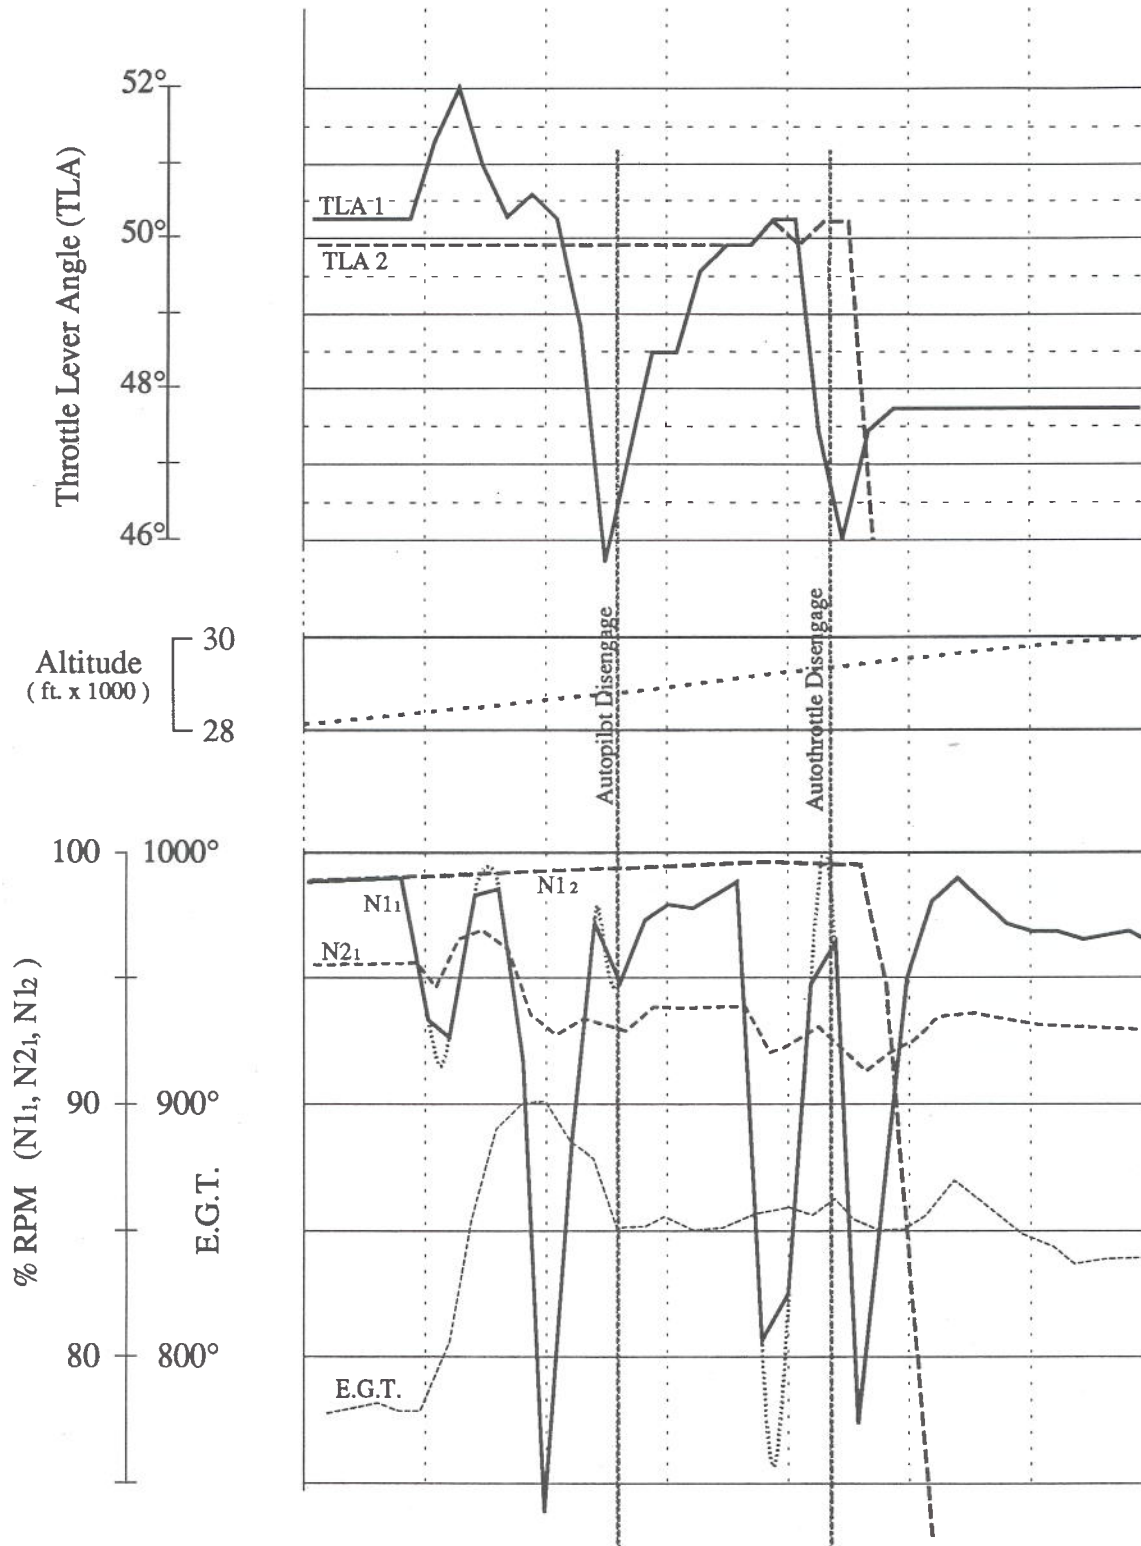
Variation of Throttle Lever Angle  
related to engine parameters and altitude during Event 1
