Loss of separation involving CASA C212-CC, VH-MQD, operating in the Richmond parachuting area and Boeing 737-7BX, VH-VBP

near Richmond Aerodrome, NSW | 5 November 2011

ATSB Transport Safety Report
Aviation Occurrence Investigation
AO-2011-142
Final – 16 December 2013

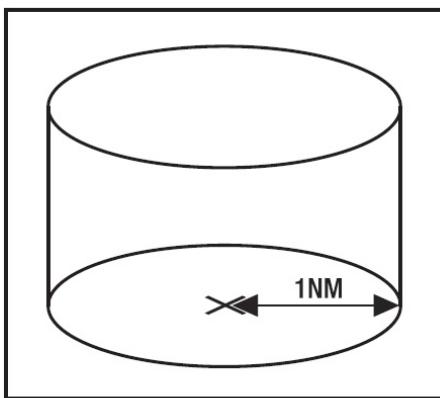
Figure 8: MATS separation requirement for parachute operations

MATS contained a graphical illustration of the separation area to be applied to parachuting operations (Figure 8).

According to the Civil Aviation Safety Authority, the 1 NM (1.85 km) radius around a declared parachute operations area had to be supplemented by an additional 1 NM buffer, as specified in MATS 10-60-420 for operations without a specifically defined separation standard (see also Figure 9 in the *Safety analysis – Loss of separation* section of this report). However, Airservices reported that it did not consider the buffer was a requirement.
