ATSB TRANSPORT SAFETY REPORT
Aviation Occurrence Investigation AO-2008-033
Final

**Operational non-compliance
Perth Airport, WA
9 May 2008
PK-GEF
Boeing Company 737-8CX**

Report No.	Publication date	No. of pages	ISBN
AO-2008-033	30 June 2009	33	978-1-921602-82-5

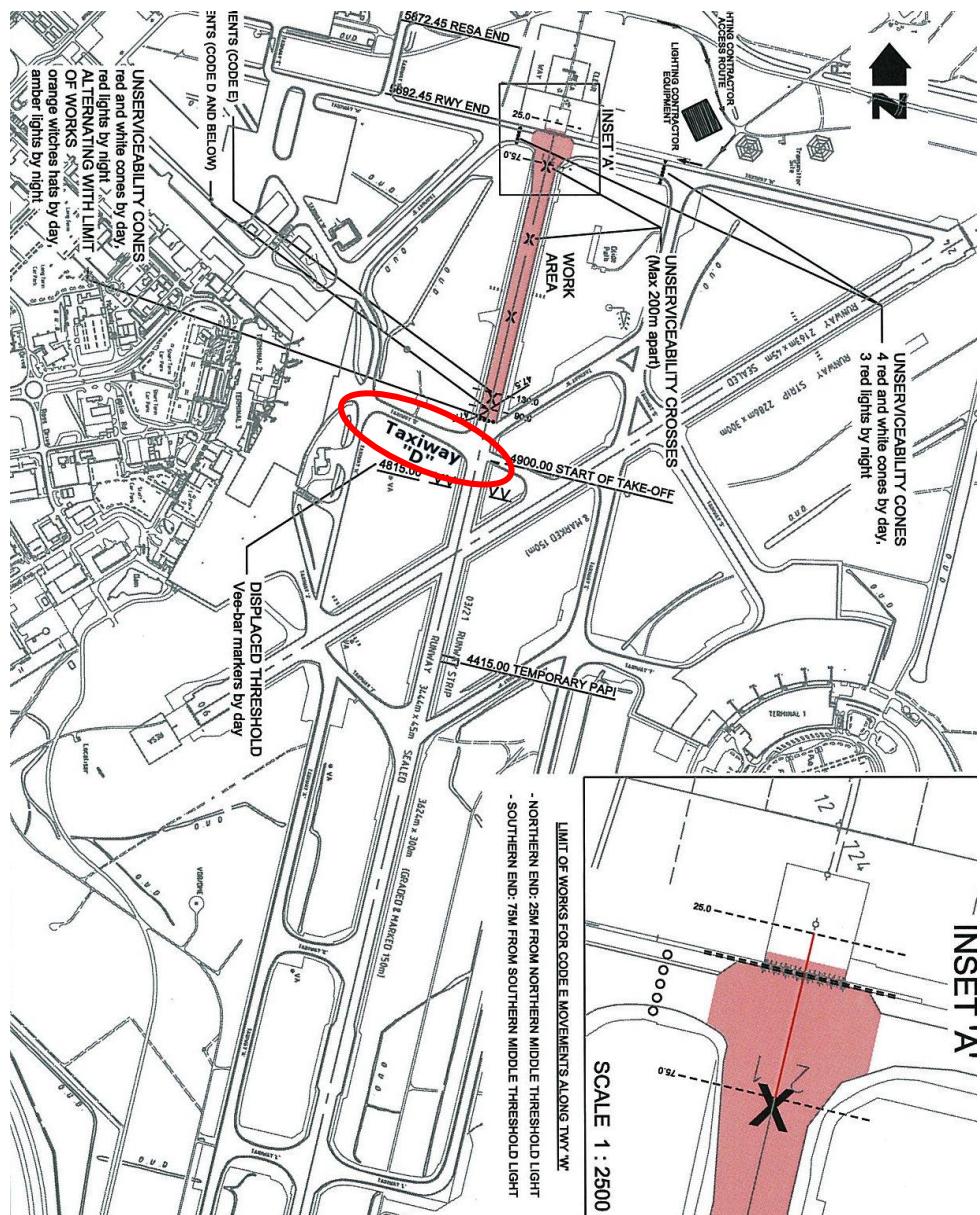
Figure 2: Part of the MOWP showing the stage 2 runway works area

plan view of the works (Figure 2) and a number of draft NOTAMs for promulgation at the appropriate stage of the works. There was no indication in the MWOP or draft NOTAMs of the consideration of the effect of those works on the final approach profile to the displaced threshold from the MDA of the runway 21 LLZ approach.

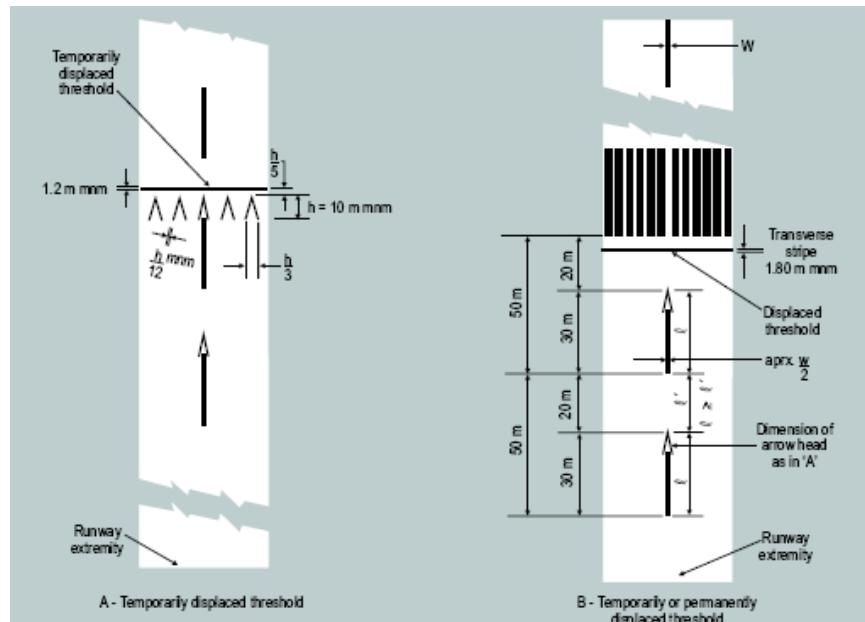
Figure 3: ICAO-recommended displaced threshold markings

5.2.4.10 When a runway threshold is temporarily displaced from the normal position it shall be marked as shown in figure 2 (A) or 2 (B) and all markings prior to the displaced threshold shall be obscured except the runway centre line marking, which shall be converted to arrows [Figure 3 below].

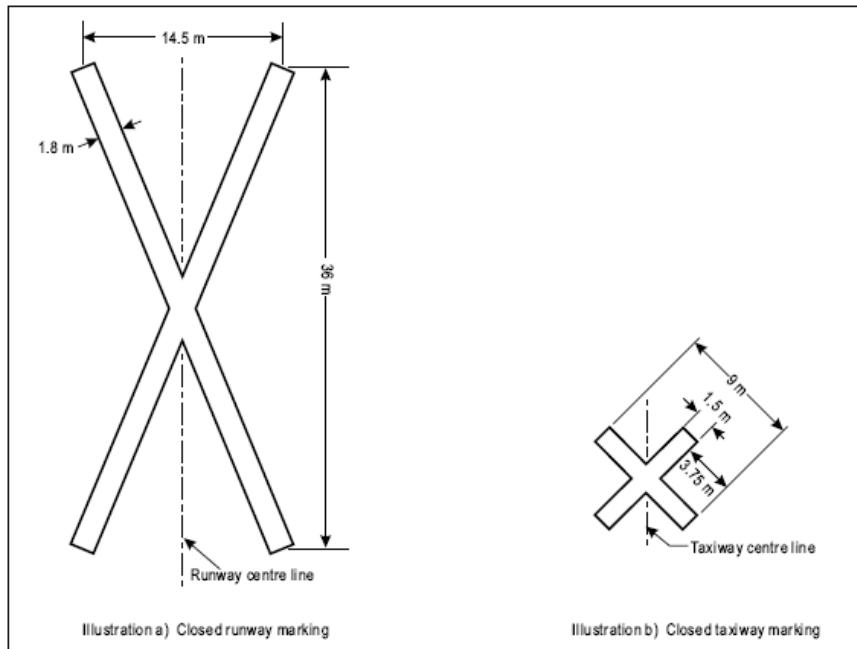
Figure 4: ICAO-recommended closed runway or taxiway markings

7.1.4 The closed marking shall be of the form and proportions as described in Figure 3, illustration a), when displayed on a runway, and shall be of the form and proportions as detailed in Figure 3, illustration b), when displayed on a taxiway. The marking shall be white when displayed on a runway and shall be yellow when displayed on a taxiway [Figure 4 below].

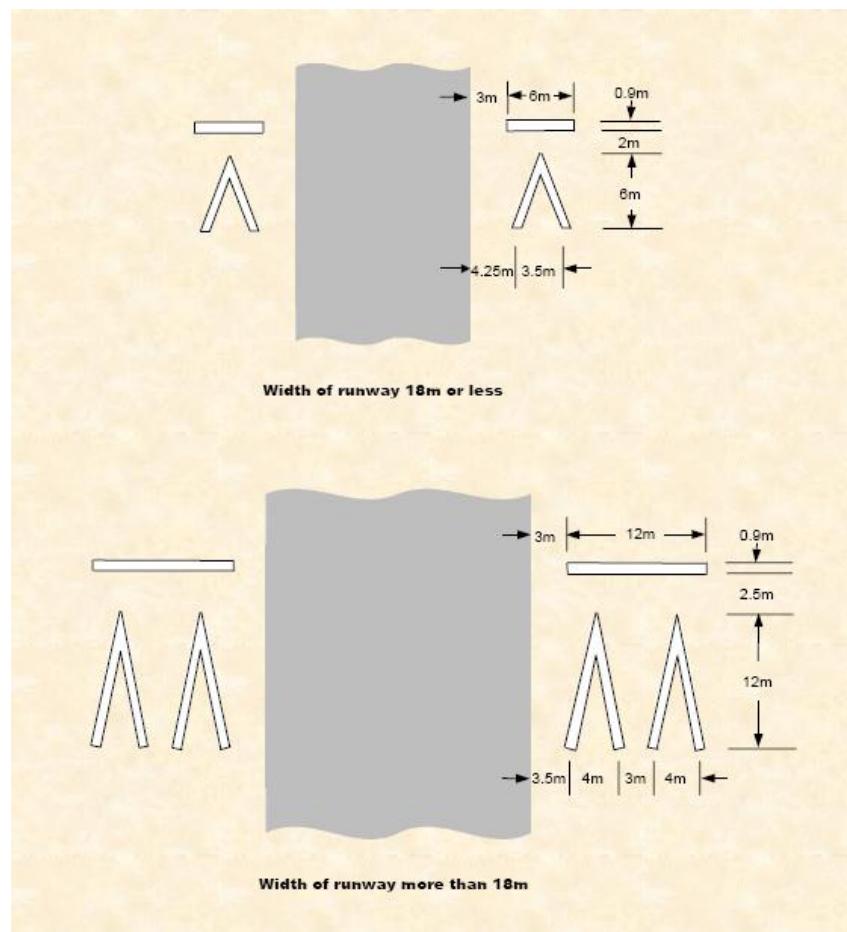
Figure 5: Australian temporarily displaced threshold markings (less than 5 days)

8.3.9.8 When a threshold at an air traffic controlled aerodrome is to be temporarily displaced for 5 days or less, and the displacement is more than 450 m, the new threshold location is to be indicated by the above markings [Figure 5 below] but the permanent threshold markings may be retained.

The Australian requirements for marking runway thresholds that were displaced for 30 days or less differed from those recommended by the International Civil Aviation Organization (ICAO). When compared with the likely visibility of the ICAO-recommended 36 m closed runway markings, the Australian 6 m markings, as used in this case, increased the difficulty for the crews in locating the precise location of the displaced threshold. As a result, there was an increased risk of a flight crew conducting a visual approach to the permanent threshold/touch-down area. The use of the larger-sized crosses, as specified in *ICAO Annex 14 Aerodromes*, would have been visible to the flight crew much earlier during their approach, allowing additional time for the identification of the closed runway area and displaced threshold. That would have allowed an early adjustment to their approach path, ensuring a stabilised approach and landing.

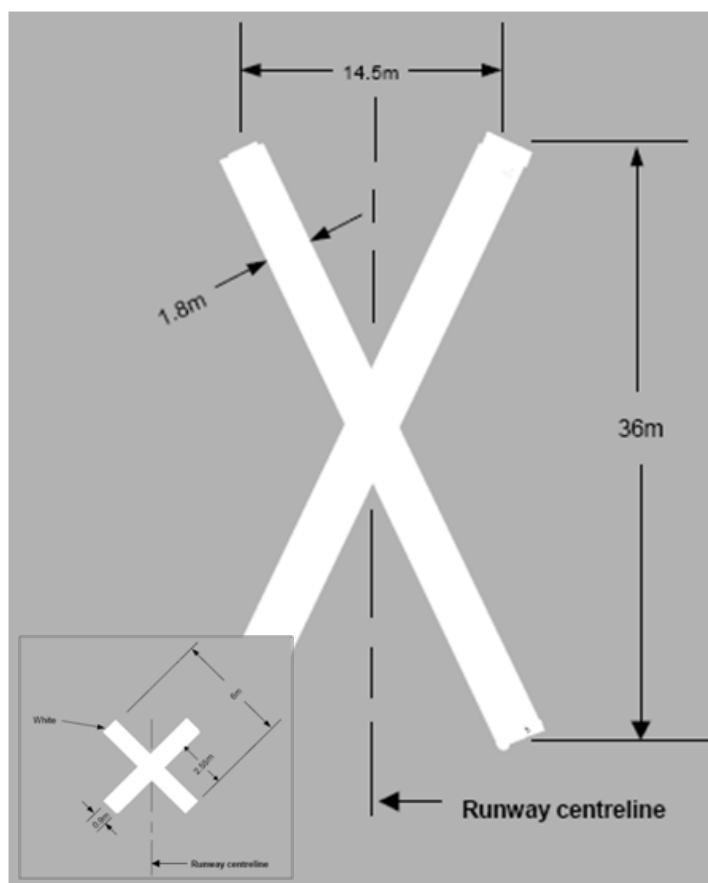
Figure 6: Unserviceability markings - large (smaller-sized marking included in the inset for comparison)

8.9.2.5 The larger markings must be used on Code 4 runways [Perth runway 21 was classified as a code 4 runway] when the whole or part of the runway is permanently closed to aircraft operations, for more than 30 days [Figure 6 below]. Markings must be displayed at each end of the unserviceable runway, and also in the intermediate area, at intervals of not more than 300m.

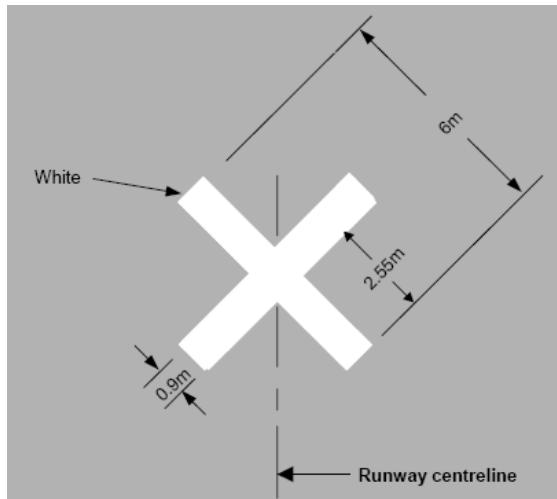
Figure 7: Unserviceability markings (small)

8.9.2.7 In other cases of runway unserviceability, if markings in accordance with the larger configuration are not used, then the smaller markings [Figure 7, see next page] must be used. The smaller markings must be displayed at each end of the unserviceability and in the intermediate area at intervals of not more than 200m.
