**AIRCRAFT ACCIDENT INVESTIGATION BUREAU**

**INVESTIGATION REPORT ON**

**ACCIDENT TO THE B737-MAX8 REG. ET-AVJ OPERATED  
BY  
ETHIOPIAN AIRLINES**

Report No. AI-01/19  
Pub, Date December 23, 2022

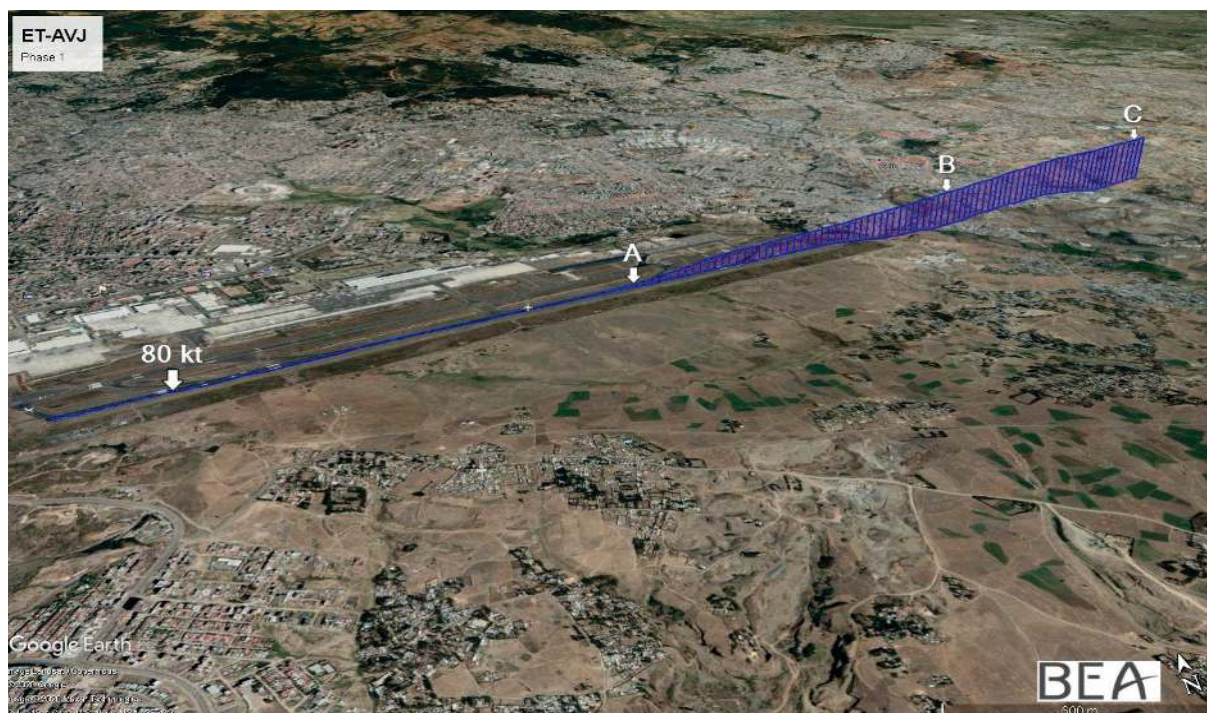
FIGURE 1: PHASE1 FROM TAKEOFF TO AUTOPILOT ENGAGEMENT

At 05:38:44, shortly after liftoff, the left and right recorded AOA values began deviating. Left AOA decreased to  $11.1^\circ$  then increased to  $35.7^\circ$  while value of right AOA indicated  $14.94^\circ$  (**point “A” in Figure 1**). Then after, the left AOA value reached  $74.5^\circ$  in  $\frac{3}{4}$  seconds while the right AOA reached a Maximum value of  $15.3^\circ$ , the difference between the left and the right AOA values decreased from  $59^\circ$  to approximately  $49^\circ$  near the end of the recording, prior to the final dynamic behavior that was exhibited.

During the first phase of flight, the Airplane was kept in trim through the use of the crew-initiated main electric trim commands, there was limited force required on the control column.

Before CMD A engaged, the stabilizer trim position was around 5.6 units, with elevator positions around 4° (consistent with the elevator neutral position for the stabilized flight condition).

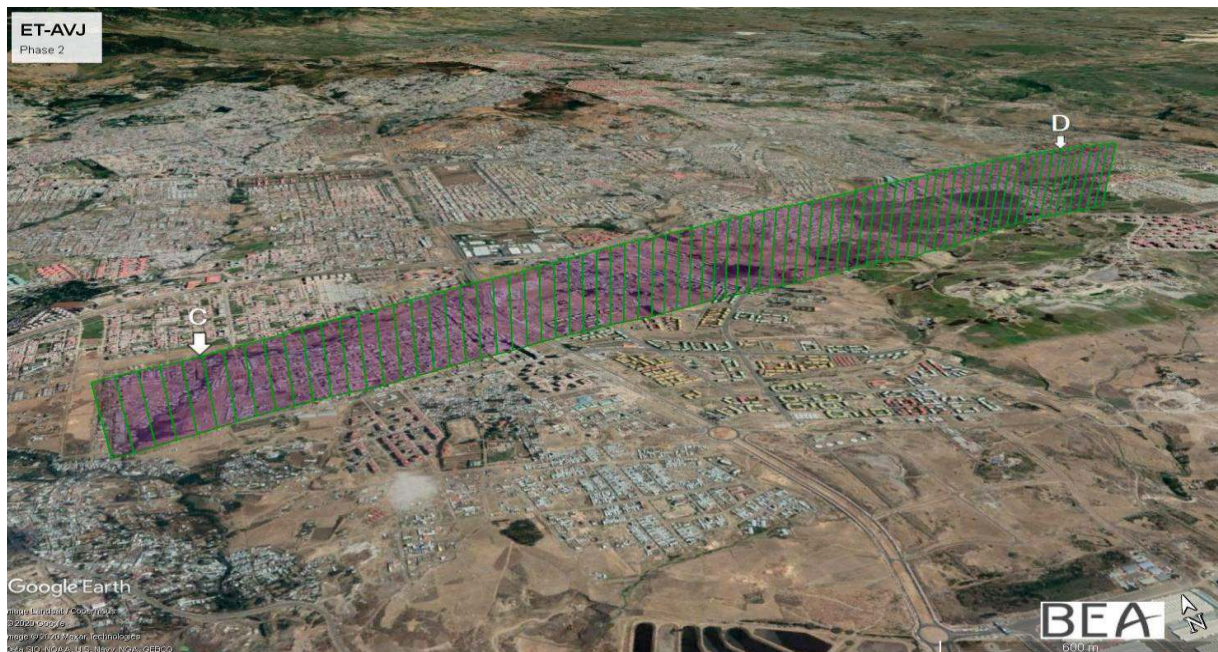
FIGURE 2: PHASE 2 DURING AUTOPILOT CONTROL

At 05:39:56, the A/P disconnected automatically (**point D**) after remaining engaged for 32 seconds as the following logic conditions were reached:

The engagement of the LVL CHG mode and the new associated target speed most probably led to several transient AP mode computations leading to the decrease in vertical speed to stop at around 450 ft/min and the pitch values to stabilize at around 4°. After that, the erroneous excessive minimum speed related to the erroneous AOA triggered again an AP pitch down command to increase the speed. After reaching a Maximum altitude of around 9,100 ft (RH baro corrected altitude) during this phase, the Airplane started descending, triggering the autopilot to disconnect.

At the end of this phase, the pitch angle was around 1°, the stabilizer was at 4.6 units and the vertical speed was around -1,400 ft/min. Flaps were still moving up.

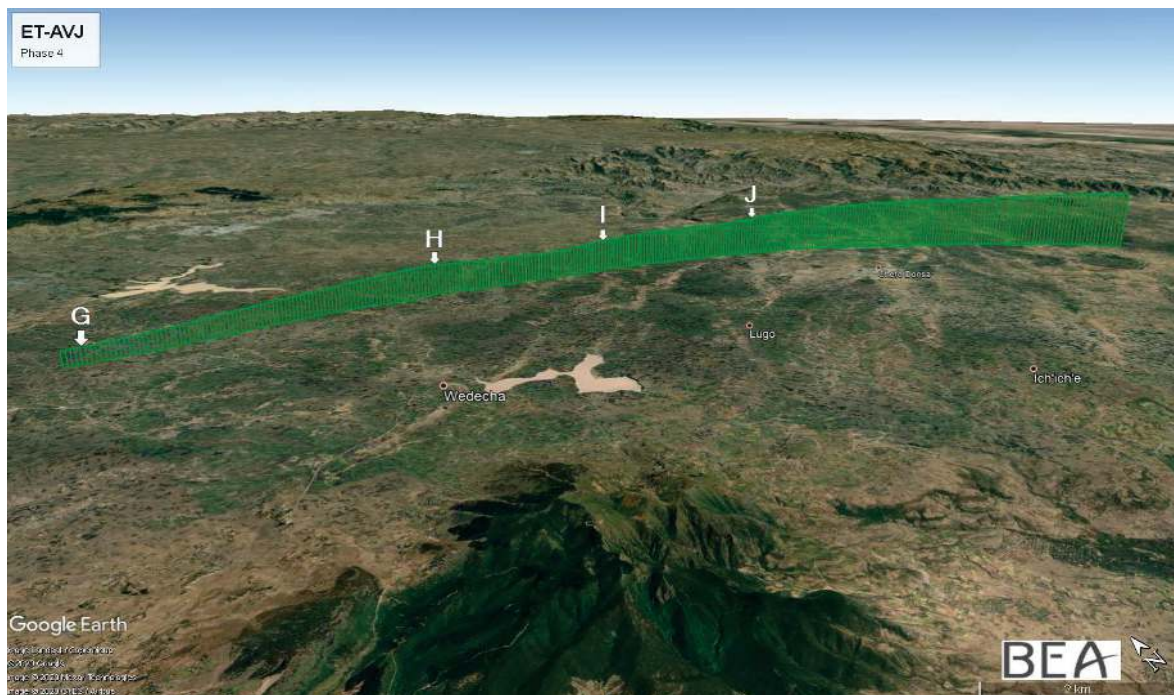
FIGURE 4: PHASE 4 FLIGHT WHILE THE STAB TRIM CUTOUT SWITCHES WERE IN THE CUTOUT POSITION

At 05:41:47, the Captain asked the F/O if the trim was functional. The First-Officer replied that the trim was not working and asked if he could try it manually. The Captain told him to try **(Point I Figure 4)**.

- The Airplane was at an altitude of 6,200 ft above the airfield elevation (computed from the RH pressure altitude). LH altitude values were 1,250 ft lower.
- Computed airspeed was around 367Kt (RH value), LH erroneous value was 344 Kt.
- The pitch angle of the Airplane was lower than 1°
- The vertical speed was around + 125 ft/min and decreasing
- The bank angle was around 21° right, with a slight trend to increase.

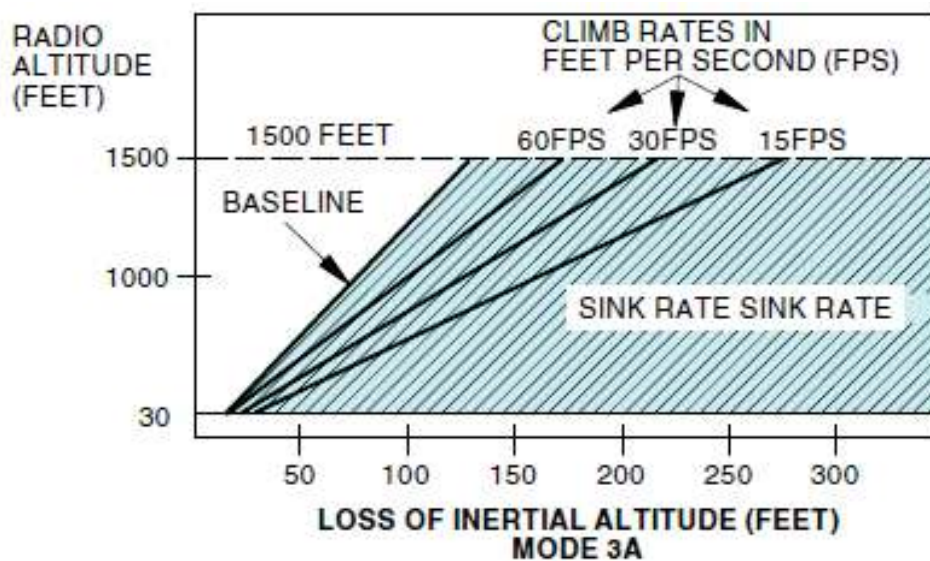
FIGURE26: ALERT ENVELOPE FOR THE MODE 3A (FROM AMM §34-49-00)

The mean vertical speed of the Airplane before the Maximum value was around 12 ft/s. An alert triggering around 1,271 ft – after 229 ft of altitude loss was consistent with the GPWS Mode 3A alert envelop shown in Figure 26.

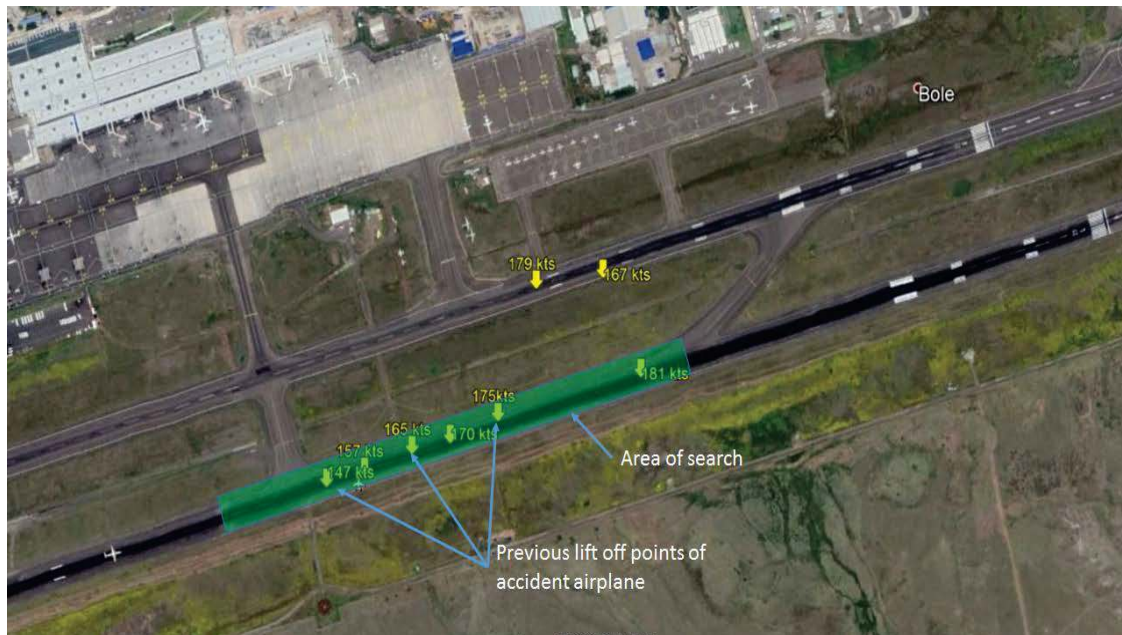
PICTURE: 29 AREA OF SEARCH FOR AOA VANE & BIRD REMAIN

The EAIB investigation, Airworthiness group chairman and team members obtained permission to walk the runway and its sides to check for airplane debris and any evidence of a bird-strike or tail strike. The Investigators walked the area of runway 07R (12,400 feet in length) highlighted in green in the picture 29 below. The length and width of the runway inspected was approximately 3,000 feet and 150ft to the left and

right of the centerline. The team started the search in the vicinity of taxiway C and extended toward taxiway D as well as back towards taxiway B. Those participating in the walk searched along in the grass and the runway side where small broken rocks were. The team walked two rounds along the same area but there were no bird remains and AOA vane wreckage. The investigation team confirmed that there was no evidence of a bird and AOA vane remains in the highlighted search area. The team also noted no evidence of damage to the runway surface in this area consistent with a tail strike. FDR data shows that Left AOA deviations began when the airplane was located over taxiway D.

The analysis part of Collins laboratory simulation test for the AOA vane was presented to the EAIB. Even though bird strikes maybe one of the causes, a wide range of power quality problems and error sources that can affect an airplane's electrical and electronic systems resulting in unstable and erroneous AOA Sensor output signals were not analysed.

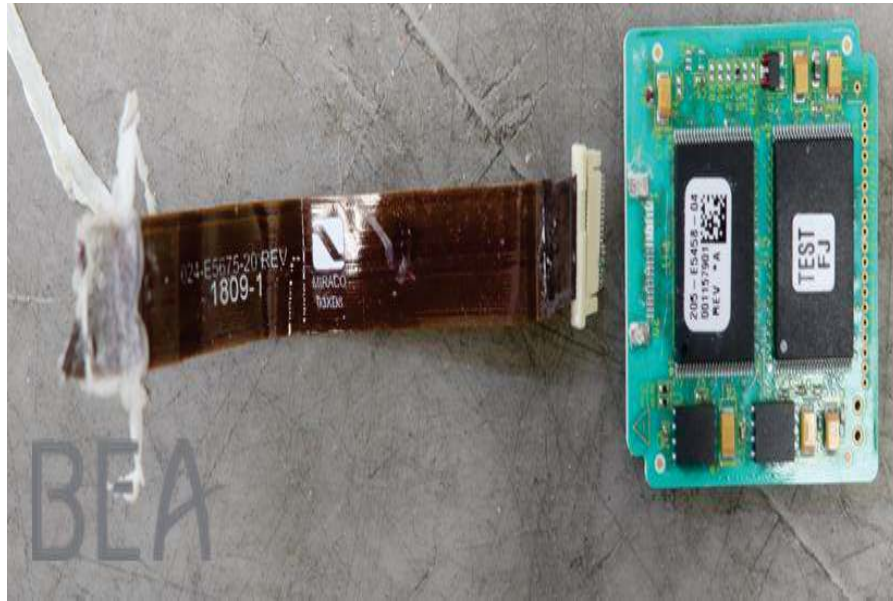
FIGURE 34: FDR MEMORY BOARD, FLEX AND CONNECTOR

The memory board was visually inspected with a Keyence microscope. Apart from the connector pads, the memory board was in good condition. There was no trace of impact. The two memory chips as well as the micro-processor were found in good condition.

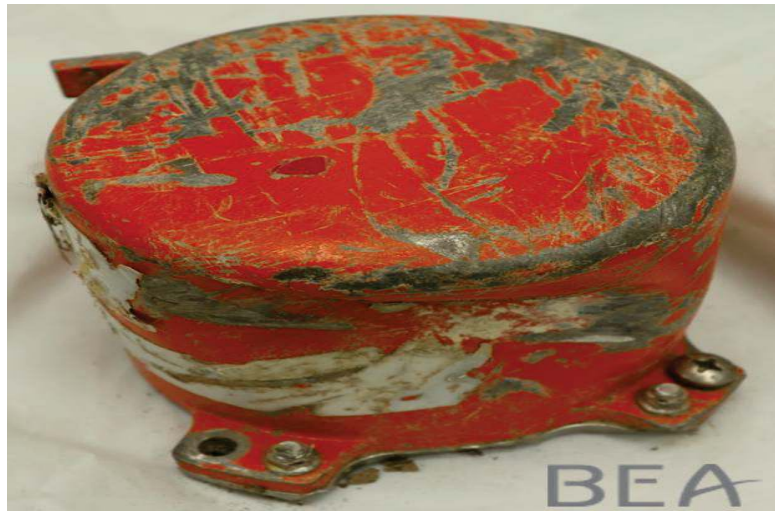
FIGURE 38: CVR CSMU

On 11 March 2019, the CVR was recovered from the accident site by the EAIB. The CVR CSMU was transported to the BEA recorder facility for data downloading. The CSMU was found separated from the chassis during wreckage recovery. The read-out was performed by BEA under the authority of the Ethiopian Accident Investigation Bureau (EAIB), with the observation of the National Transportation Safety Board (NTSB) of United States of America.

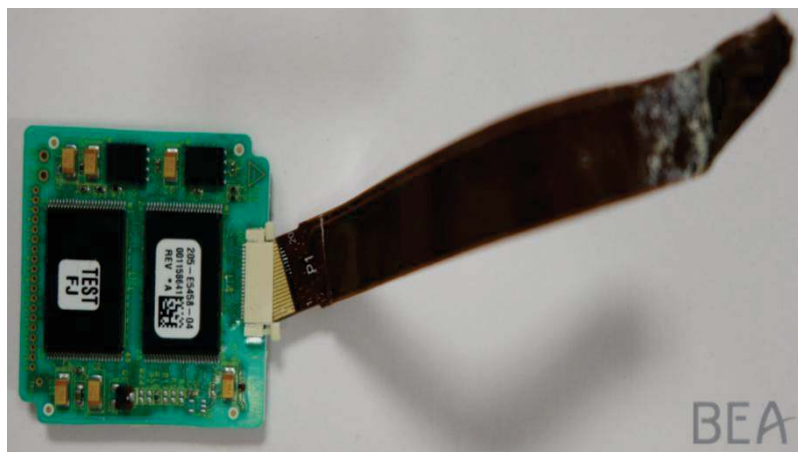
FIGURE 39: CVR MEMORY BOARD AND FLEX

The CVR memory board and flex were visually inspected with the Keyence microscope. There was no damage on the board and the connector was in good condition.

A second observation with the X-ray was made, which confirmed that the connector soldering were in good condition.

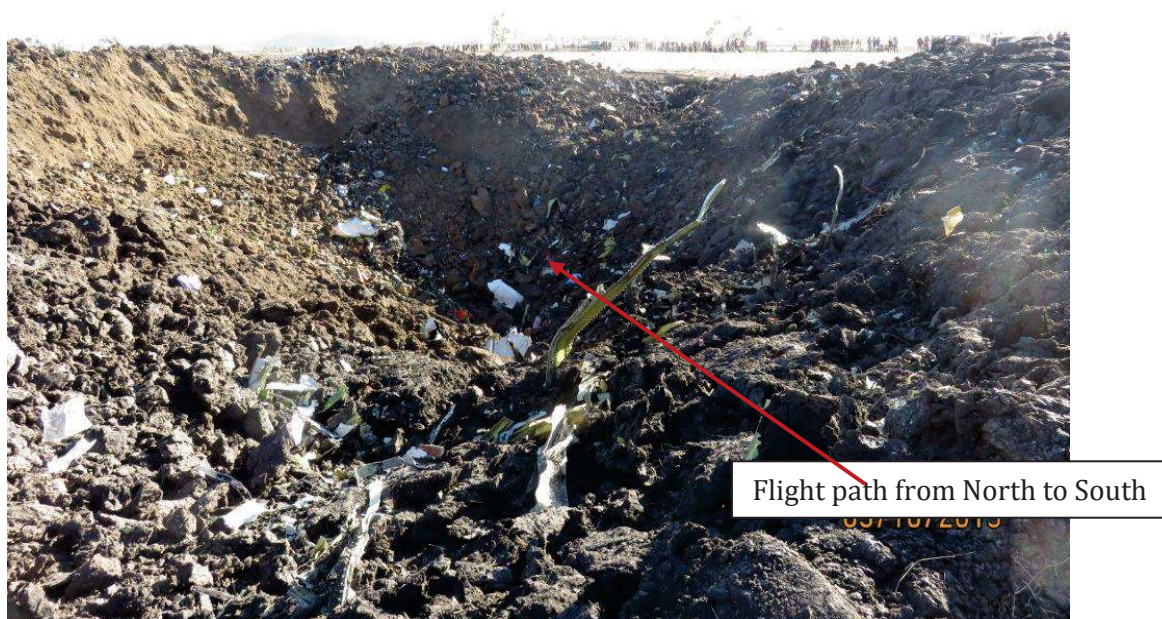
FIGURE 41: CLOSE VIEW OF THE CRATER BEFORE EXCAVATION

The Airplane impacted terrain at a farm field and created a crater approximately 10 meters deep (last Airplane part found) with a hole of about 28 meters width and 40 meters length. Most of the wreckage was found buried in the ground; small fragments of the Airplane were found scattered around the site in an area about 200 meters wide and 300 meters long. Damages to the Airplane were consistent with a high energy impact.

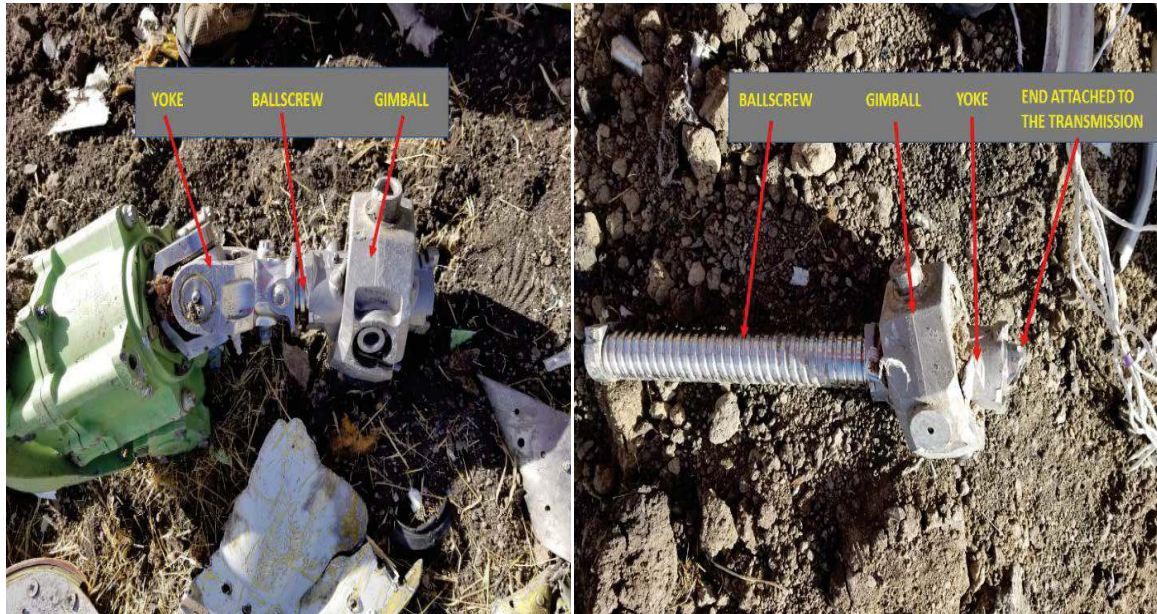
FIGURE54: FLAP TRANSMISSION & BALLSCREW FIGURE55: FLAP TRANSMISSION

The installed location of each unit has not been identified. The position of each gimbal is consistent with the flaps in the fully retracted position.

Again, all three were found in the fully retracted position. There was one additional transmission portion that was found as well as three ball screw segments. All examined damage appears consistent with high energy impact.

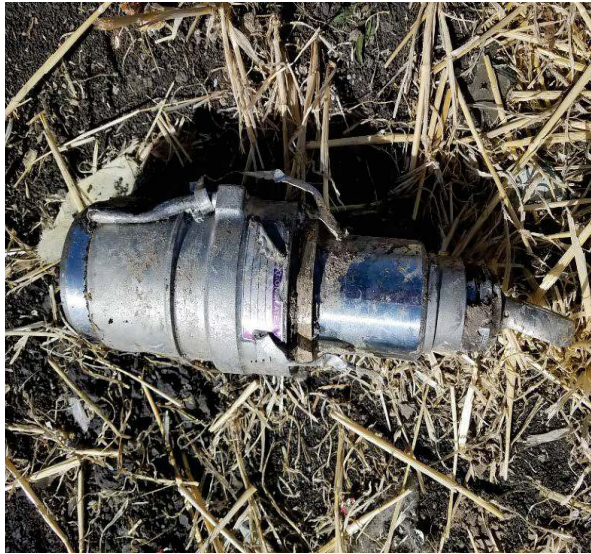
FIGURE 57: SLAT ACTUATOR (POSITION UNKNOWN)

Three of the 8 leading edge slat actuators were photographed (see Figures below) at the impact site. The installed location for each actuator has not been identified. The actuator position, as photographed, is in the fully retracted position.

During the examination of the wreckage pile located at the Addis Ababa airport EAIB store the Airworthiness group identified a total of three leading edge slat actuators at the impact site. The actuator position, as photographed, was in the fully retracted position.

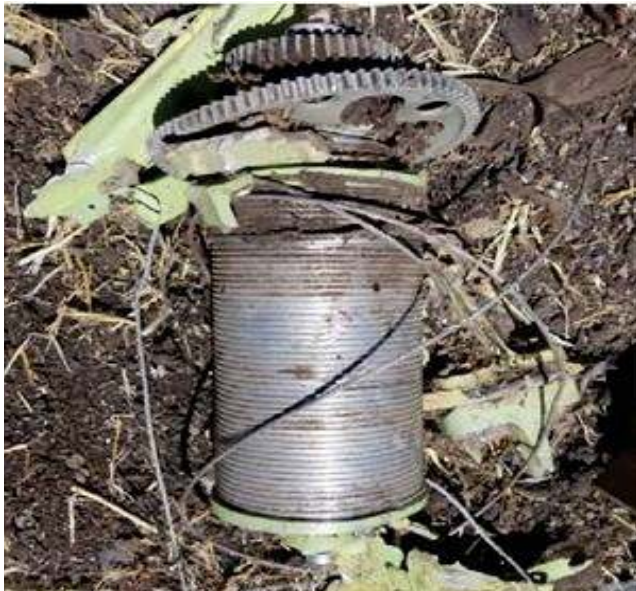
FIGURE59: AFTCABLE DRUM

Two parts of the control system were located and examined at the impact site. One consists of aft cable drum; the other consists of the stab trim actuator (see Figures 59 & 60 below respectively). These

components do not provide any evidence of what position the horizontal stabilizer may have been at the time of impact.

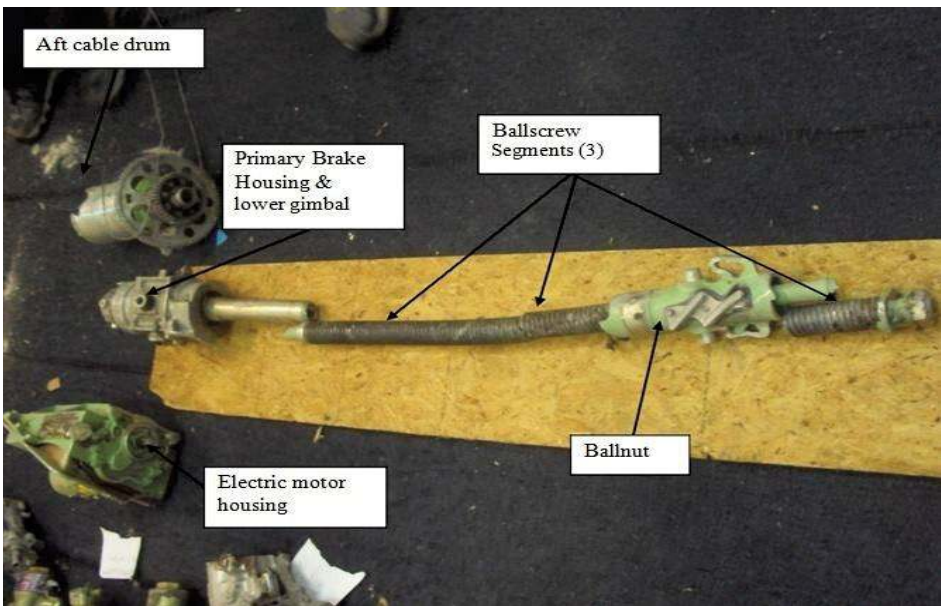
FIGURE 61: RECOVERED STABILIZER TRIM COMPONENTS

Most of the located components of the stabilizer trim system were located once the wreckage was transported to Bole International Airport. The only part of the stab trim system located on site was the motor housing (see above). Referencing **figure-54** above, the parts located in the wreckage pile at the airport consisted of the Primary Brake Housing (has the Lower Gimbal on it), the entire jackscrew (fractured into three pieces), and the ballnut (jammed onto the screw). Damage to the components of the stabilizer trim system is consistent with a high energy impact.

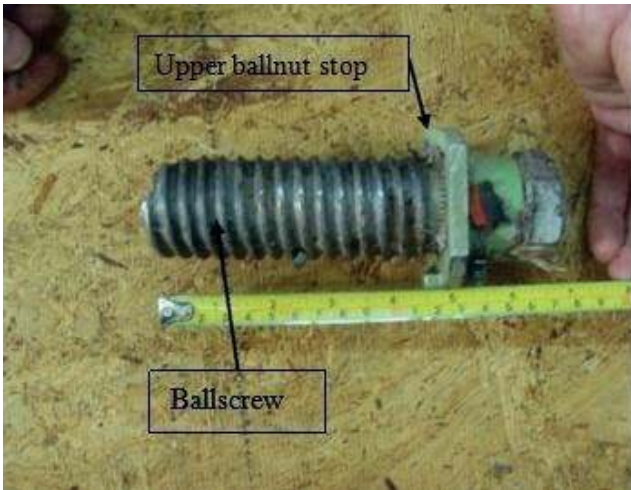
FIGURE62: UPPER BALLSCREW SEGMENT

Examining the fracture surfaces, the upper screw segment fits with the fracture face just inside the ballnut giving a measurement between the stops on the ballnut and the upper ballnut stop of ~5". Referencing Boeing document D251A122 (737NG Control Position Data), this measurement equates to a stabilizer trim setting of 1.5 degrees Airplane Nose Down (AND) or an indicated position of 2.5 units of trim. Although the data is for the 737NG, the position of the MAX stab trim holds the same relationship. According to Boeing:

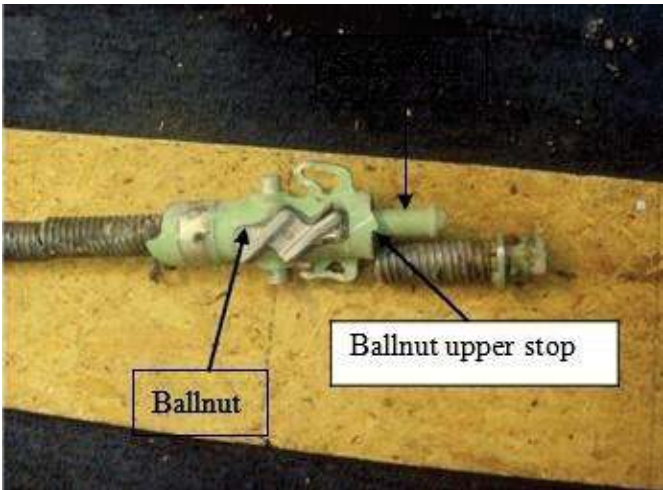
FIGURE 63: BALLNUT AND UPPER BALLSCREW SEGMENT

The figure below shows the relationship of the ballnut position along the ball screw. There is a safety rod which acts as a secondary load path should the ball screw fracture in service for any reason. It is attached to a separate set of secondary gimbals below the primary support gimbals on the primary brake housing and to the top of the ball screw. Figure 54 shows the safety rod and that it protrudes out from the ball nut. However, the fracture faces on the 5" long upper screw portion (*note the measurement in Figure 53*) match those found near the ballnut upper stop. This is consistent with the safety rod being pulled out several inches prior to final fracture.

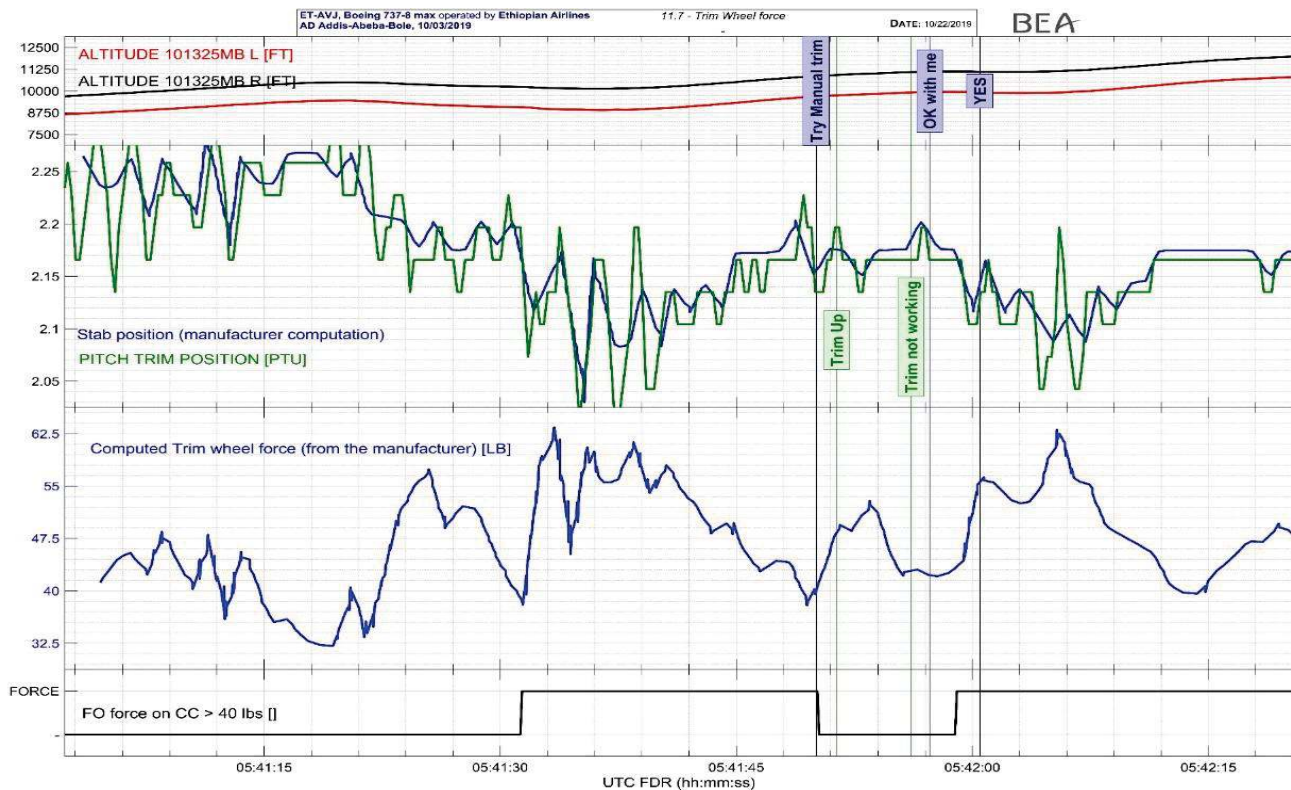
FIGURE 77: FORCE NEEDED TO MOVE THE TRIM WHEEL

By the time the FO tried to move the trim wheel manually a force between 42 lbs and 53 lbs was required according to the Airplane manufacturer computation, (see Figure 77).

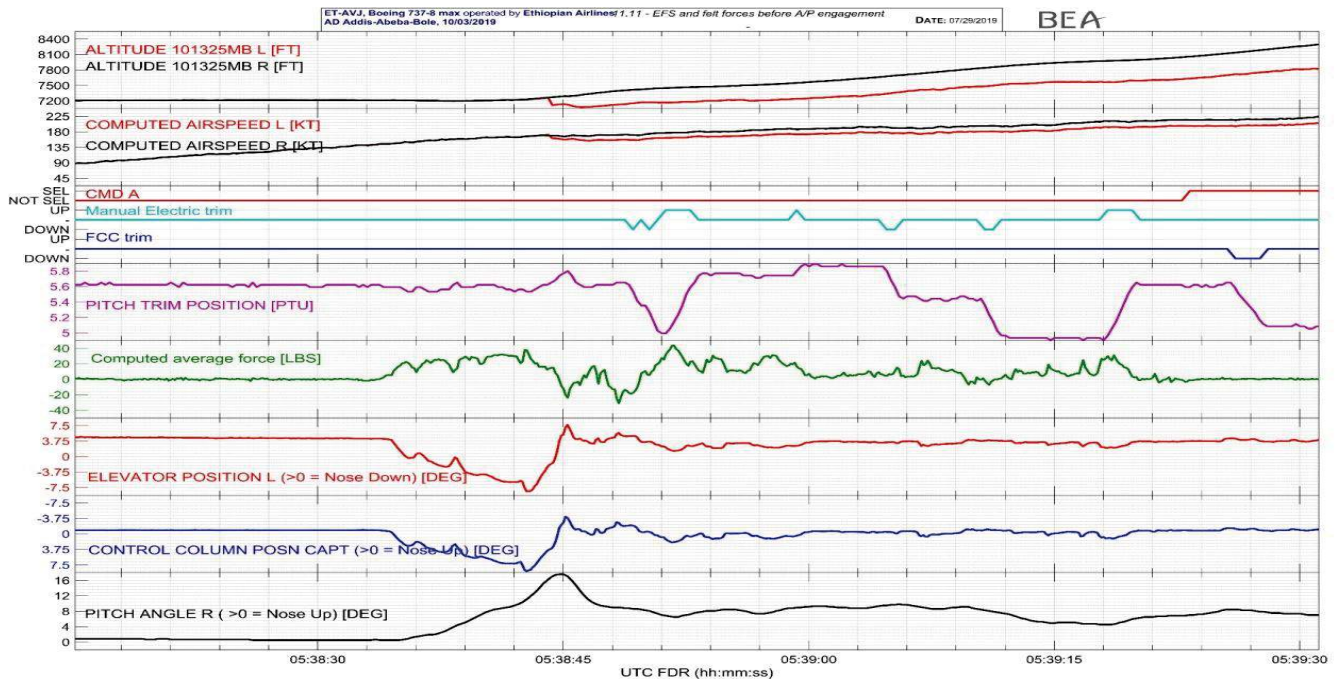
**FIGURE 78: FORCE BEFORE A/P ENGAGEMENT**

Before the A/P engagement, the recorded low force level underlined an Airplane rather properly trimmed in pitch. At that time, the stabilizer position was 5.62 units (nose up setting) and the elevators position was of 3.5° (nose down setting).

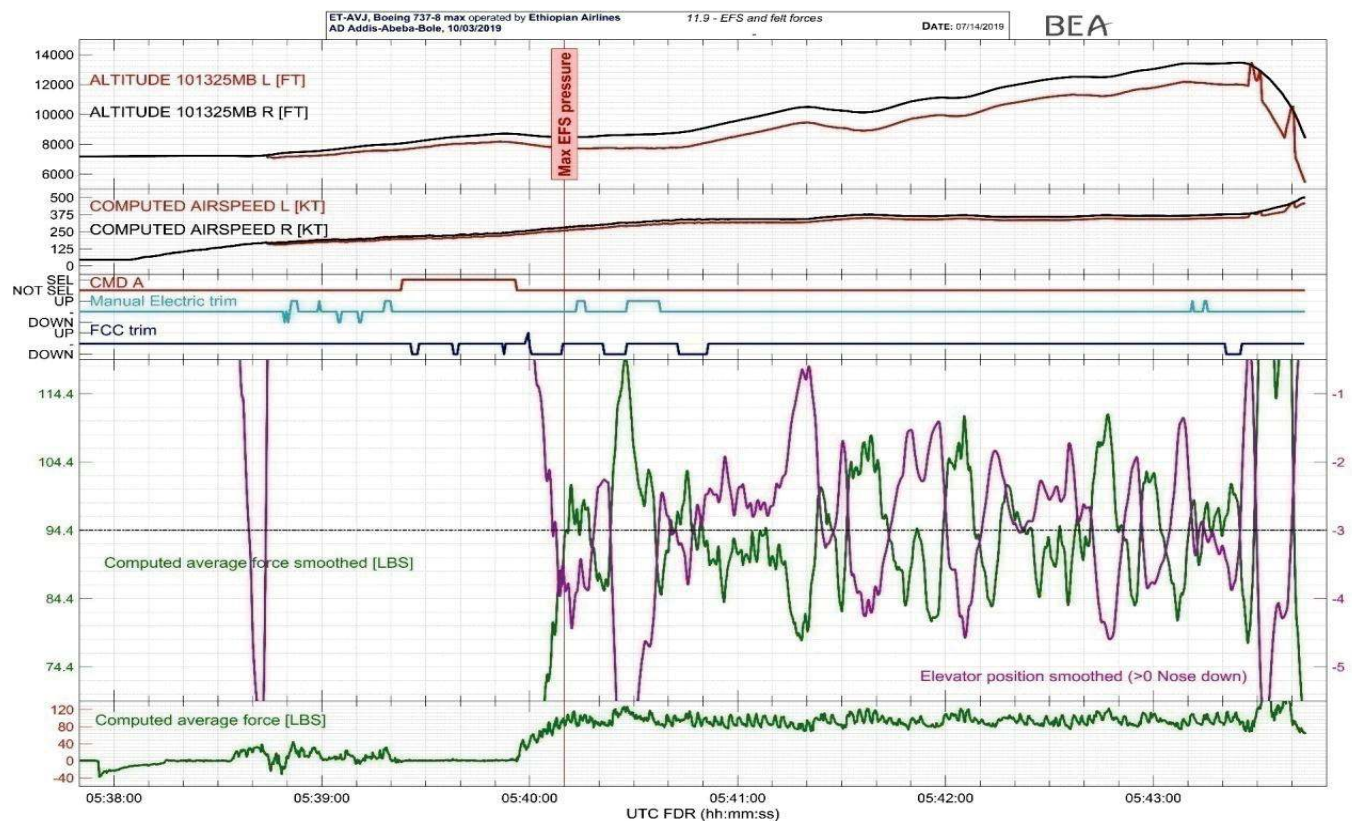
FIGURE 79: FELT FORCE AND ELEVATOR POSITION

The gradient of force felt by the crew can be illustrated by the comparison between the force applied on the control column and the position of the elevator. Note that because the flight conditions resulted in the Maximum feel pressure, the activation of EFS had no effect on these forces.

Figure 79 shows that from 5 h 40 min 10 s until the end of the flight:

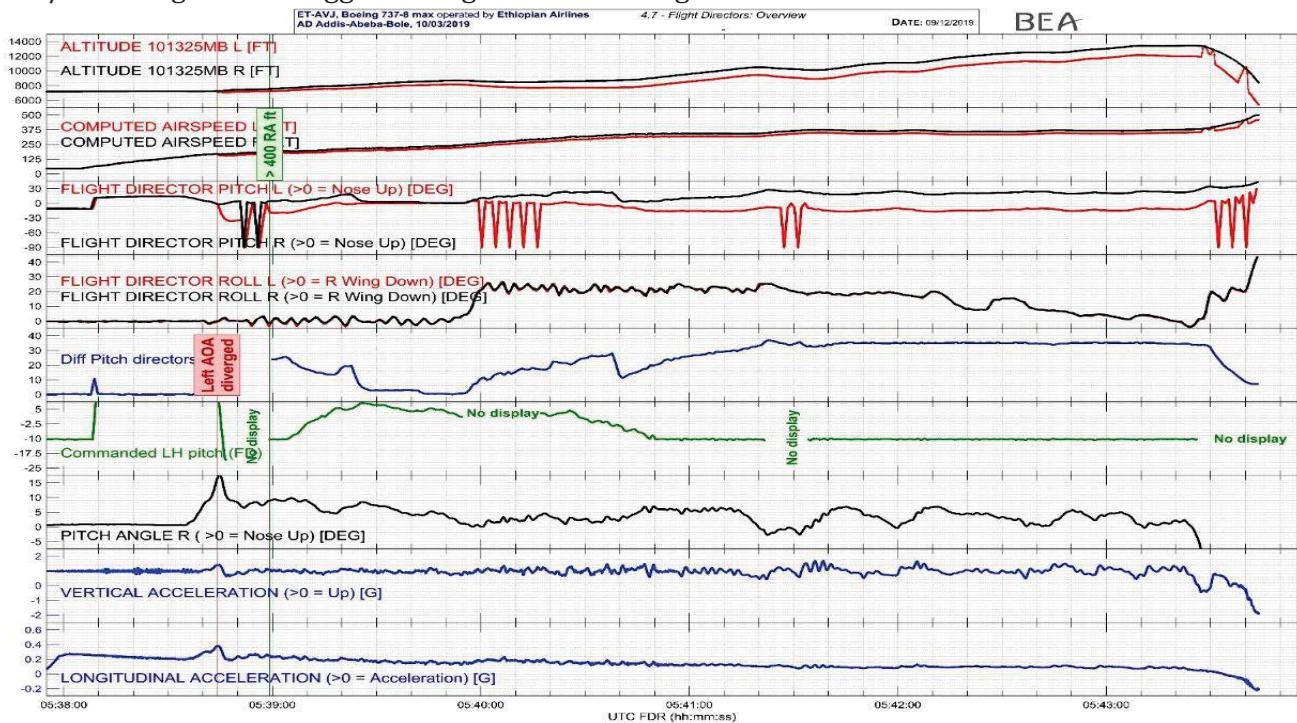
FIGURE 80: FLIGHT DIRECTOR DURING FLIGHT

Each time the LH or the RH invalidity pattern was recorded, the recorded invalidity code (NCD - No Computed Data) indicates that the pitch F/D bar was removed from the PFD (biased out of view or BOV). The F/D fail flag did not trigger during the accident flight.

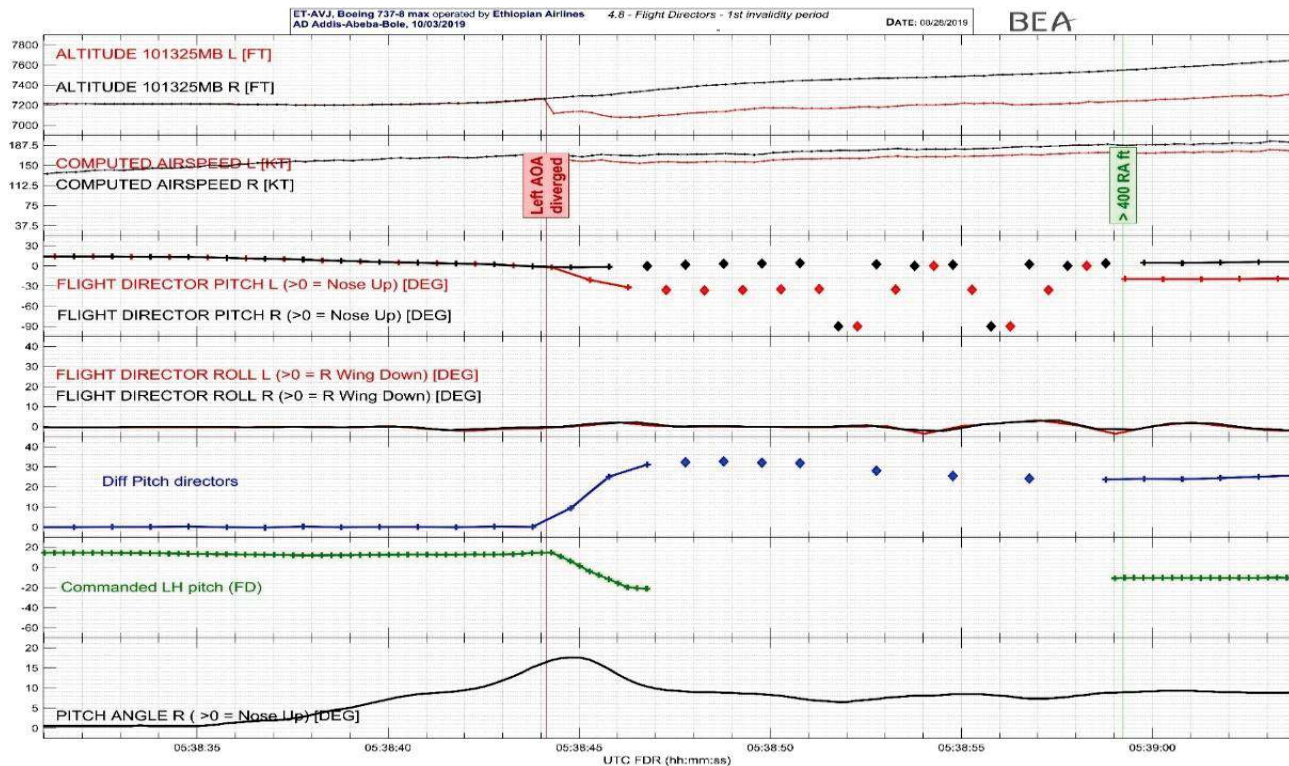
FIGURE 81: FLIGHT DIRECTORS - START OF THE FLIGHT

When the LH and RH AOA values diverged, LH pitch F/D commands recorded values quickly decreased to  $-32^\circ$  while RH pitch F/D recorded values slightly increased to  $-0.4^\circ$ . The difference between LH pitch F/D values and RH pitch F/D values were greater than the threshold above which FCCs comparators triggers and both F/D pitch were biased out of view.

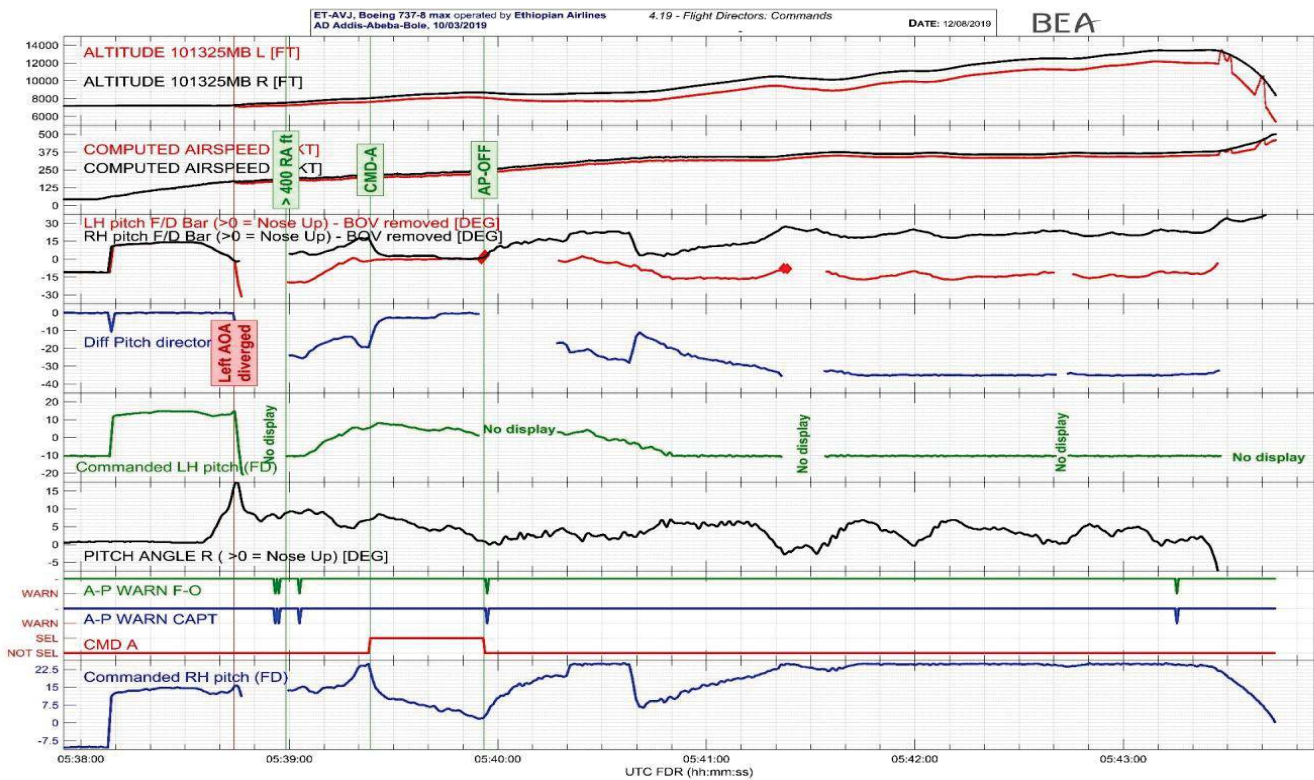
FIGURE82: PITCH F/D COMMANDS

**Note:** No anomalies were observed in the RH pitch F/D bar positions the RH pitch F/D bar positions are then considered as valid positions based the Airplane attitude, altitude, and speed engaged modes. Except under the autopilot, the LH pitch F/D bar position was at least  $10^{\circ}$  lower than the RH pitch F/D bar. The commands provided by the LH pitch F/D bar were not consistent with the true Airplane status and the engaged modes, due to the effects of the erroneous AOA on the calculation of the minimum operation speed.

- Each time the LH pitch F/D bar automatically reappeared, without any crew action. The underlying cause of the anomalous LH pitch F/D behavior was confirmed to be erroneous LH AOA sensor values. Erroneous AOA results in display of the IAS DISAGREE and ALT DISAGREE alerts. The appropriate NNC for these alerts is the Airspeed Unreliable NNC, which, as a memory item, requires that the crew turn off both flight directors.

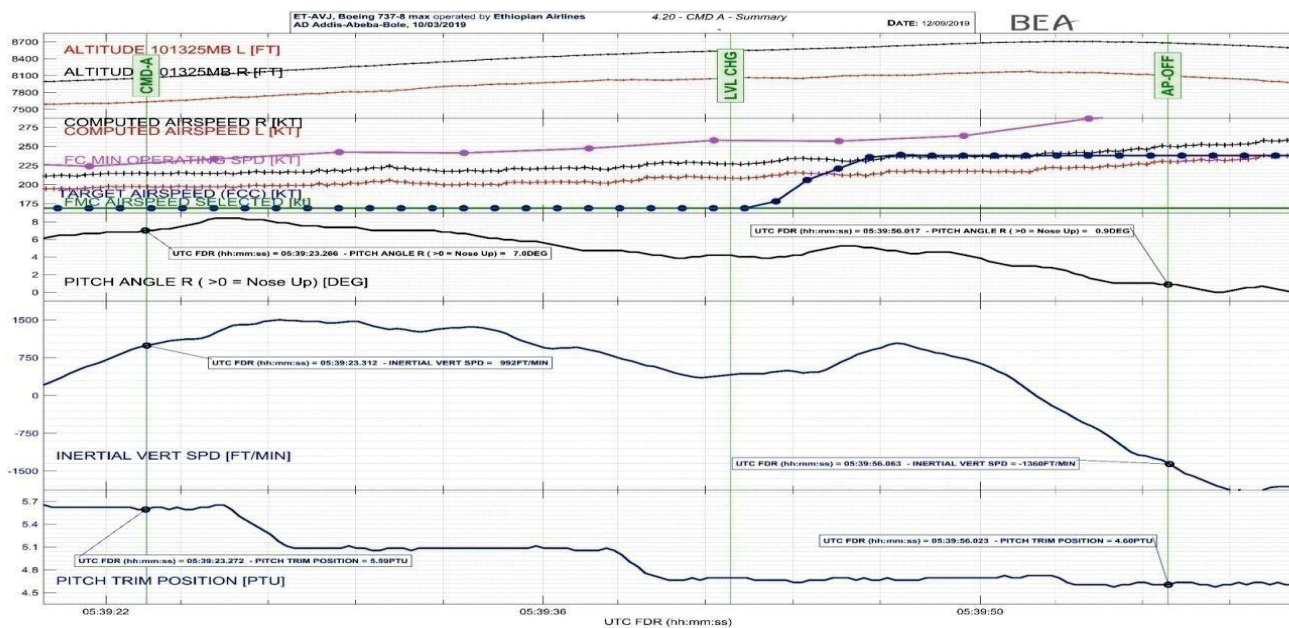
FIGURE85: CMD A - SUMMARY

At the connection of CMD A, the Airplane was climbing with a vertical speed of around 1,000 ft/min increasing, a pitch value of around 7° increasing and a stabilizer position of 5.6 units.

When CMD A automatically disconnected, the Airplane was descending with a vertical speed of around -1,400 ft/min, a pitch angle of around 1° and a stabilizer position of 4.6 units.

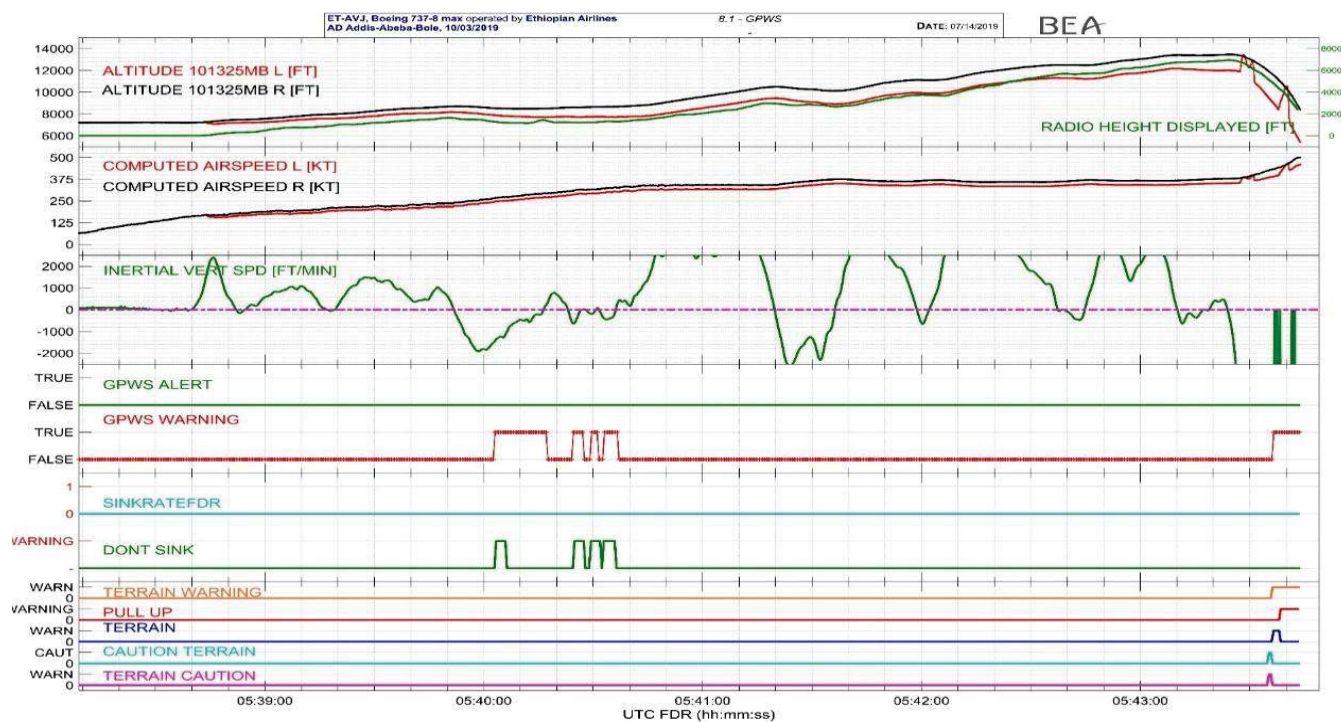
FIGURE87: GPWS ALERTS

At the end of the flight, the combination of the vertical speed and the height of the Airplane made the terrain and pull up warning trigger.

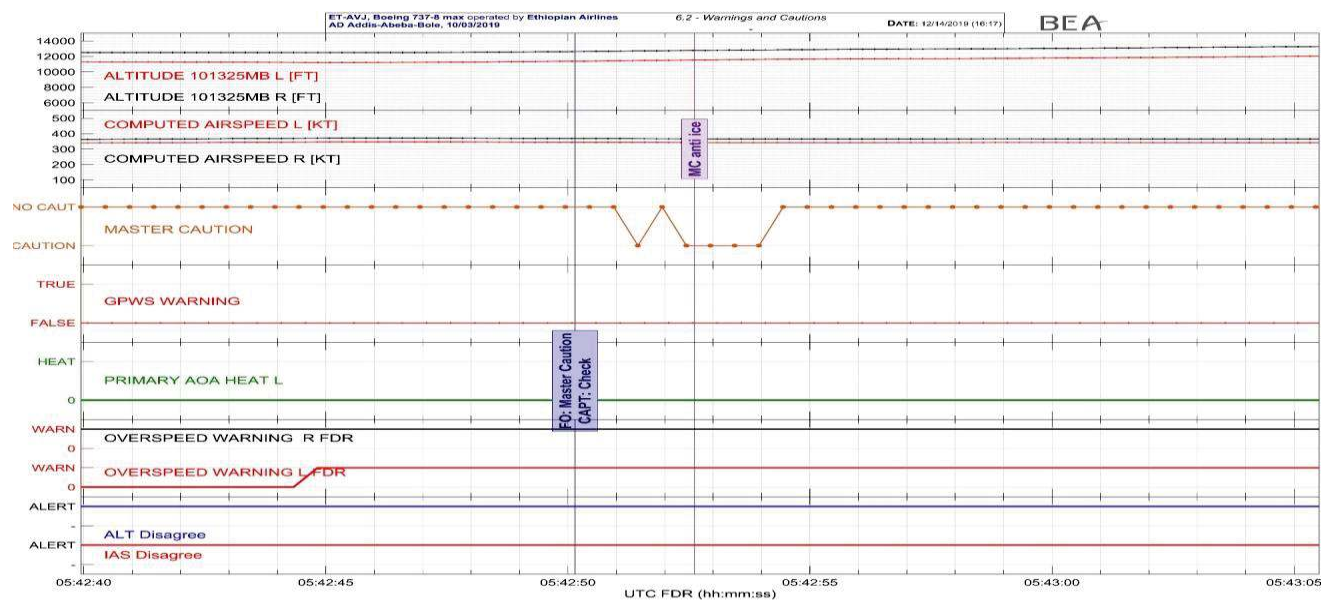
FIGURE 89: MASTER CAUTION RECALL

The first master caution triggered at 5 h 38 min 48 s during 7s. The reason for this master caution was anti-ice left alpha vane. This caution is triggered when low current is sensed in the AOA vane internal heater circuit. At 5 h 42 min 47 s, the crew exchanged about the master caution.

Then master caution triggered a second time at 5 h 42 min 51 s during 2.5 s. The crew detected: "Master Caution/anti Ice/left Alpha Vane".

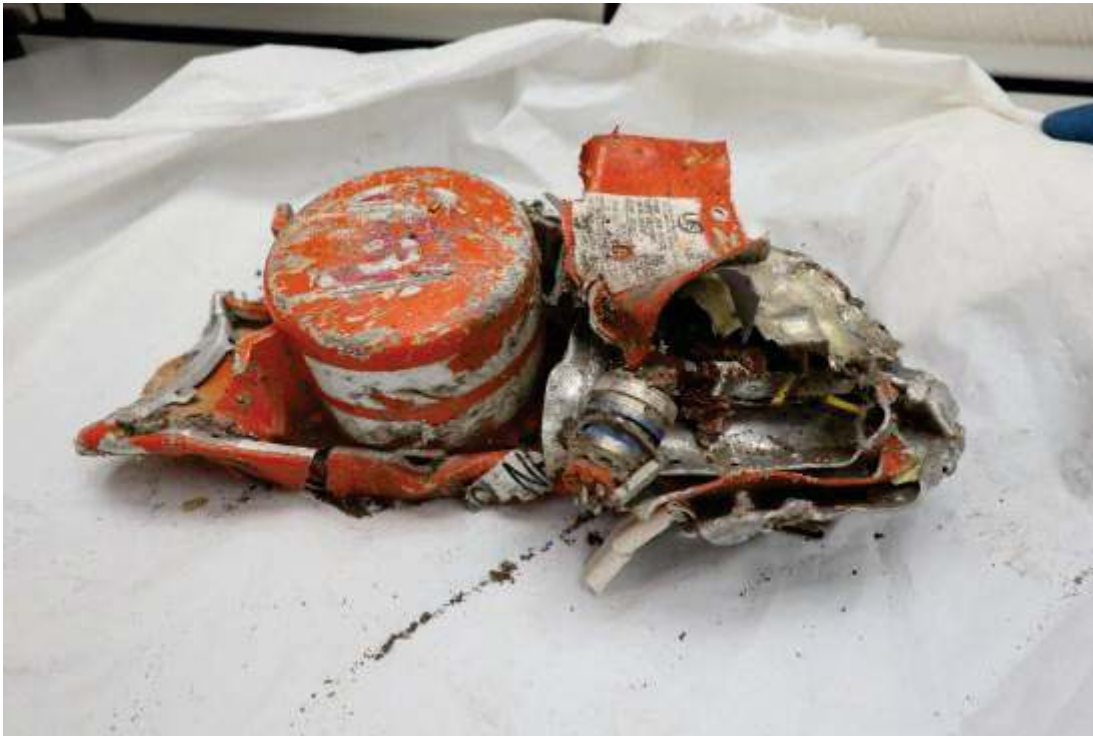
FIGURE 1: FDR FOUND IN THE SUITCASE BROUGHT BY ETHIOPIAN EAIB

The FDR was first visually examined. The chassis was damaged and folded on itself. The acquisition boards were visible as well as some internal connectors. The protected module Crash Survival Module Unit (CSMU) was still attached to the chassis and presented scratches. There was no ULB attached to the CSMU. A recorder identification plate was found close to the CSMU on the chassis, but not fixed to the chassis, on which the following numbers were written: P/N 2100-4945-22, S/N 001217995

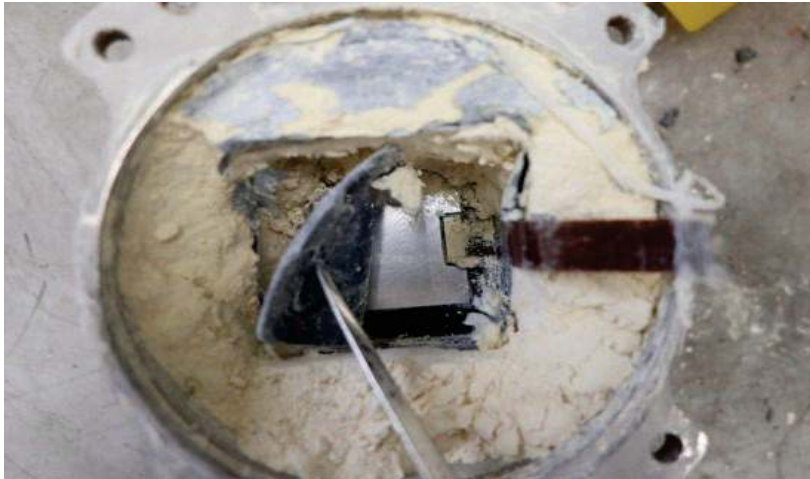
**FIGURE 2: AT OPENING THE FDR CSMU, SHOWING THE MEMORY PUCK AND FLEX**

As the chassis and the CSMU were damaged, it was decided to open the CSMU to extract the memory puck. The CSMU was unscrewed from the chassis. The interface board located under the CSMU was damaged. The flex connector between the interface board and the memory puck was found broken and the flex between the interface board and the chassis was also found broken.

It was first attempted to extract the memory puck by gently pulling on the flex. It was found that the connector was not properly attached to the memory puck.

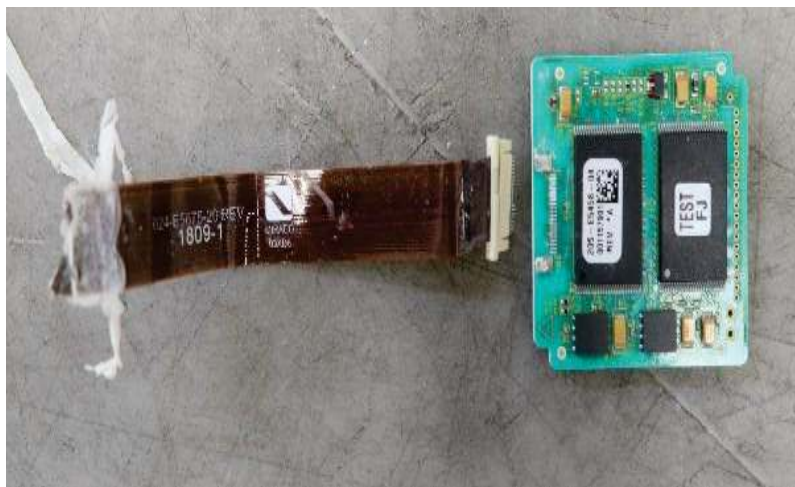
**FIGURE3: FDR MEMORY BOARD, FLEX AND CONNECTOR**

When examining the flex and connector, it was found that the missing pads from the memory board had migrated to the connector pins. There were also pieces of PCB material on the connector pins.
