**AIRCRAFT ACCIDENT INVESTIGATION BUREAU**

**INVESTIGATION REPORT ON**

**ACCIDENT TO THE B737-MAX8 REG. ET-AVJ OPERATED  
BY  
ETHIOPIAN AIRLINES**

Report No. AI-01/19  
Pub, Date December 23, 2022

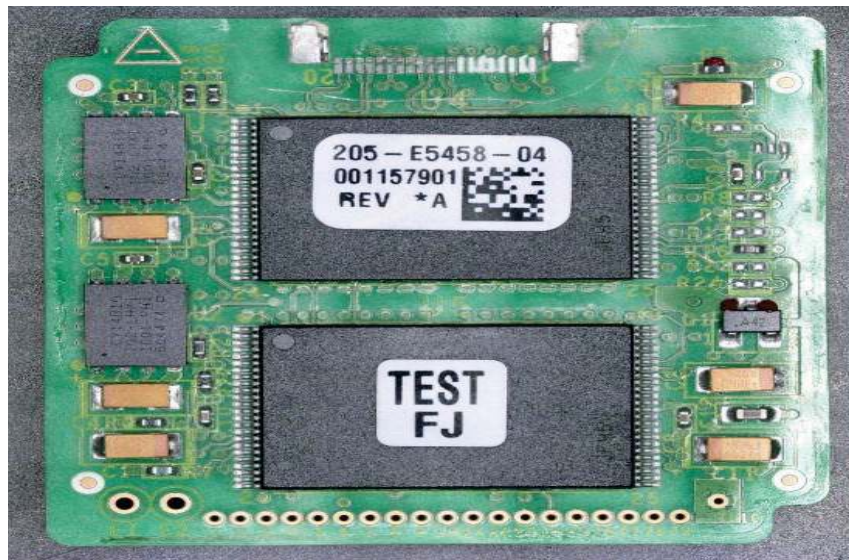
FIGURE 4: FDR MEMORY BOARD

The memory board was visually inspected with a Keyence microscope. Apart from the connector pads, the memory board was in good condition. There was no trace of impact. The two memory chips as well as the micro-processor were found in good condition.

At the connector location on the memory board the first 8 pads (on Figure 4)) were found missing. The holes were filled with insulation dust. The last 12 pads were in good condition.

The FDR memory board was also inspected with the X-ray machine. This confirmed that the first 8 pads of the connector were missing on the memory board (*Figure 4*) and that the 12 others were in good condition. There was continuity between those 12 pads and their vias (left side on *Figure 4*).

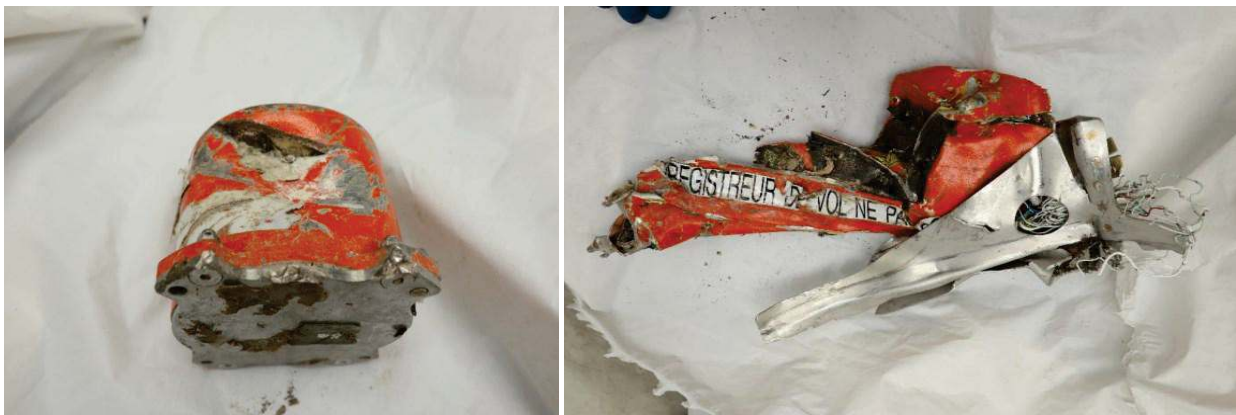
FIGURE: 8 CVR CSMU AND CHASSIS WHEN BROUGHT BY ETHIOPIAN EAIB

The CVR CSMU was already separated from its chassis when it was brought to the BEA facilities. There was no ULB attached to it and no identification plate was found on the CSMU.

The isolated chassis was damaged and still partially attached to the Airplane rack on which it was mounted. There was no identification plate on it. Wires were visible on the back side.

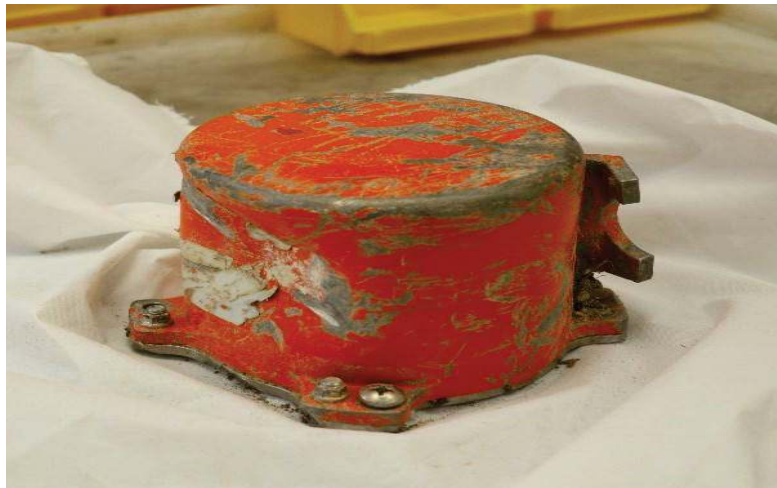
FIGURE 9: CVR WHEN OPENING THE SUITCASE BROUGHT BY ETHIOPIAN EAIB

The CSMU case showed an opening. The hole on the side opposite to the ULB fixation allowed seeing the internal insulation material

The interface board that is supposed to be located under the CSMU was missing and the flex connecting it to the memory puck was damaged.

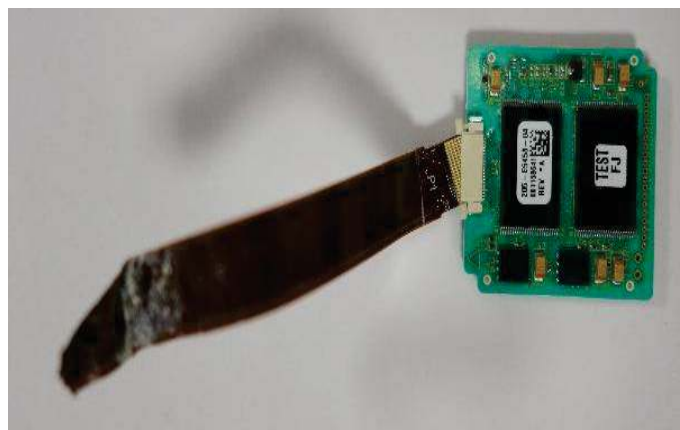
FIGURE 10: CVR MEMORY BOARD AND FLEX

The CVR memory board and flex were visually inspected with the Keyence microscope. There was no damage on the board and the connector was in good condition.
