Runway Incursion (RI)

Serious Incident Investigation Final Report

**Air Cargo Global Boeing 747-400SF,
OM-ACB and Hong Kong Airlines
Airbus A330-343, B-LNS at
Hong Kong International Airport
22 September 2017**

02-2021

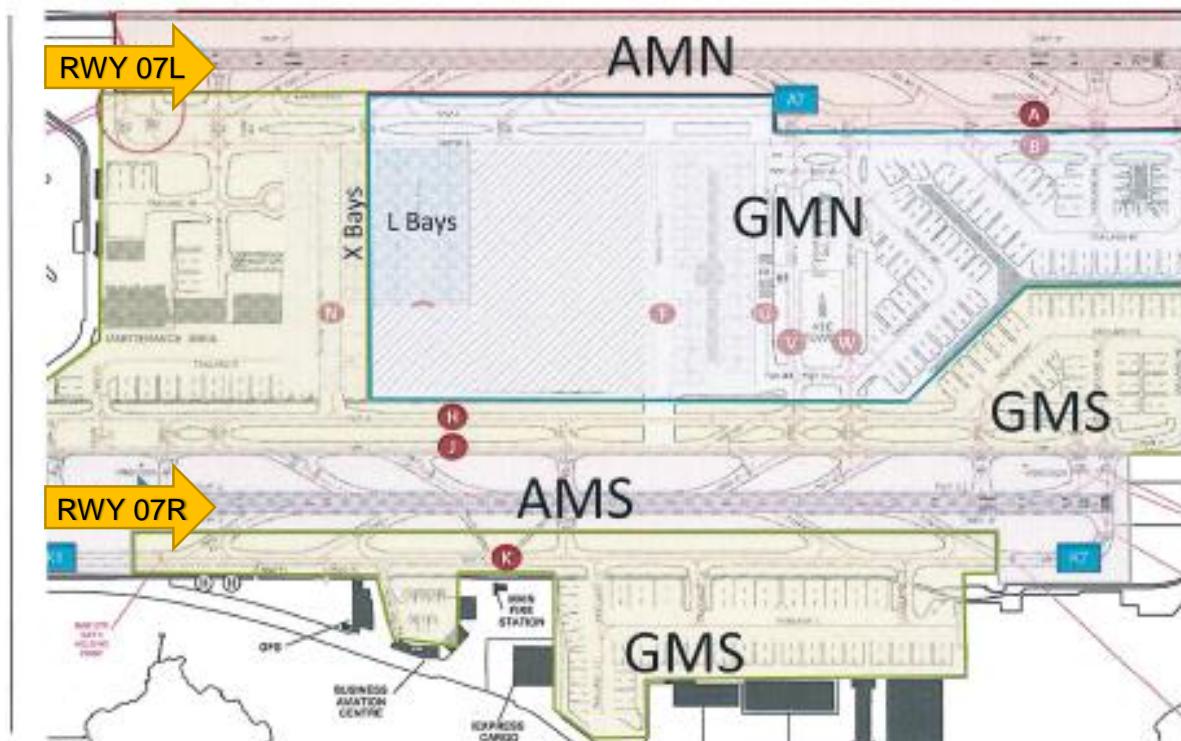
Figure 2: Division of controller responsibilities for Runway 07 operation

Figure 2 shows division of controller responsibilities when both Runway 07L and 07R are in use.
