Controlled Flight into Terrain Marginally Avoided

Serious Incident Investigation Final Report

**B747-87UF
Lo Fu Tau, Lantau Island,
Hong Kong
24 September 2017**

03-2021

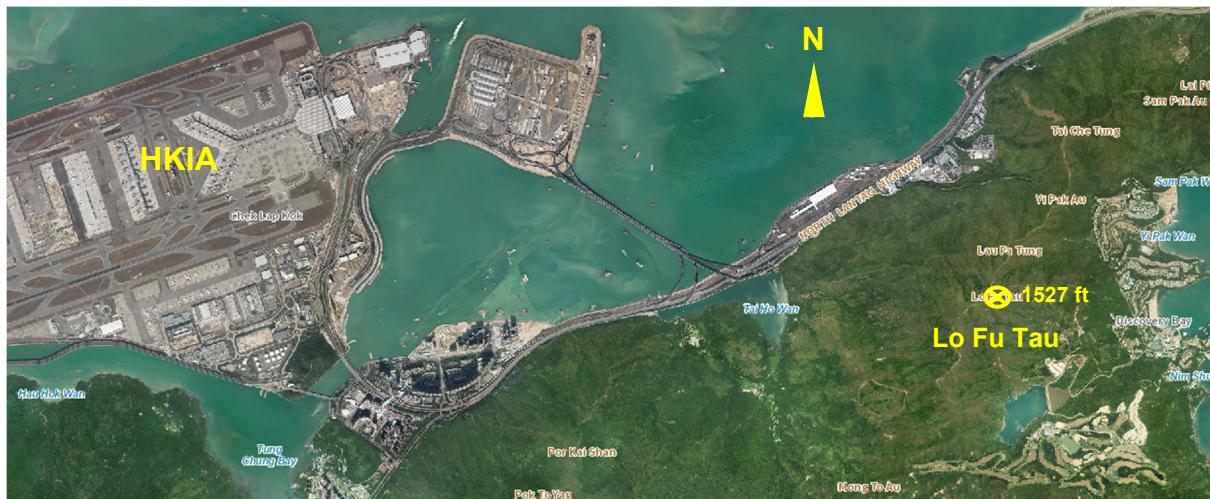
Figure 1: Overview of the area

At approximately 2,000 ft AMSL, the Enhanced Ground Proximity Warning System (EGPWS) on board the aircraft was triggered with a Mode 2A³ visual and the aural warning “TERRAIN, TERRAIN; PULL UP” annunciated. In response, the Pilot Flying (PF) reacted and the aircraft climbed, overflying the terrain. The aircraft evaded the high ground by approximately 670 ft AGL. Subsequently, the aircraft re-established the SID track at approximately 23:46 hrs and the flight continued without further incident. There was neither injury to personnel nor damage to the aircraft involved and no other air traffic was affected.
