Technical report IN-033/2019

Accident on 16 July 2019 involving a Boeing 737-800 aircraft operated by Air Europa, registration EC-LYR, and a Boeing 737-8AS aircraft operated by Ryanair, registration EI-FRP, to the south of Écija (Seville)

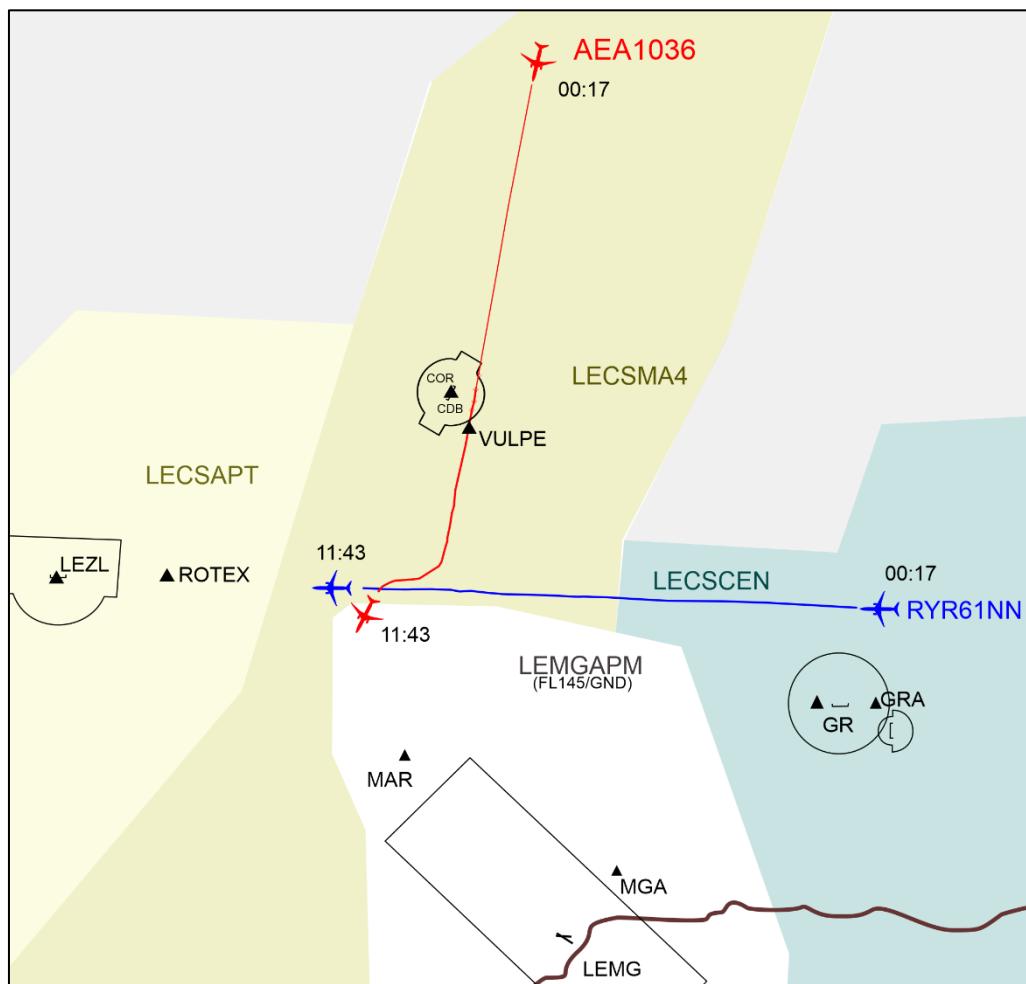
Despite the fact that 29 seconds before the loss of separation occurred, the air control system STCA-PAC proximity alert activated, the controllers of the different units failed to coordinate in time to prevent an infringement of the regulatory separation distance, which occurred at 13:11:02. In the end, the aircraft crossed paths at a minimum distance of 1.3 NM horizontally and 0 ft vertically, at 13:11:17.

Illustration 1: Overview of the trajectories of both aircraft and the affected control sectors

At 13:11:02, the loss of regulatory separation between the two aircraft occurred, which activated the STCA-VAC (minimum distance violation) alert. At this moment, the distance between them was 1.5 NM and 800 ft. Fifteen seconds later, they reached the point of closest proximity to one another, being separated by 1.3 NM and 0 ft.

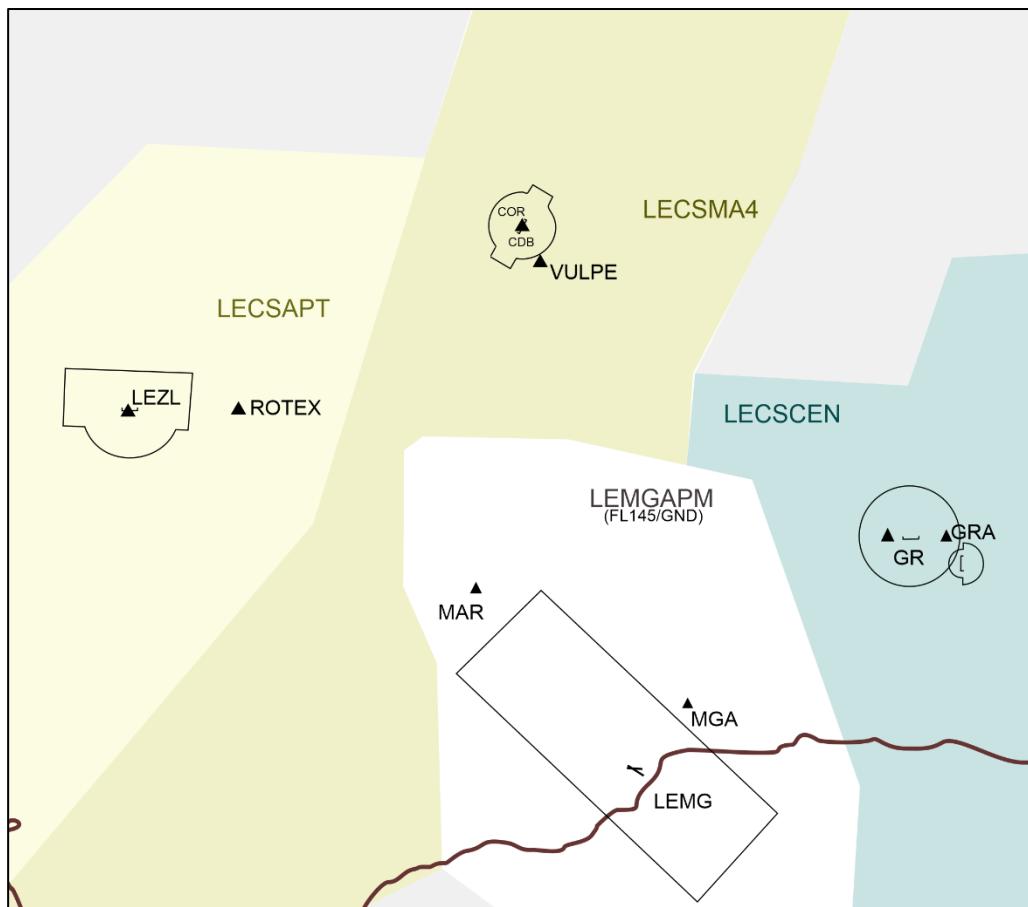
The LECSMA4 sector was the last route sector for the AEA1036 aircraft. It was subsequently transferred to the LEMGAPM sector to complete its instrument approach to Malaga airport. The vertical boundary of this last sector is from FL 145 to the ground.

The LECSCE4 sector was a route sector for the RYR61NN aircraft that was flying east to west. This aircraft was subsequently transferred to the collateral route sector, LECSMA4, which later handed it over to the LECSAPT sector for its approach to Seville Airport.

Illustration 3: Configuration of the sectors involved during the incident.
