Aircraft Accident Investigation Bureau of Myanmar

**FINAL REPORT ON TAIL STRIKE INVOLVING AN AIRBUS A330-343
AIRCRAFT (REG: 9V-SSI) AT YANGON INTERNATIONAL AIRPORT,
ON 25 NOVEMBER 2019**

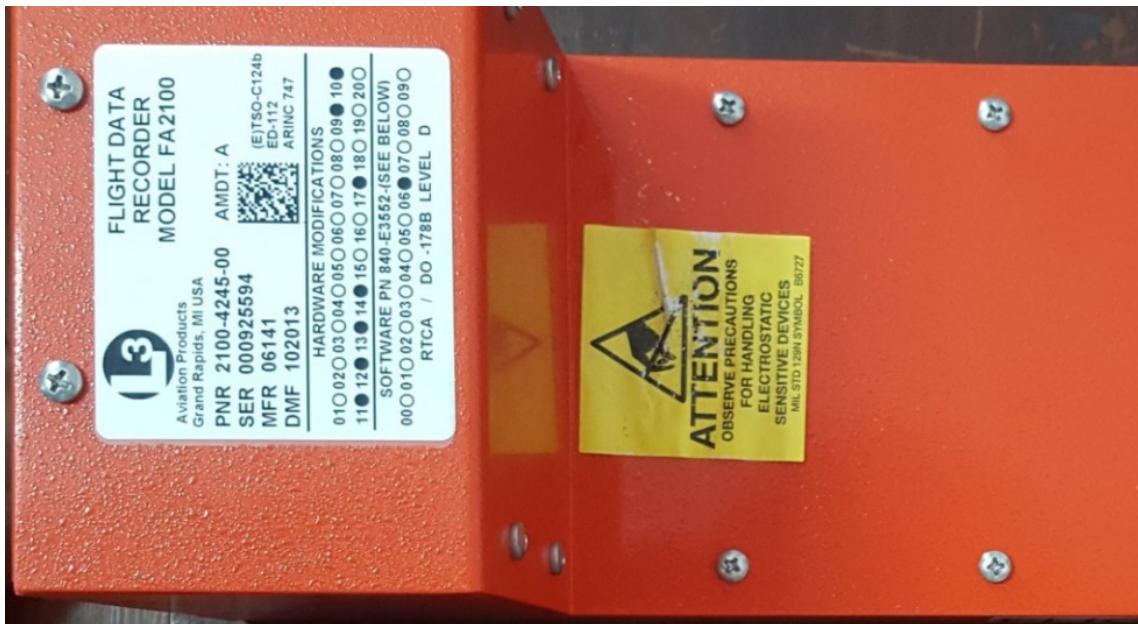
Figure (7) Flight Data Recorder

The recording of the FDR data was of good quality. The FDR contained 109 hours and 55 minutes and 58 seconds of flight data that included recorded data of the incident flight. The FDR had 1131 parameters in the data frame file.

The recorded data contained information pertaining to the event flight. The information was useful for the investigation team to analyse the sequence of events related to the occurrence.

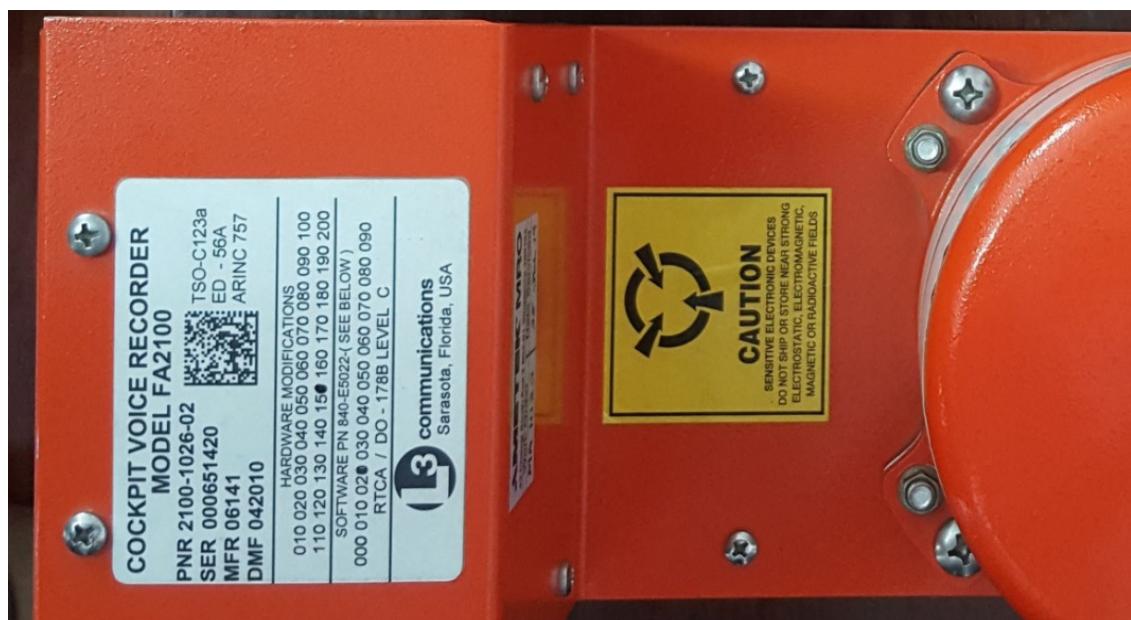
Figure (8) Cockpit Voice Recorder

The Cockpit Voice Recorder (CVR) was of Part Number 2100-1026-02 and Serial Number 010651420. The recorded data contained information pertaining to the event flight which was useful for the investigation team to understand the communication among the flight crew members during the occurrence.
